| <b>Title</b> | ECCOSORB Failure Analysis |

**TITLE:** ECCOSORB failure analysis

**DOC. TYPE:** TECHNICAL NOTE

**PROJECT REF.:** PL-LFI-TES-TN-015

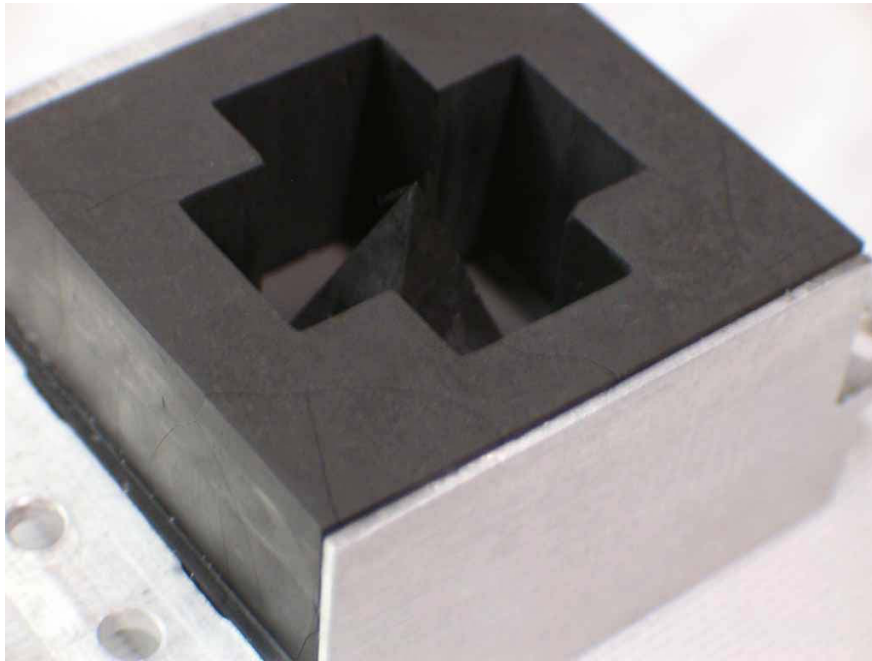
Some cracks on the ECCOSORB CR110 cross have been observed on one of the 30GHz targets (id parte) after the 15<sup>th</sup> thermal cycle to 4K. Flakes are also visible.

Figure 1: Images of the damaged target after the cryo cycles.

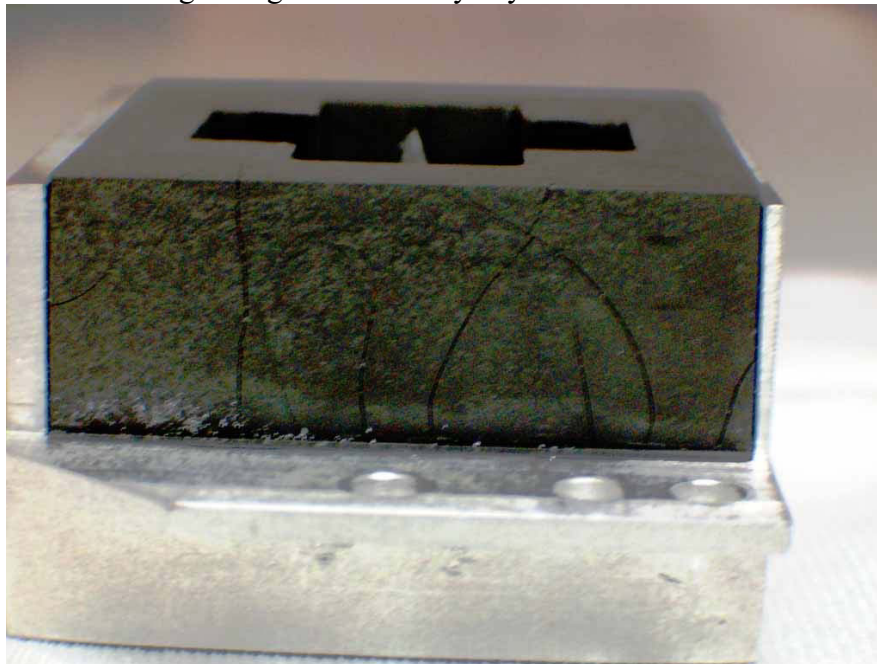
Figure 2: Lateral view of the damaged target

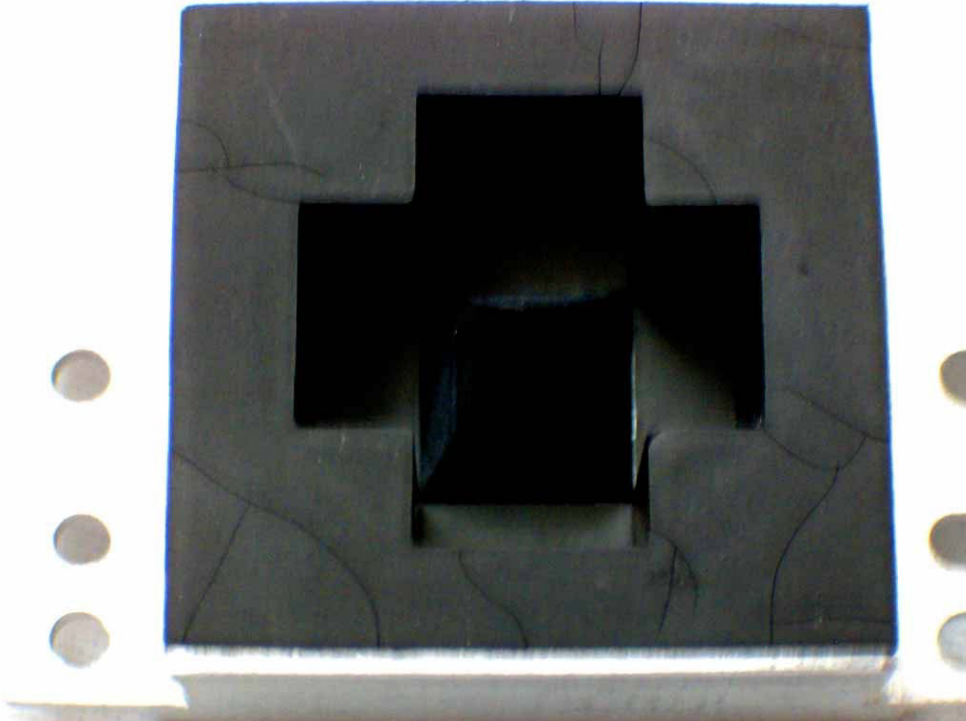
Figure 3: Another view of the damaged 30GHz target

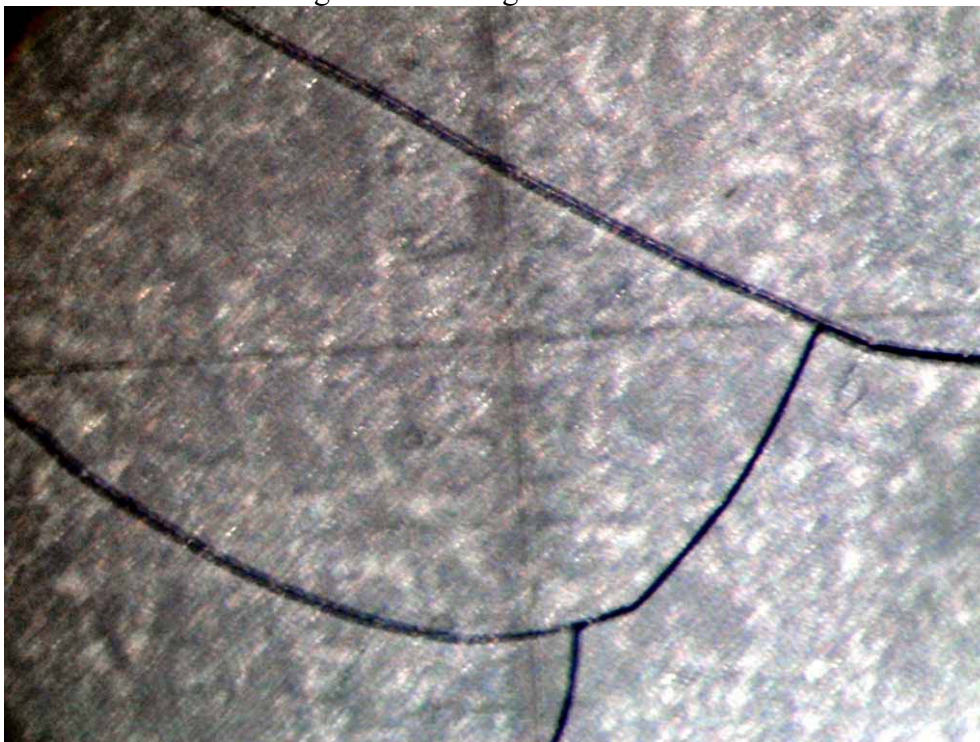
Figure 4: Details of some of the cracks view through a microscope.

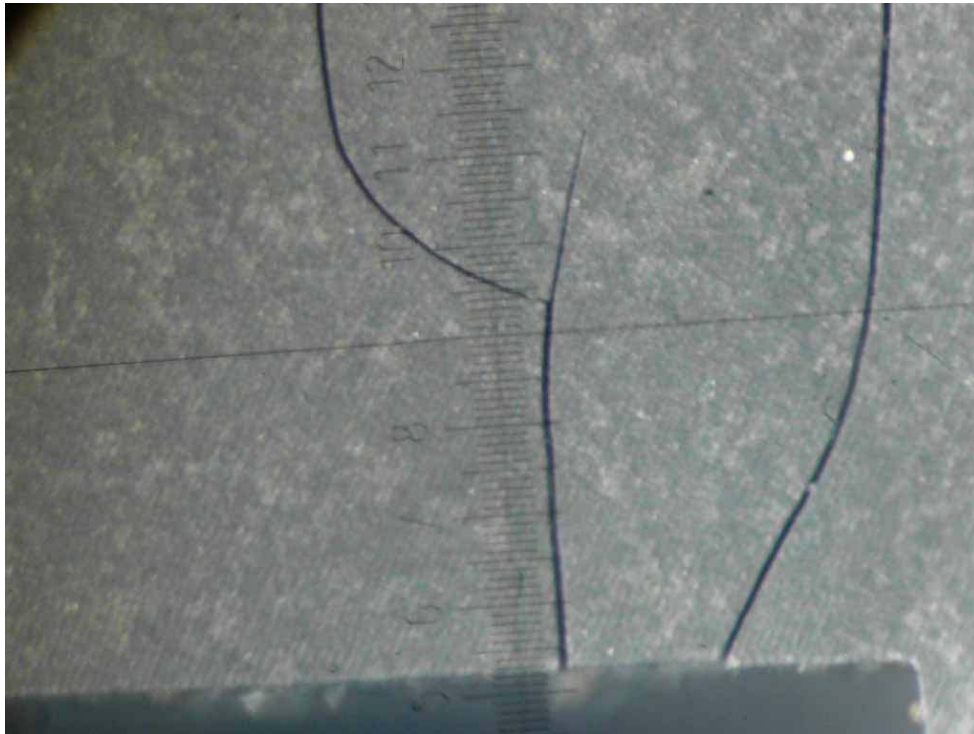
Figure 5: Details of some of the cracks view through a microscope: a reference scale is also visible.

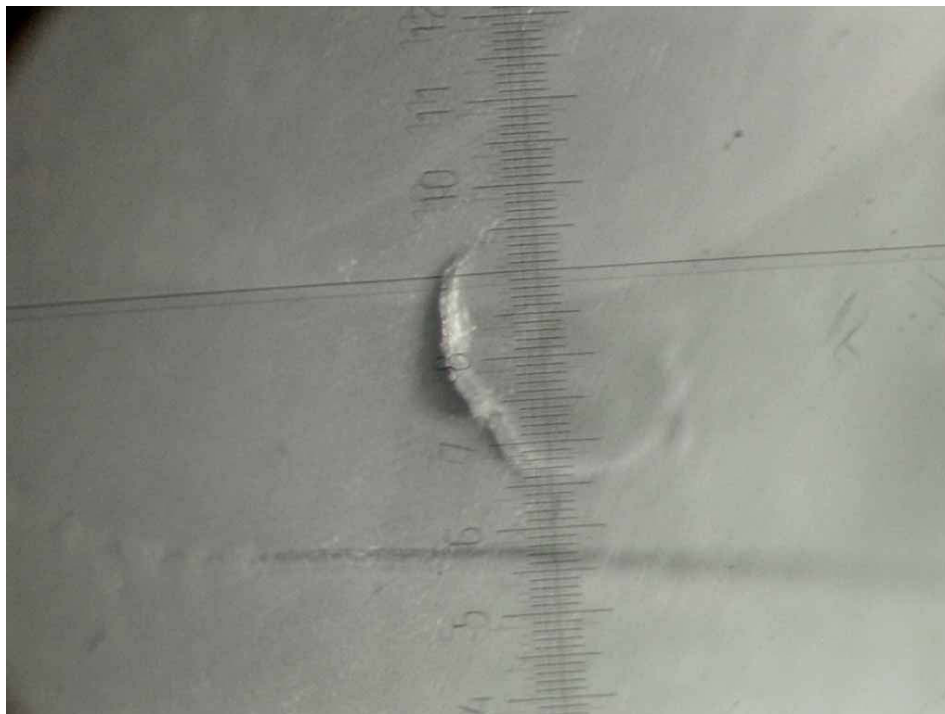
Figure 6: Details of one of the flakes view through a microscope

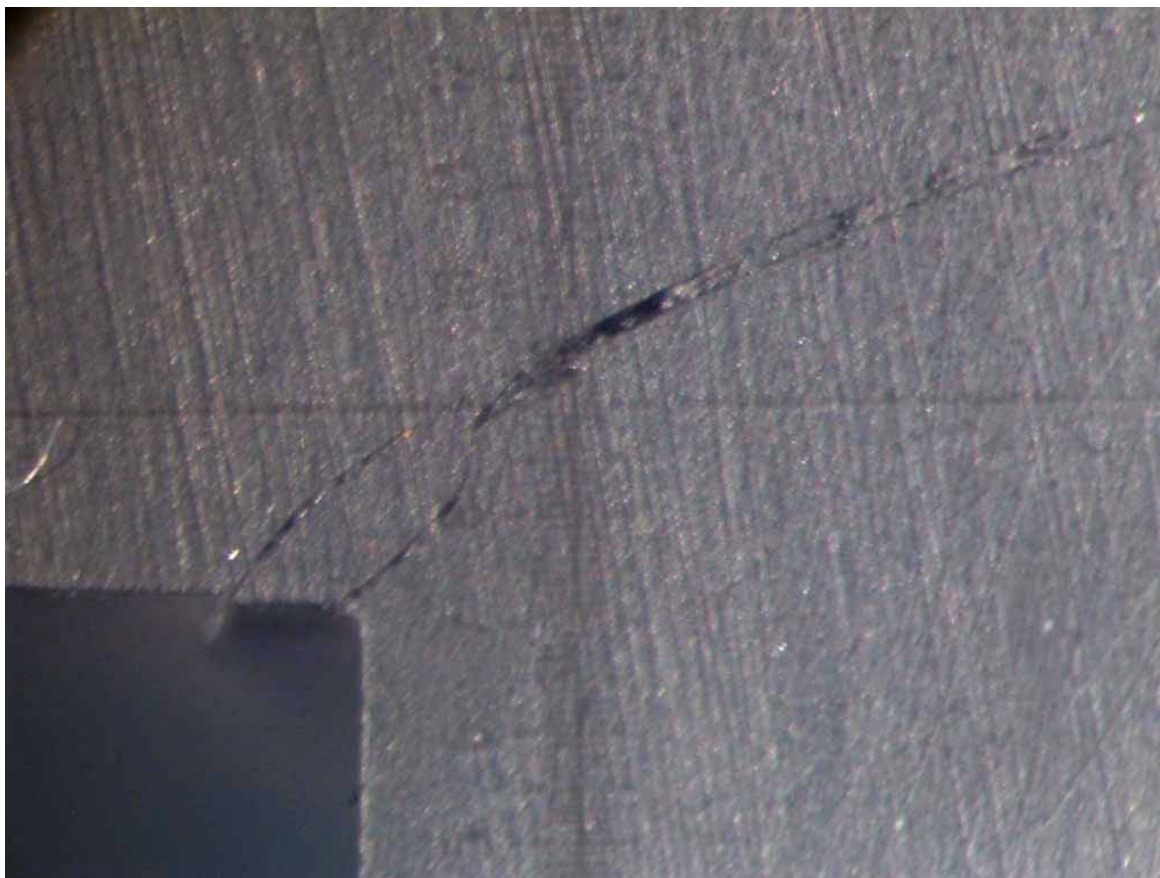
Figure 7: Details View through a microscope of the crack on the 44 GHz target (id parte)

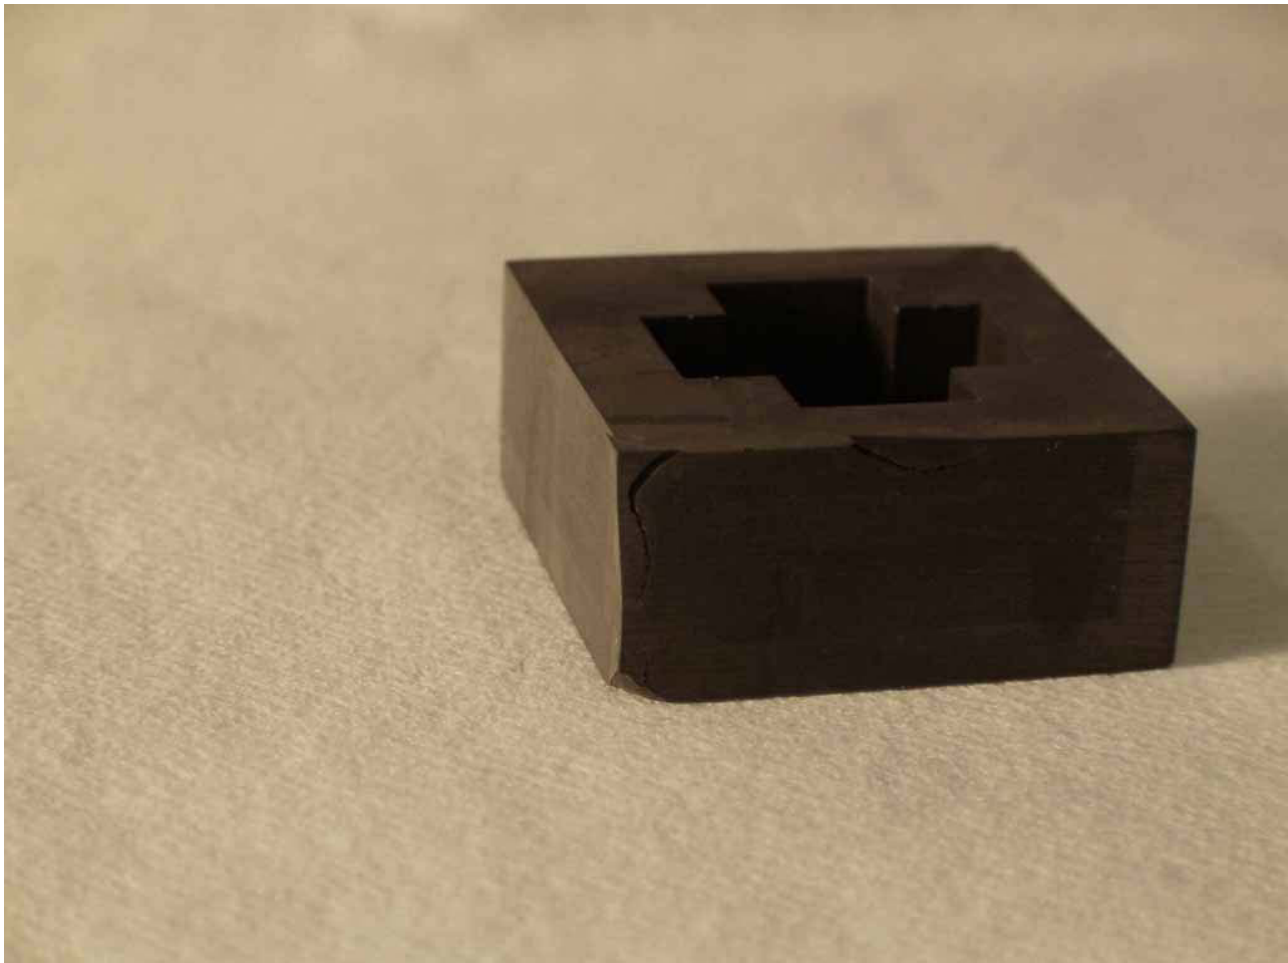
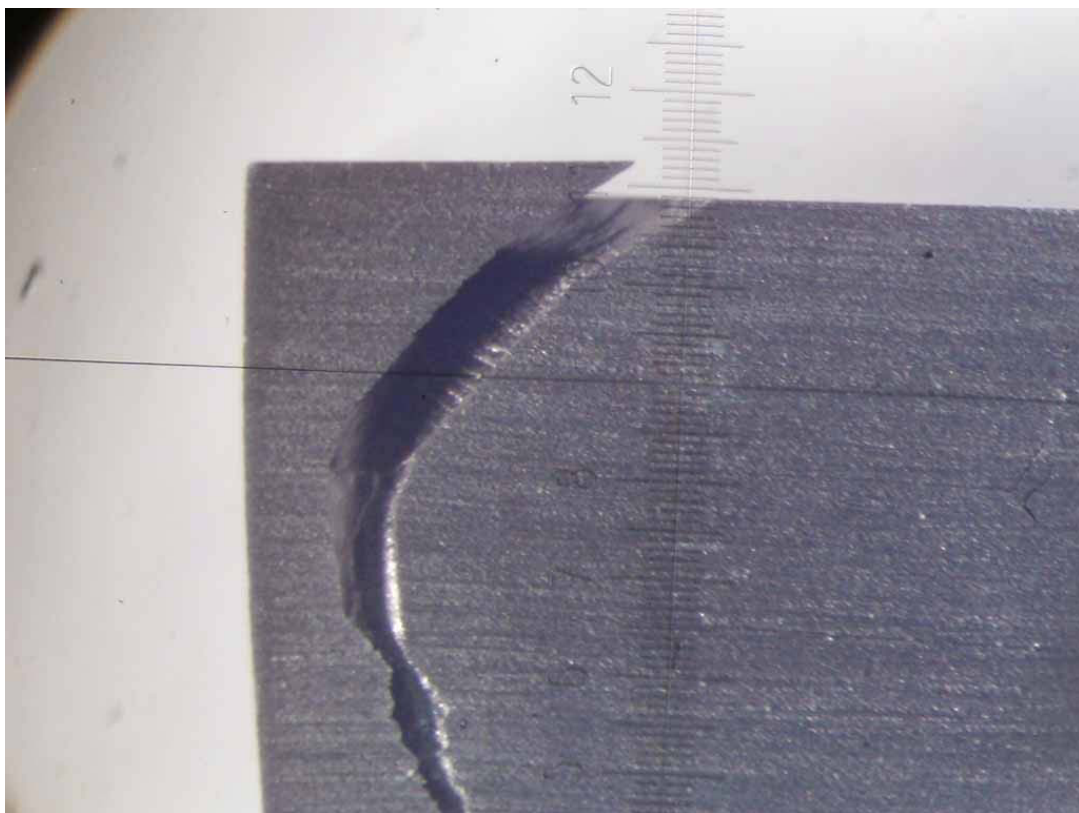
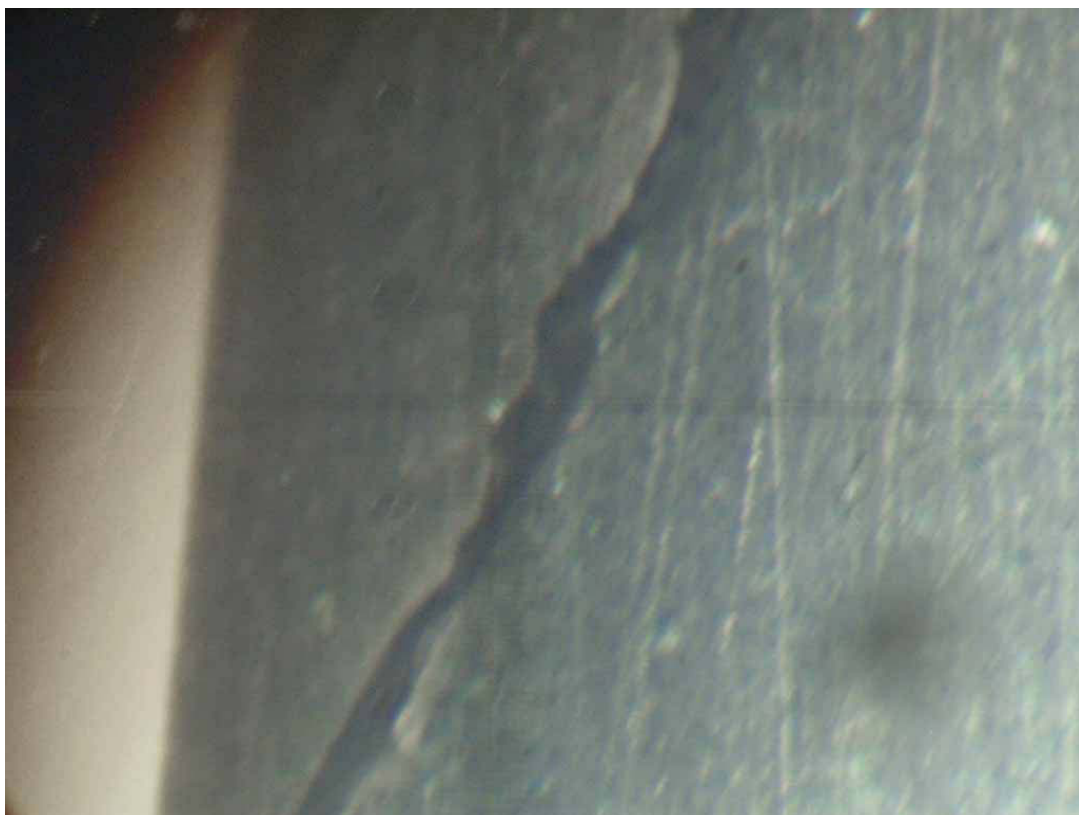
| DATE | TIME | TEST<br>CONDITION | NOTE |
|---|---|---|---|
| 09/03/05 | 12.30 | | <b>End of cycles.</b><br><b>Visual Inspection:</b> The specimen has several cracks on all the edge.<br><b>Mass:</b> 5.7[g] |

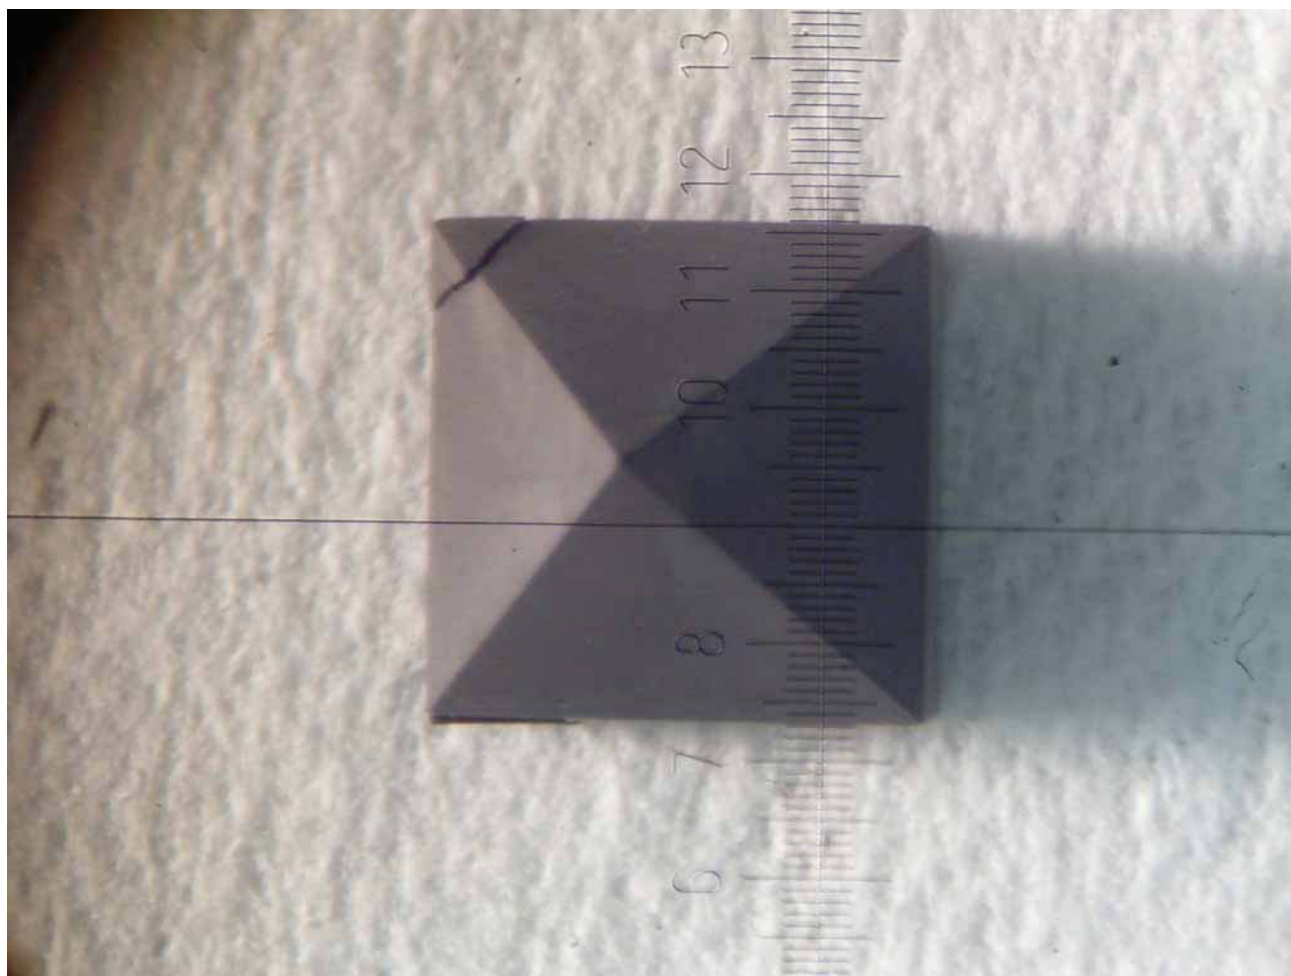
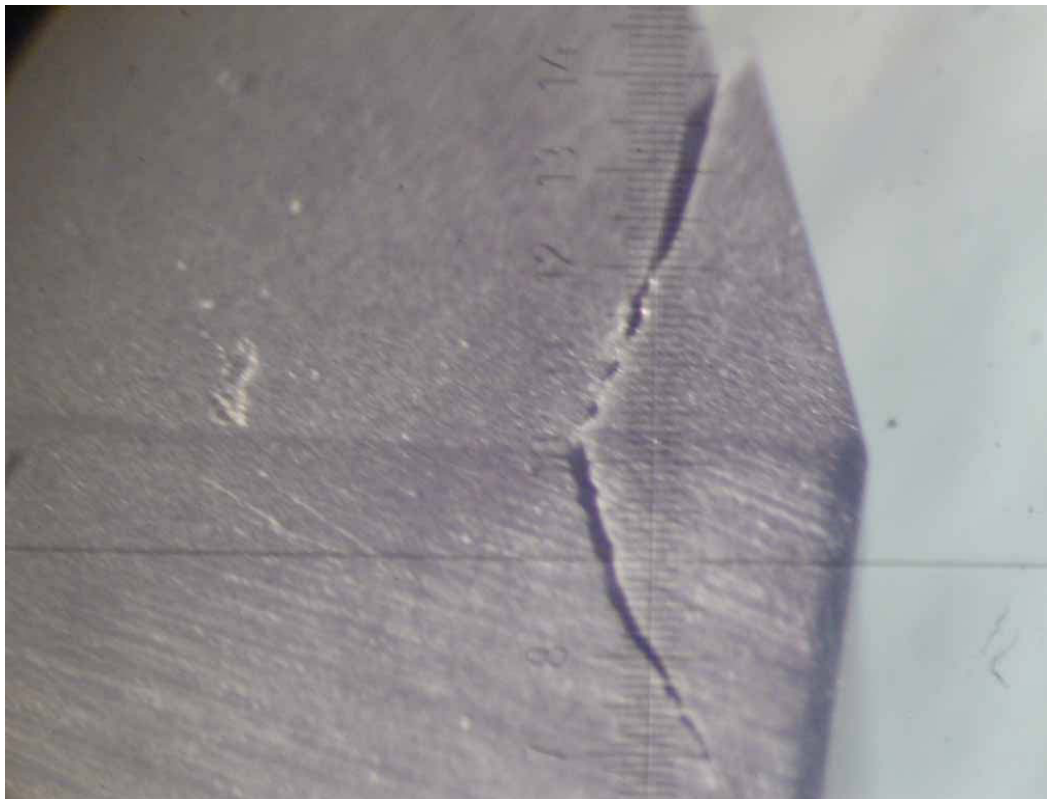
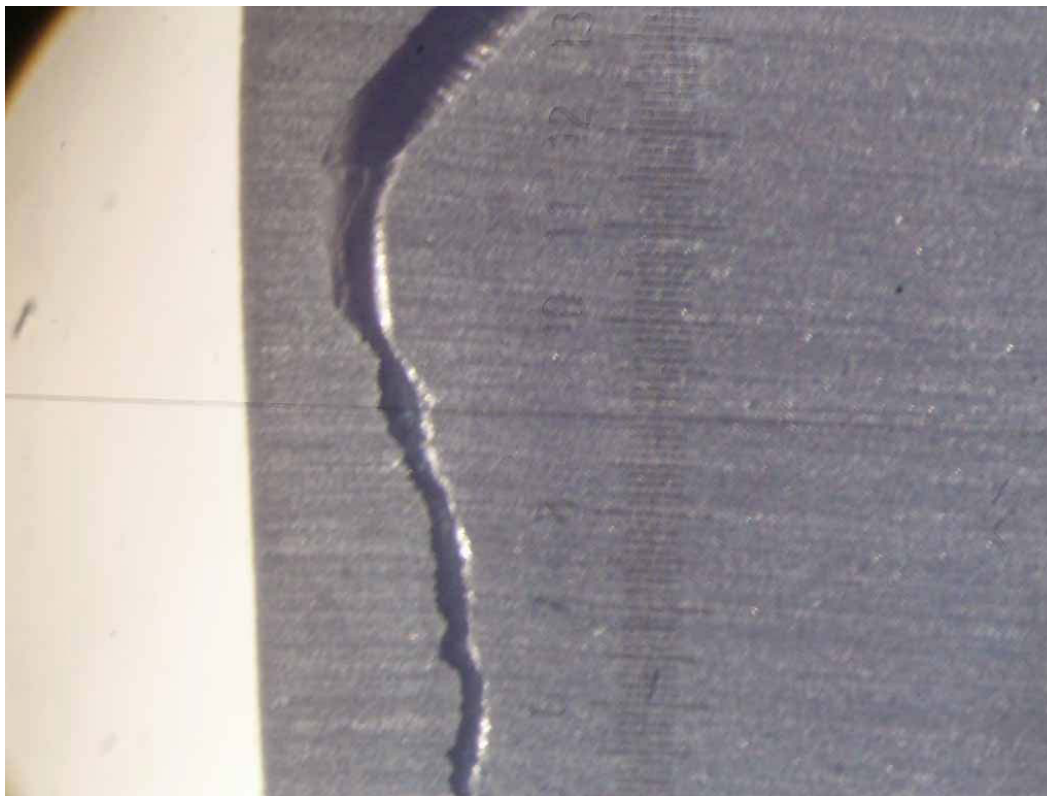
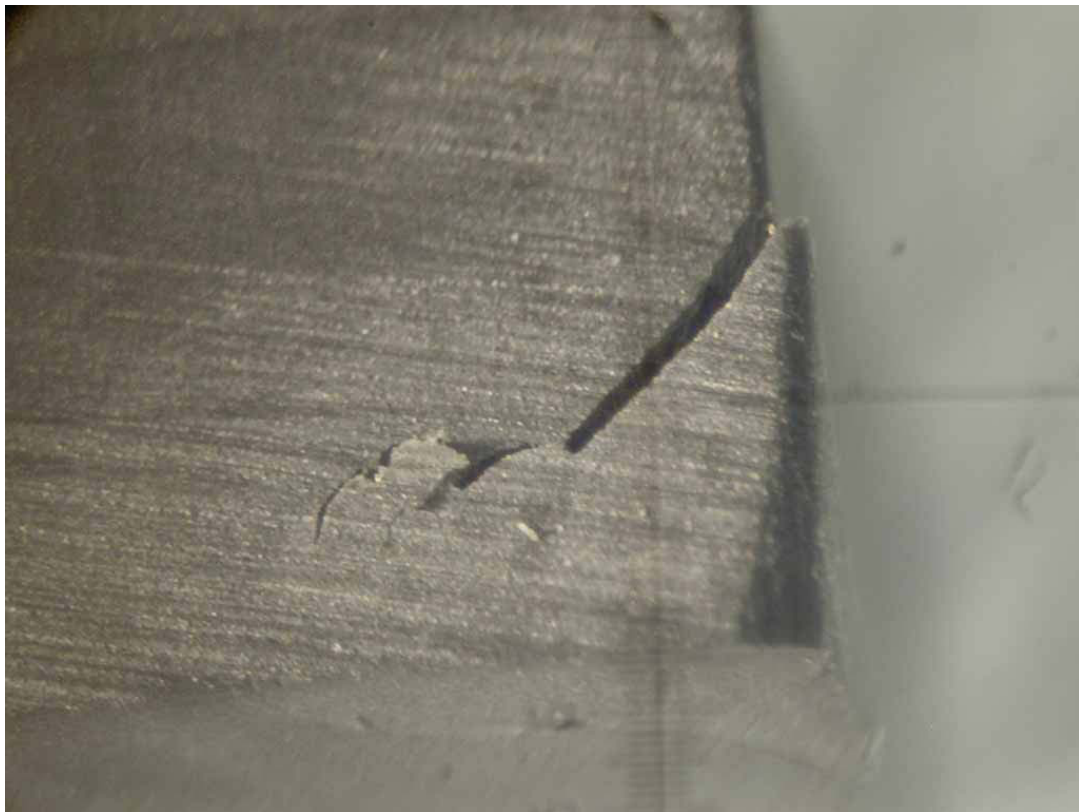
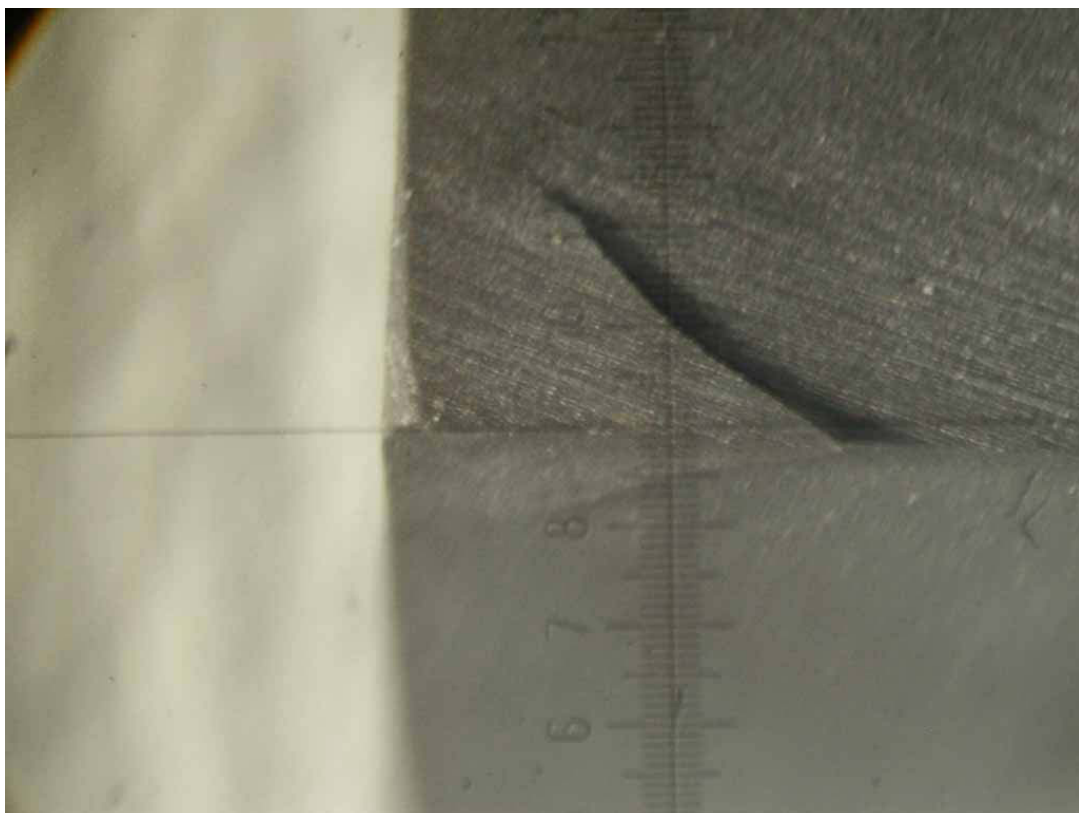
## 10.2 Specimen 1b – Pyramids @44GHz acetone&ultrasound

| DATE | TIME | TEST<br>CONDITION | NOTE |
|---|---|---|---|
| 09/03/05 | 12.30 | | <b>End of cycles.</b><br><b>Visual Inspection:</b> The specimen has several cracks on all edges.<br><b>Mass:</b> 0.5[g] |

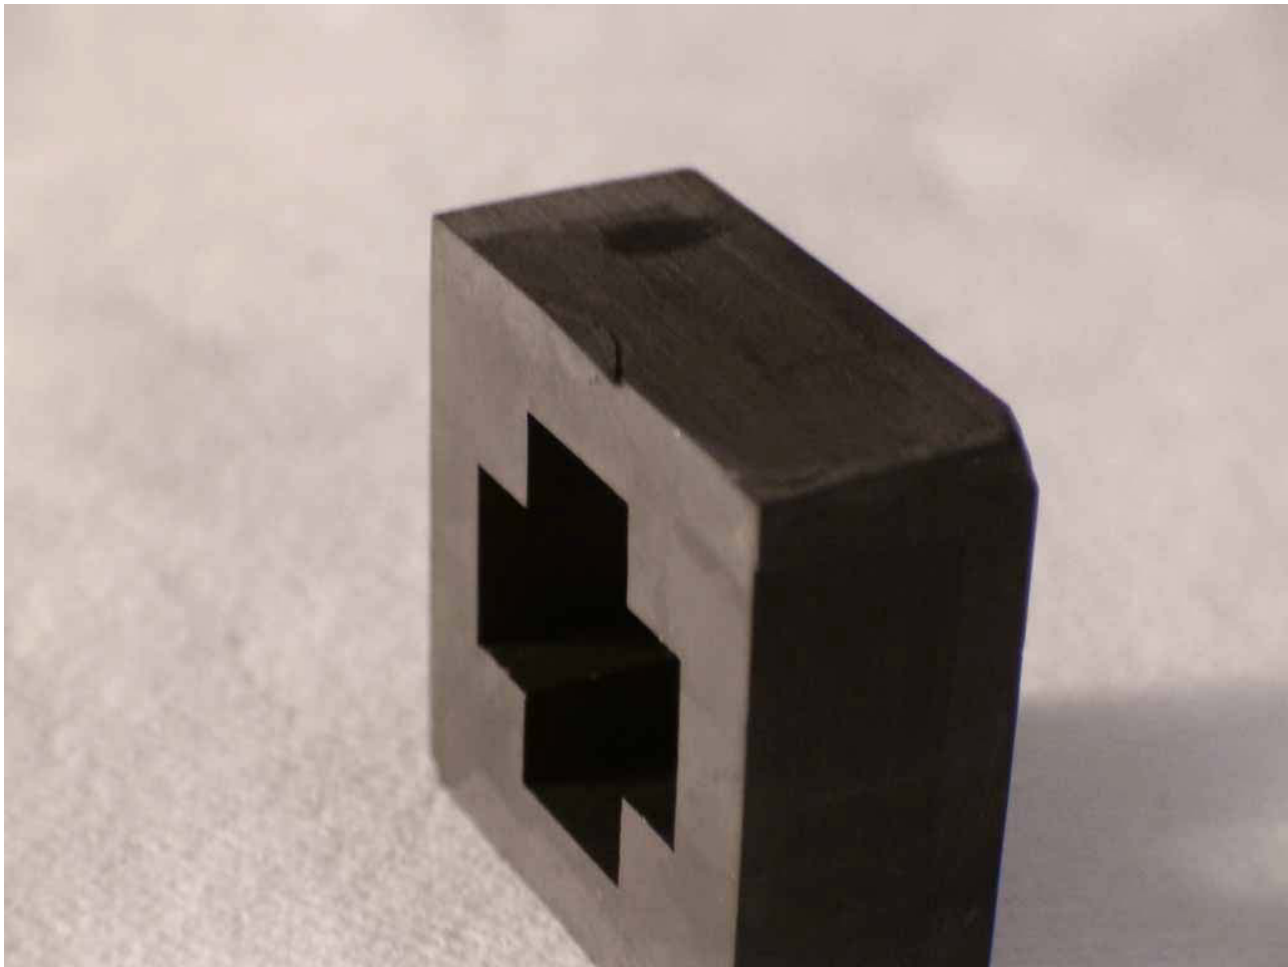
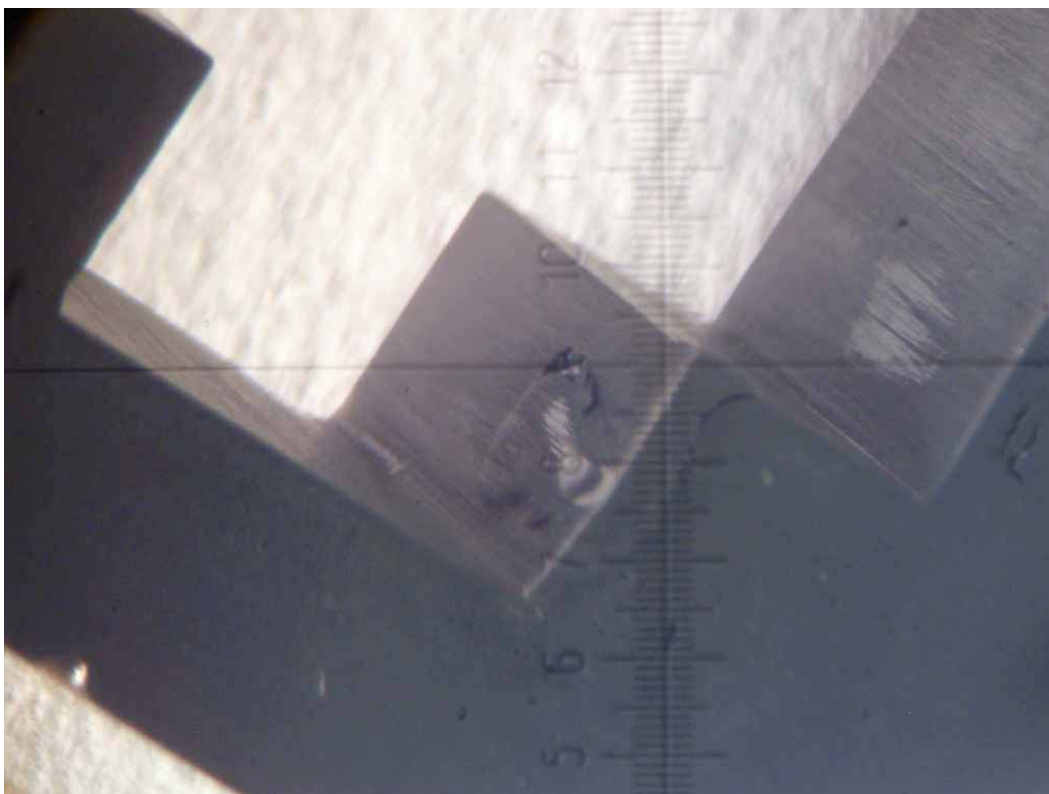
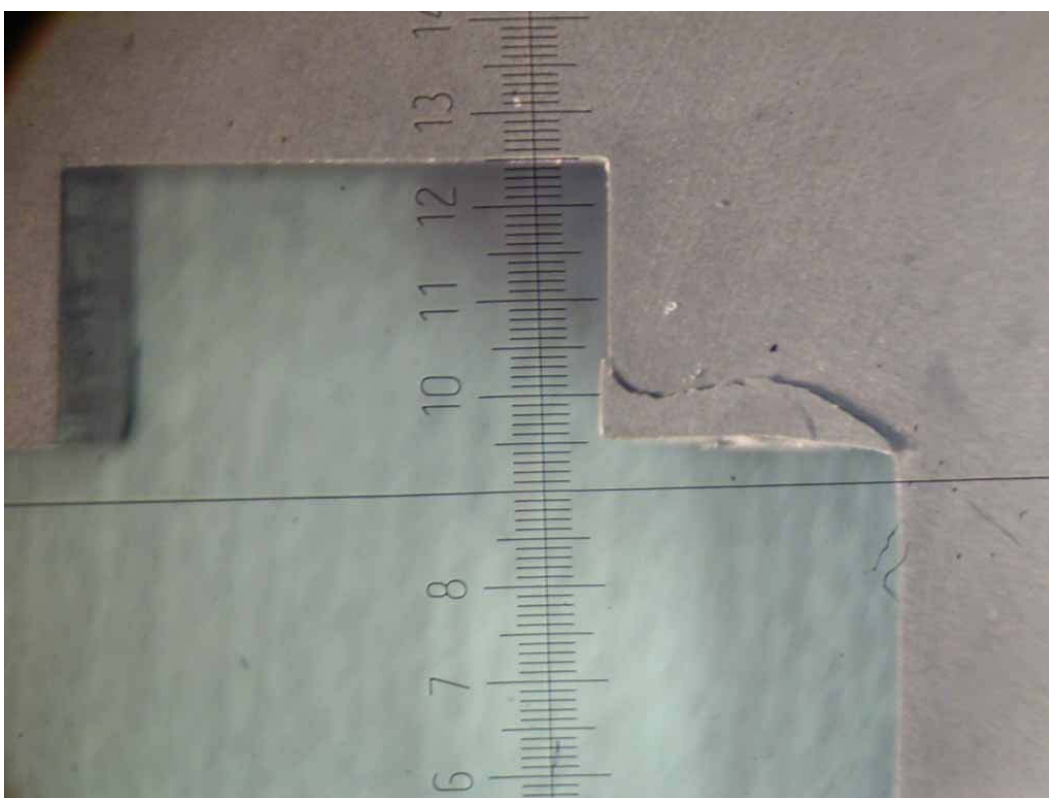
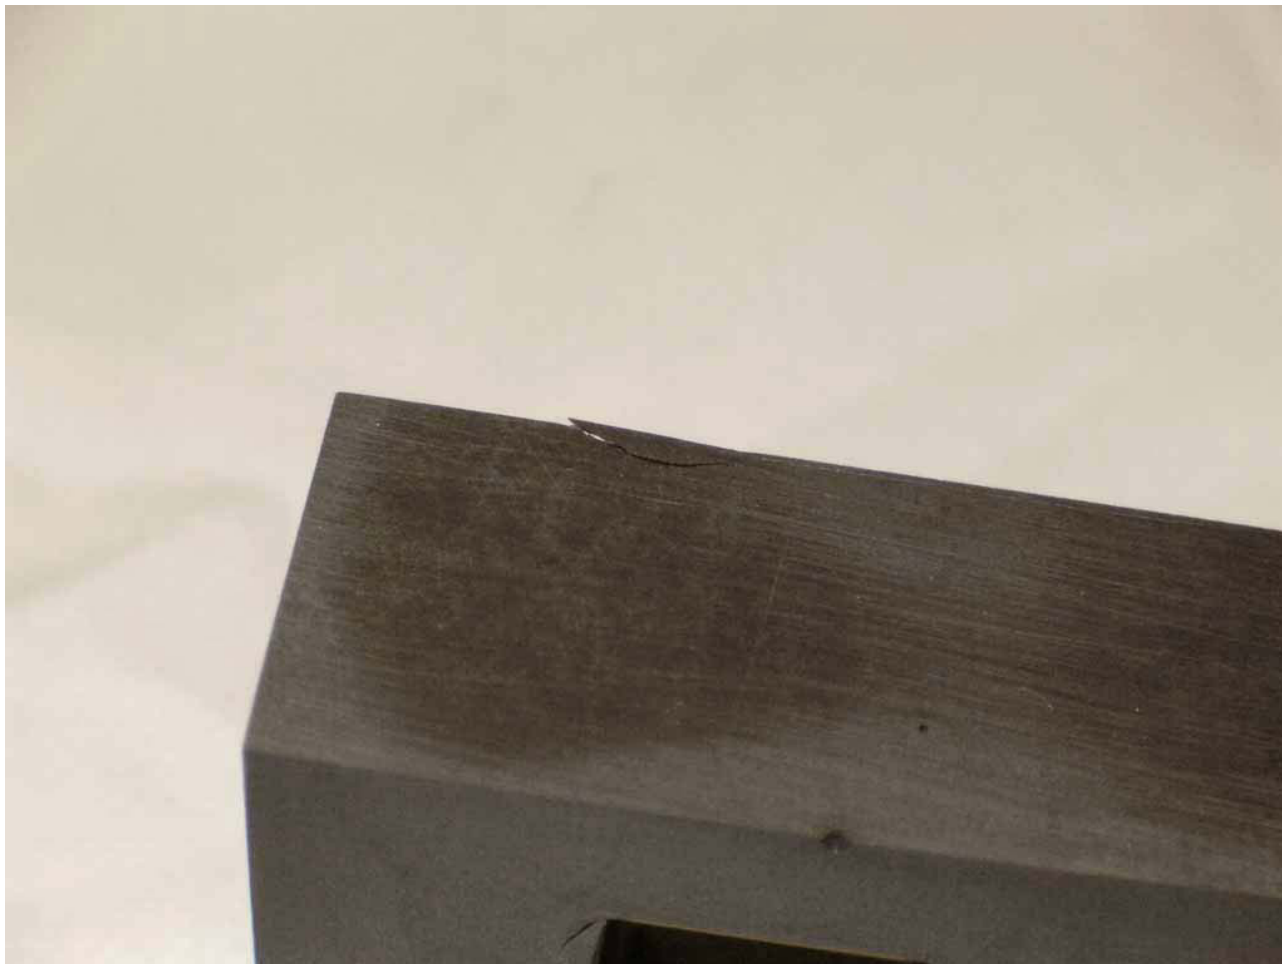
### 10.3 Specimen 2 – Cross @30GHz acetone&ultrasound

| DATE | TIME | TEST<br>CONDITION | NOTE |
|---|---|---|---|
| 09/03/05 | 17.00 | | <b>End of the cycle</b><br><b>Visual Inspection:</b> There are visible cracks on all the edges |

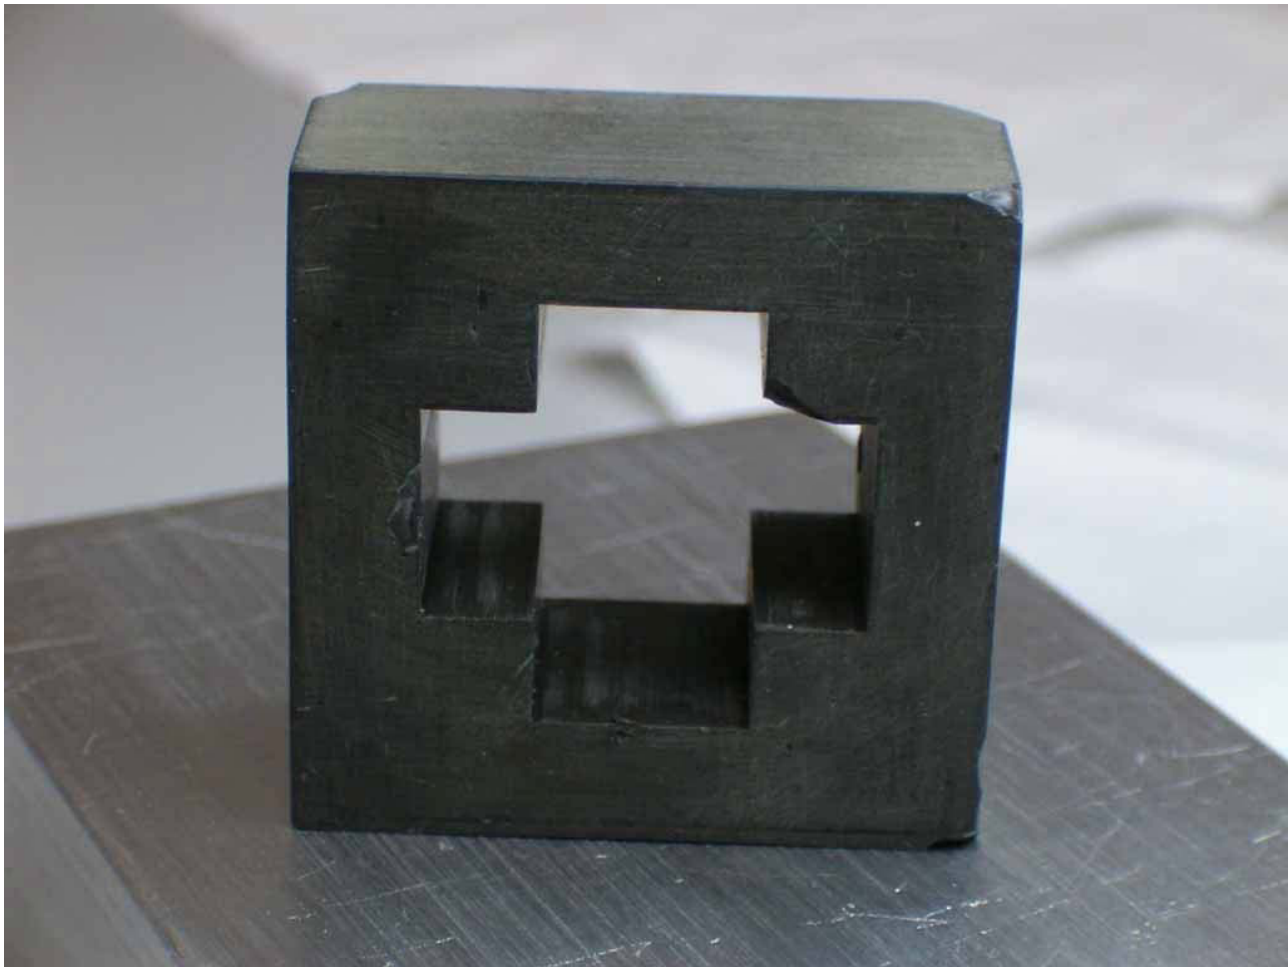
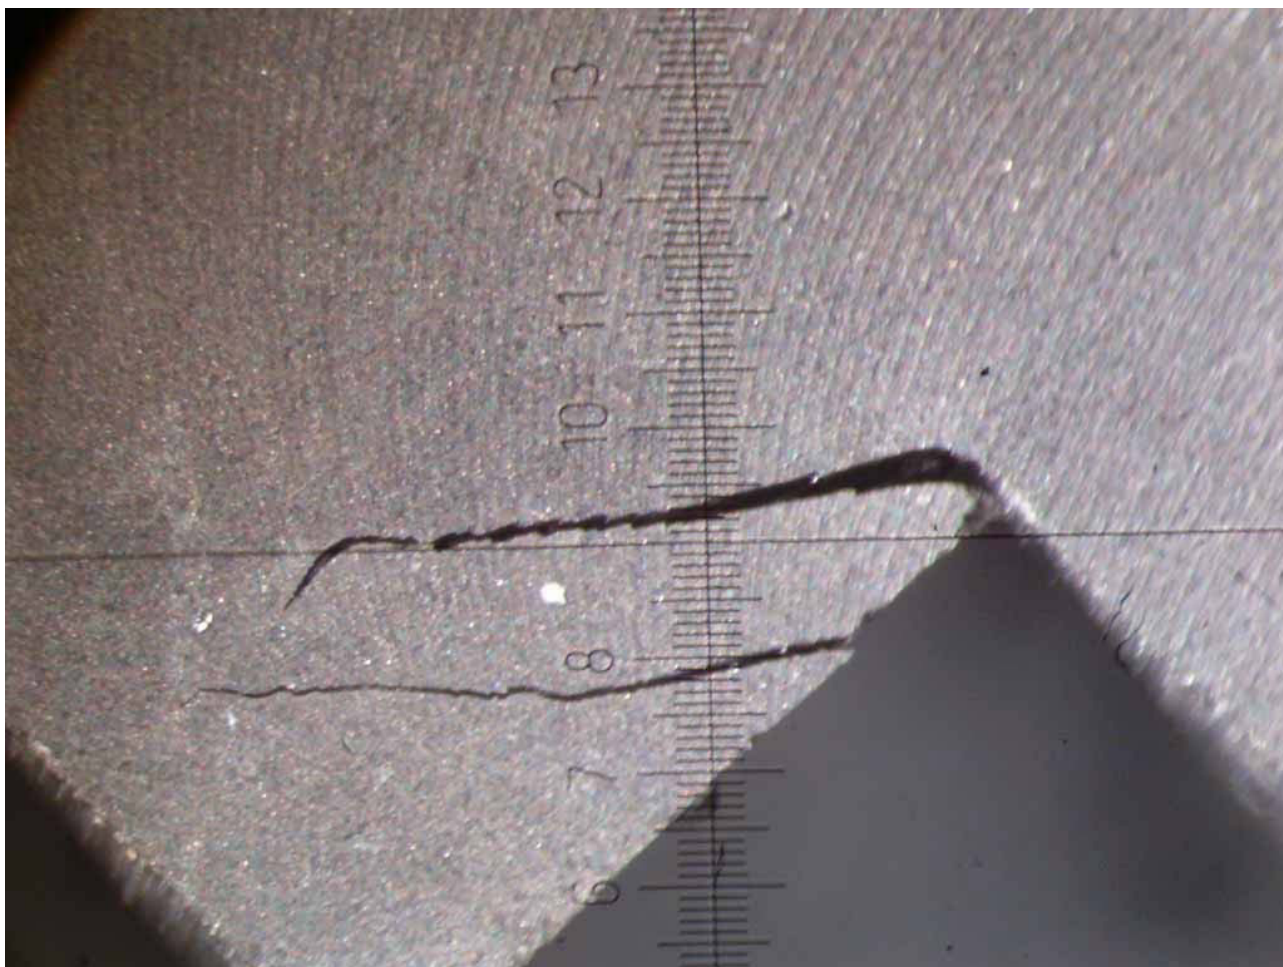
#### 10.4 Specimen 3a – Cross@30GHz acetone

| DATE | TIME | TEST<br>CONDITION | NOTE |
|---|---|---|---|
| 10/03/05 | 10.15 | 21.3°C47%HR | <b>Visual Inspection:</b> There are visible several cracks on all the specimen. It is needed to disrupt the backer to extract the specimen from the backer, since its volumes has increased. |

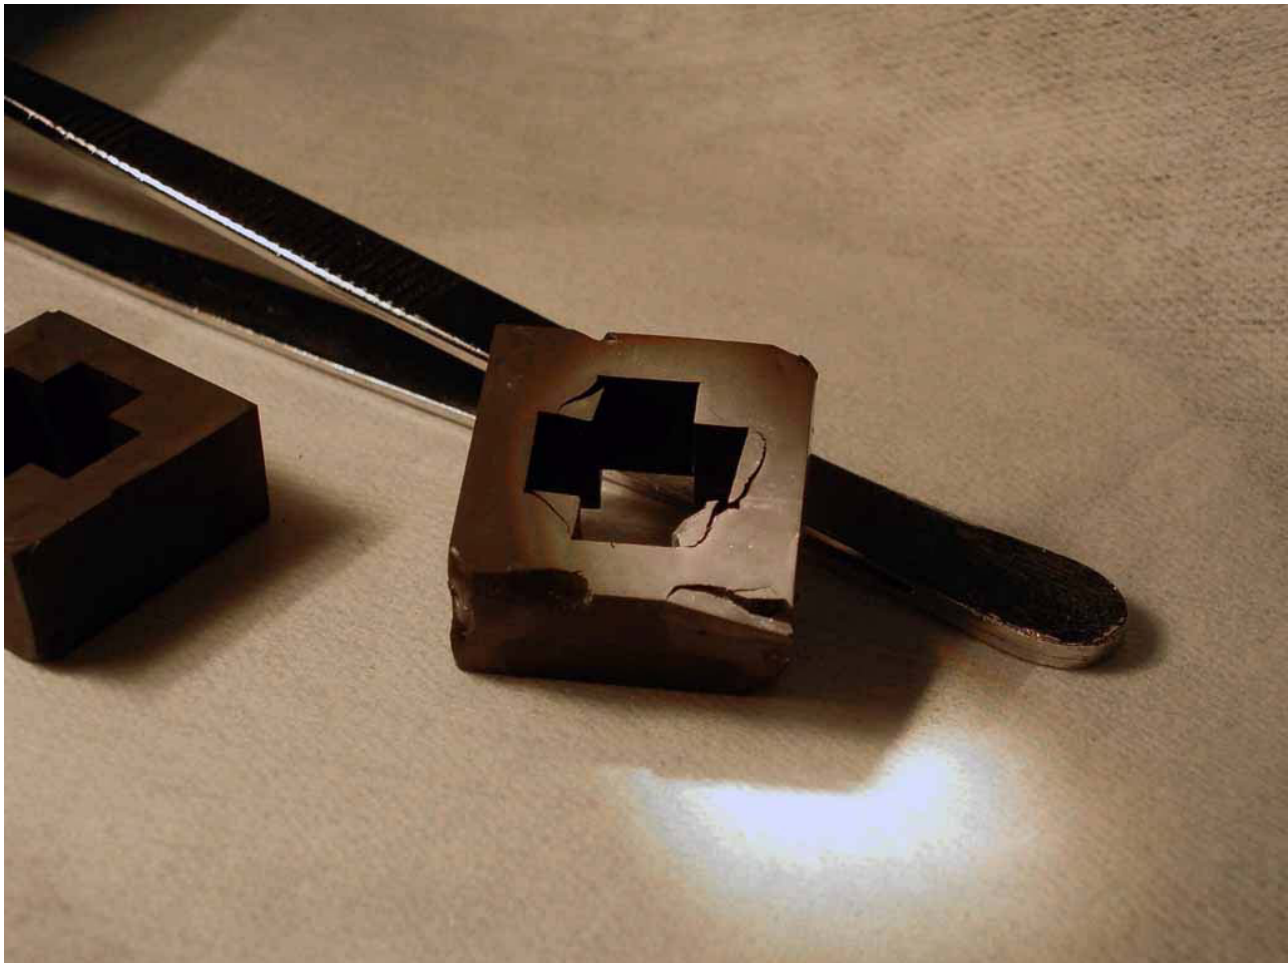
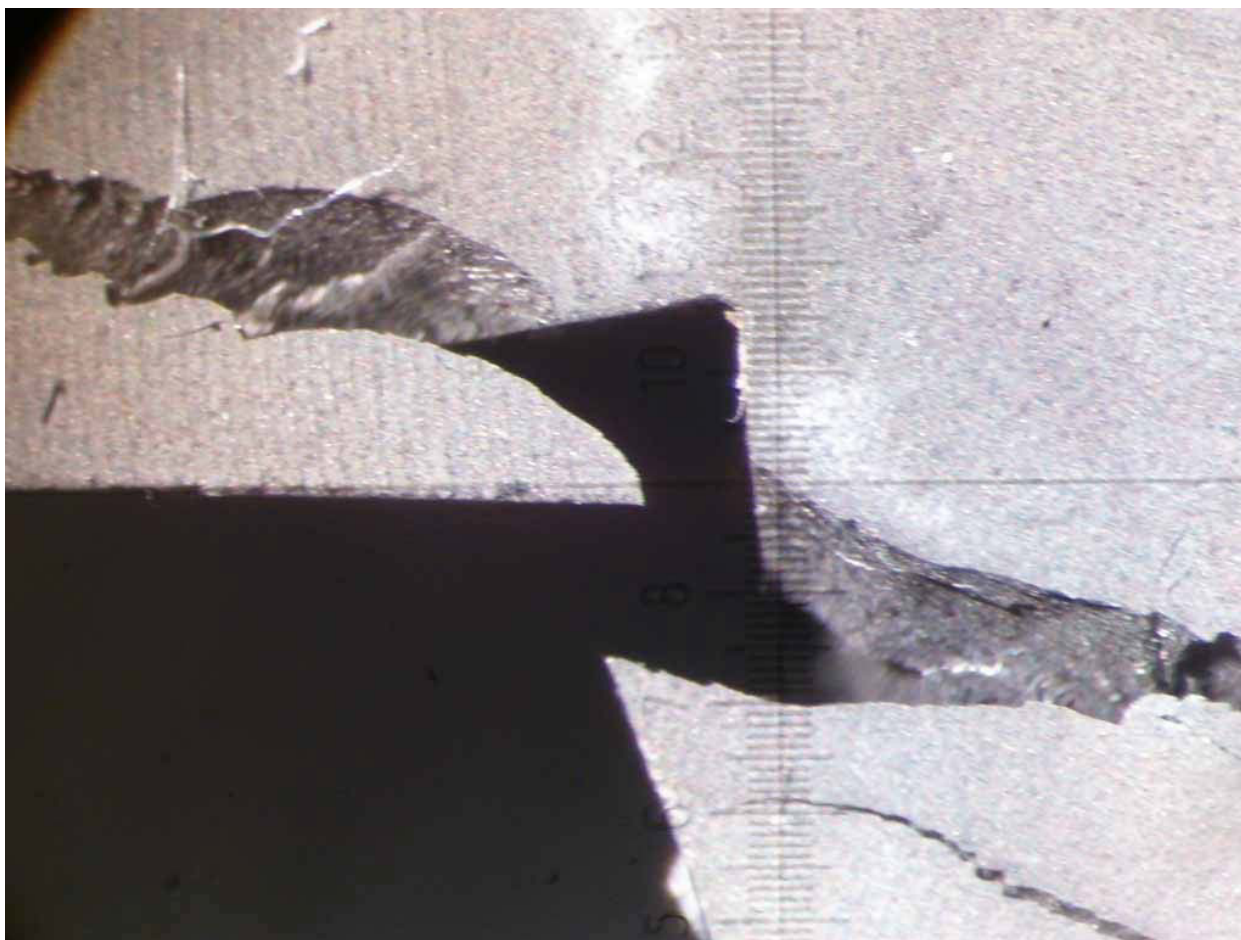
### 10.5 Specimen 3b – Cross@44GHz acetone

| DATE | TIME | TEST CONDITION | NOTE |
|---|---|---|---|
| 10/03/05 | 10.15 | 21.3°C47%HR | <b>Visual Inspection:</b> There are visible several cracks on all the specimen. It is needed to disrupt the backer to extract the specimen from the backer. |
