| <b>Title</b> | ECCOSORB Failure Analysis |

**TITLE:** ECCOSORB failure analysis

**DOC. TYPE:** TECHNICAL NOTE

**PROJECT REF.:** PL-LFI-TES-TN-015

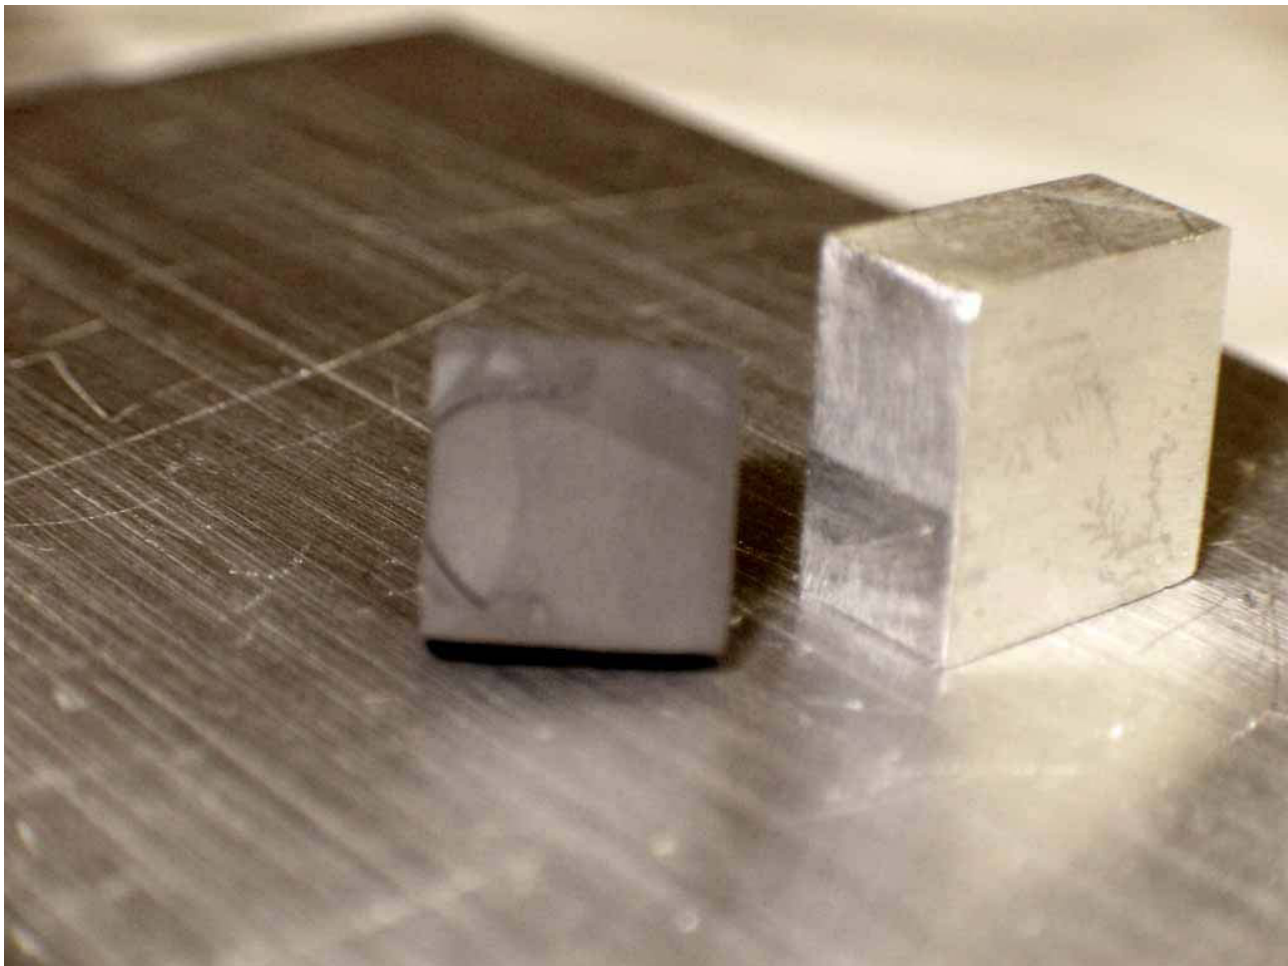
### 10.6 Specimen 4 – Sandwich Al6061-ECR110-ECR bonded acetone

| DATE | TIME | TEST<br>CONDITION | NOTE |
|---|---|---|---|
| 10/03/05 | 10.15 | 21.3°C47%HR | <b>Visual Inspection:</b> There aren't visible defects on the ECR, but the glueing is broken with a light hand force. |

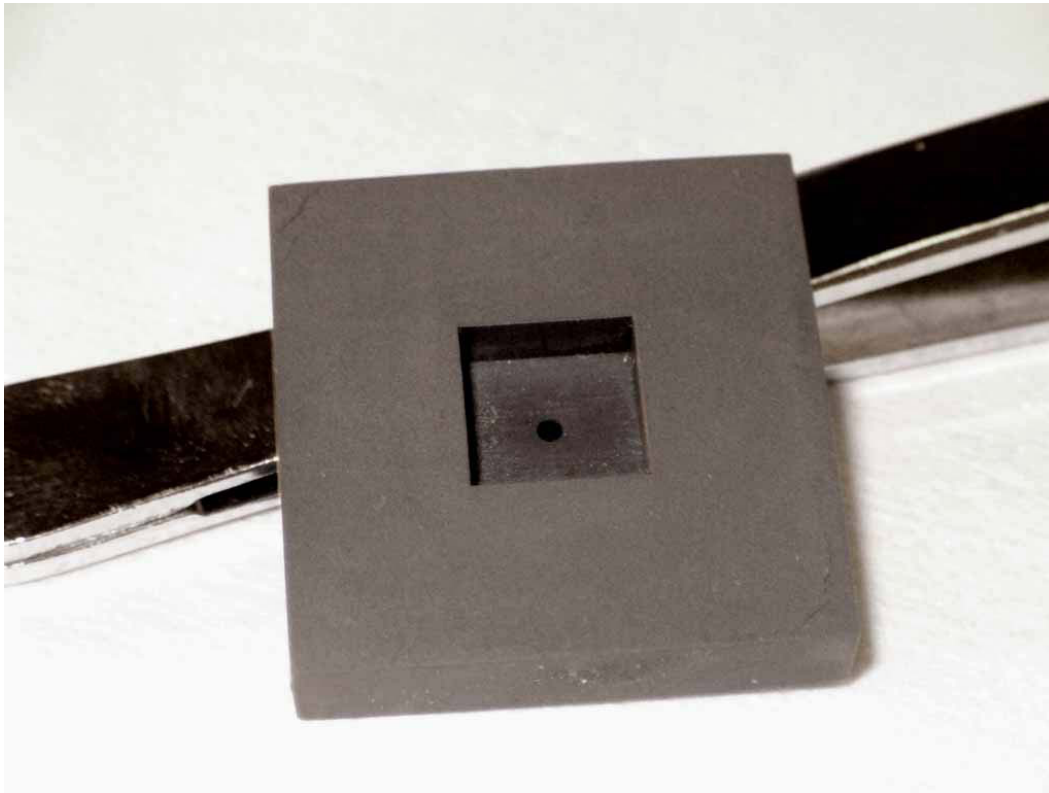
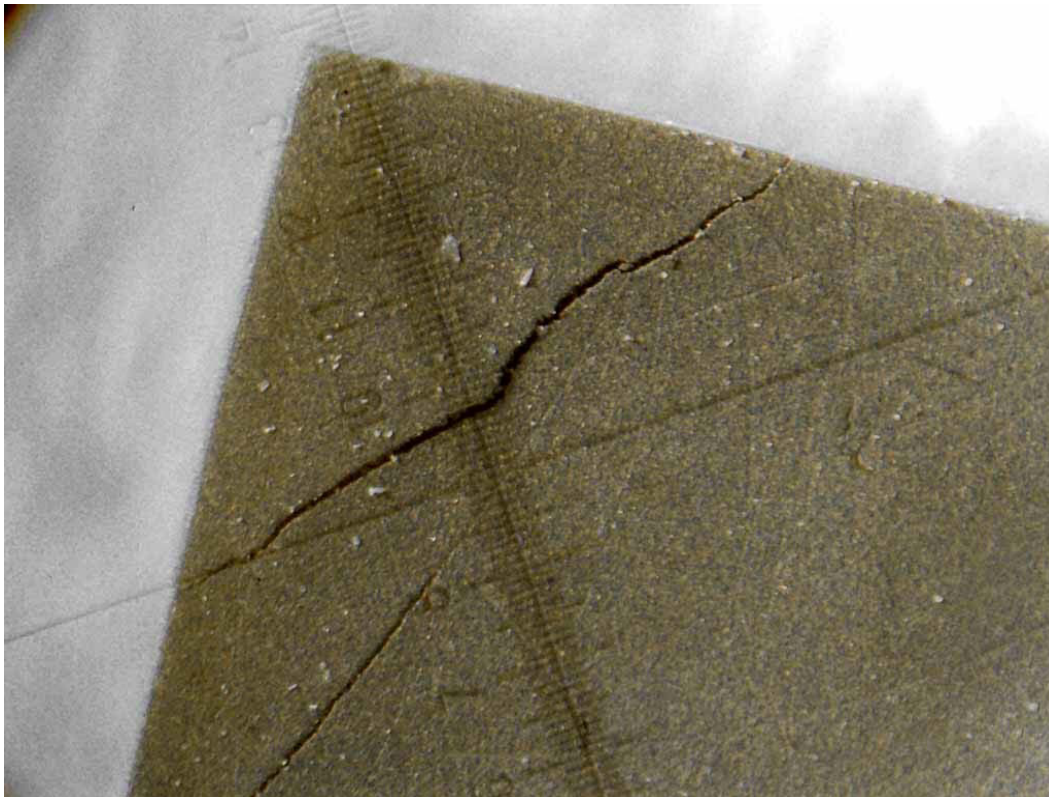
**10.10 Specimen 7 – base@44GHz acetone**

| DATE | TIME | TEST<br>CONDITION | NOTE |
|---|---|---|---|
| 15/03/05 | 10.00 | 21.5°C40.3%HR | <b>Visual Inspection:</b> there aren't visible defects, but it is possible to crack it with a light hand pressure.<br><b>Mass:</b> 9.92 [g] |

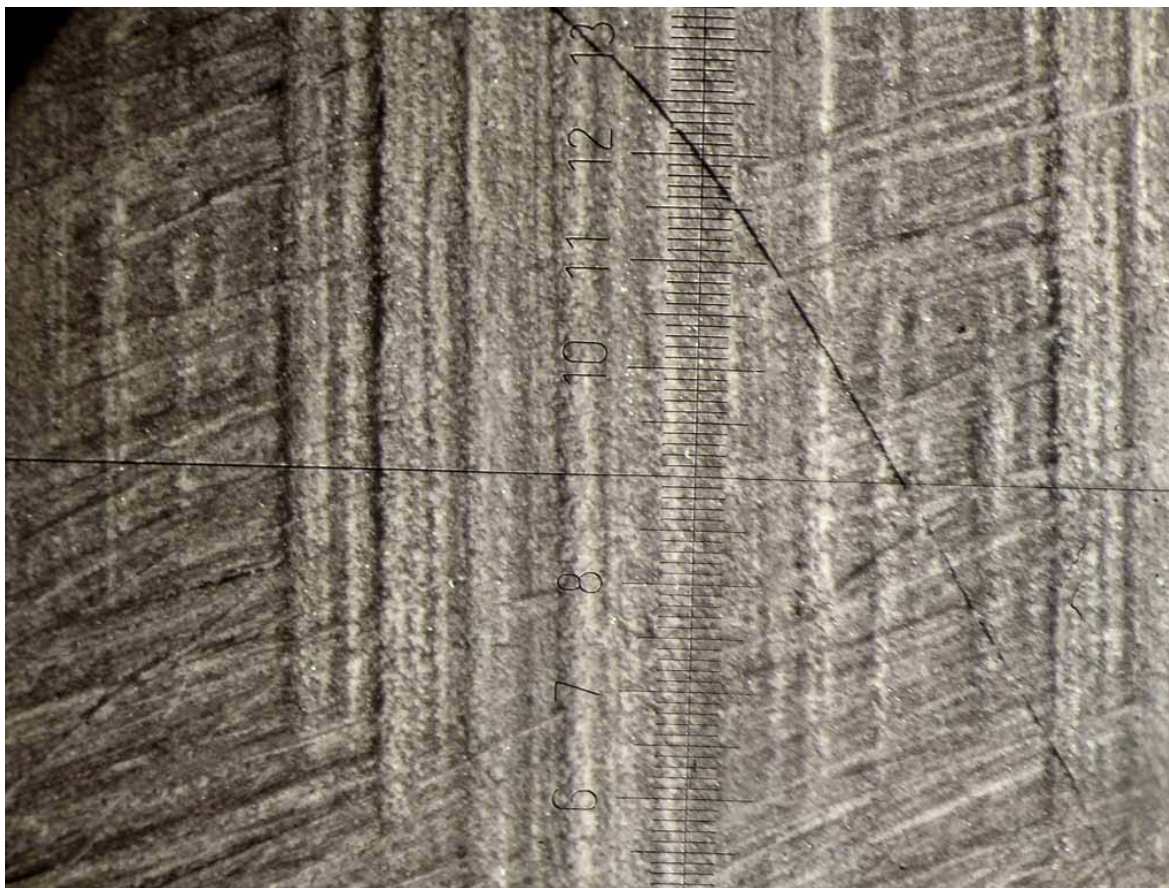
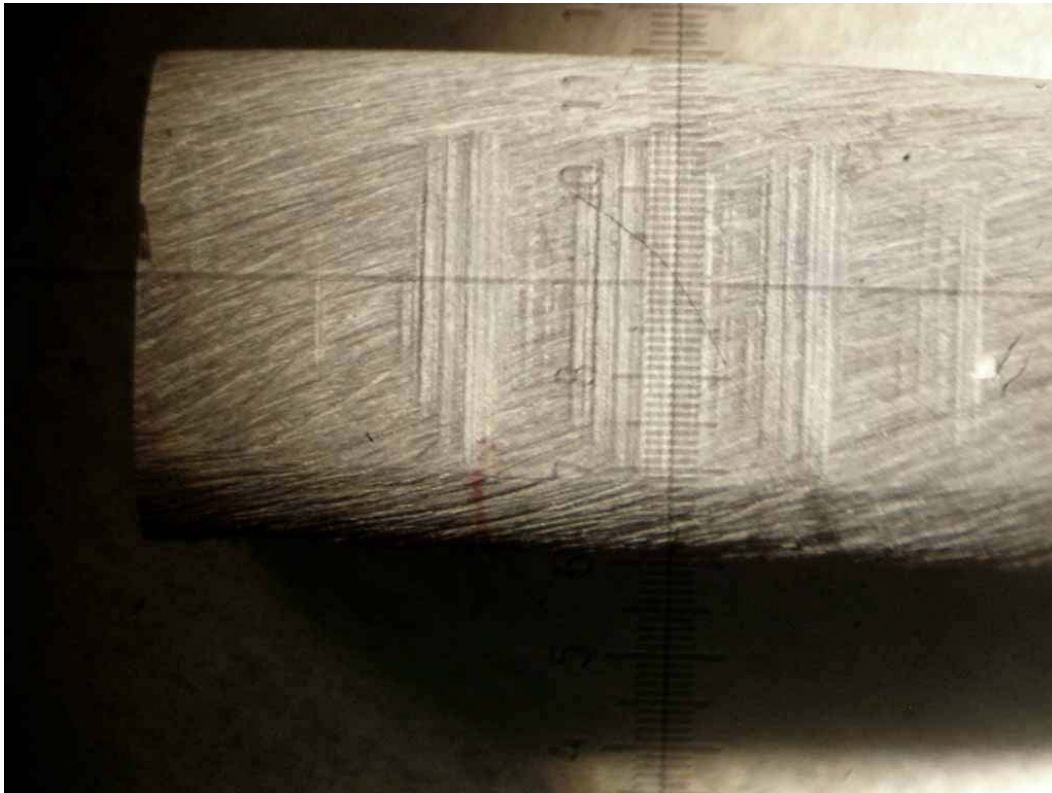
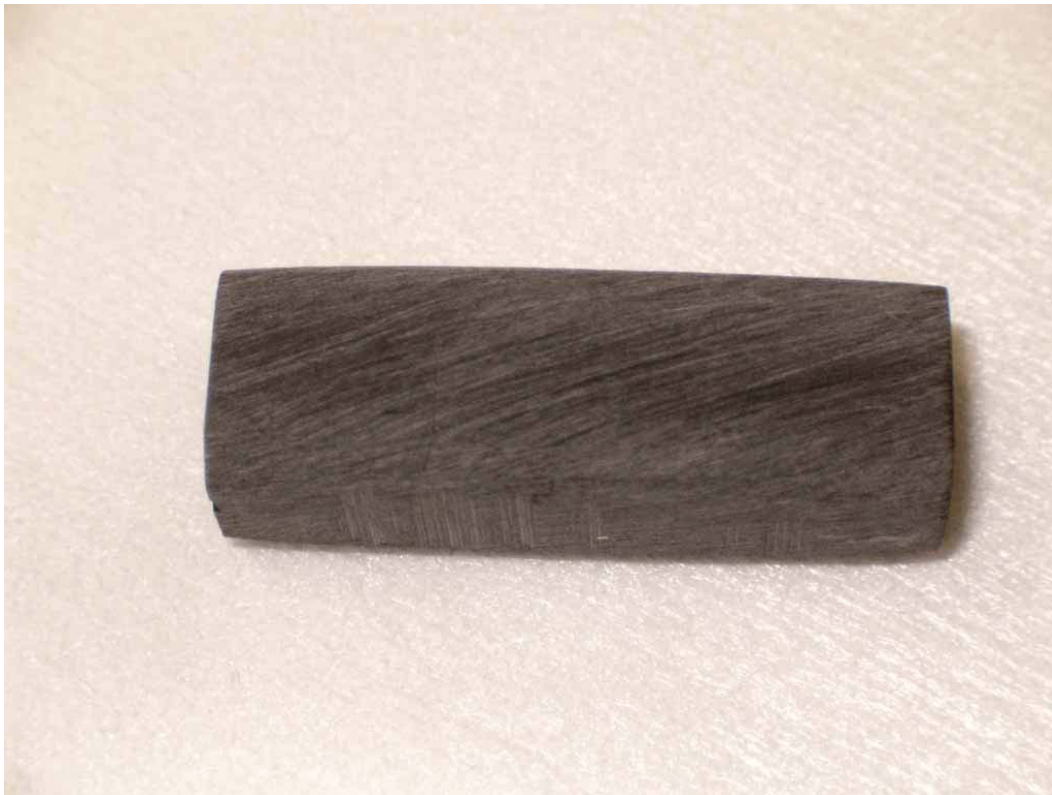
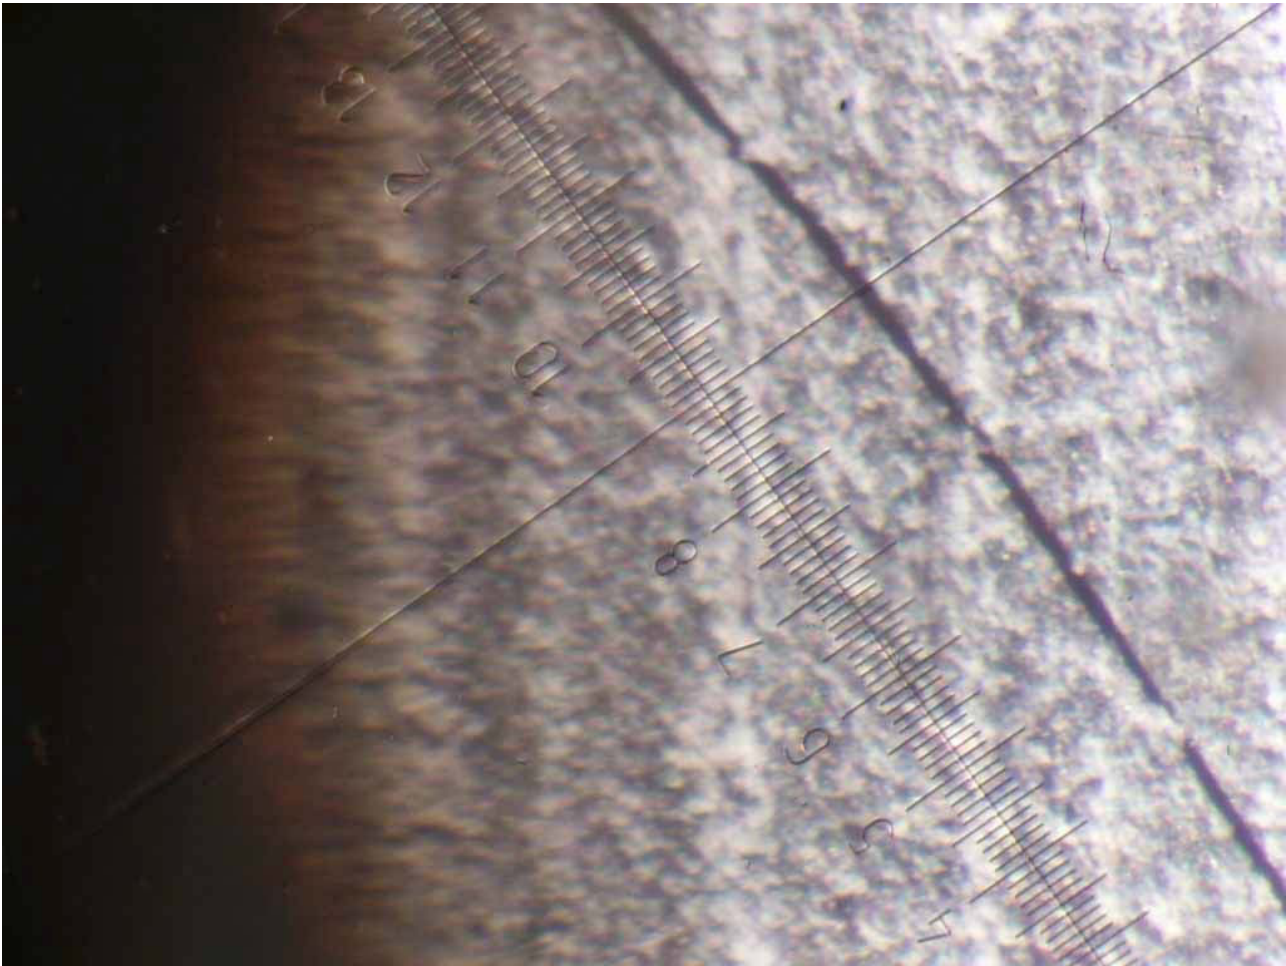
| DATE | TIME | TEST<br>CONDITION | NOTE |
|---|---|---|---|
| 15/03/05 | 15.30 | 22.9°C38.7HR | <b>Visual Inspection:</b> the specimen has the lateral surfaces lumpy<br><b>The specimen is partially covered with toluene</b> |
| 16/03/05 | 9.55 | | <b>Visual Inspection:</b> there is a log crack. |
