**Si TITLE:**                    **Analysis of Signal Swap in output  
of Channel 2510 (Action#4 H-P-  
TASF-MN-9737)**

**DOC. TYPE:**                **TECHNICAL NOTE**

**PROJECT REF.:**        **PL-LFI-PST-TN-082**        **PAGE: I of IV, 1 of 15**

**ISSUE/REV.:**            **2.0**                                **DATE: March 2008**

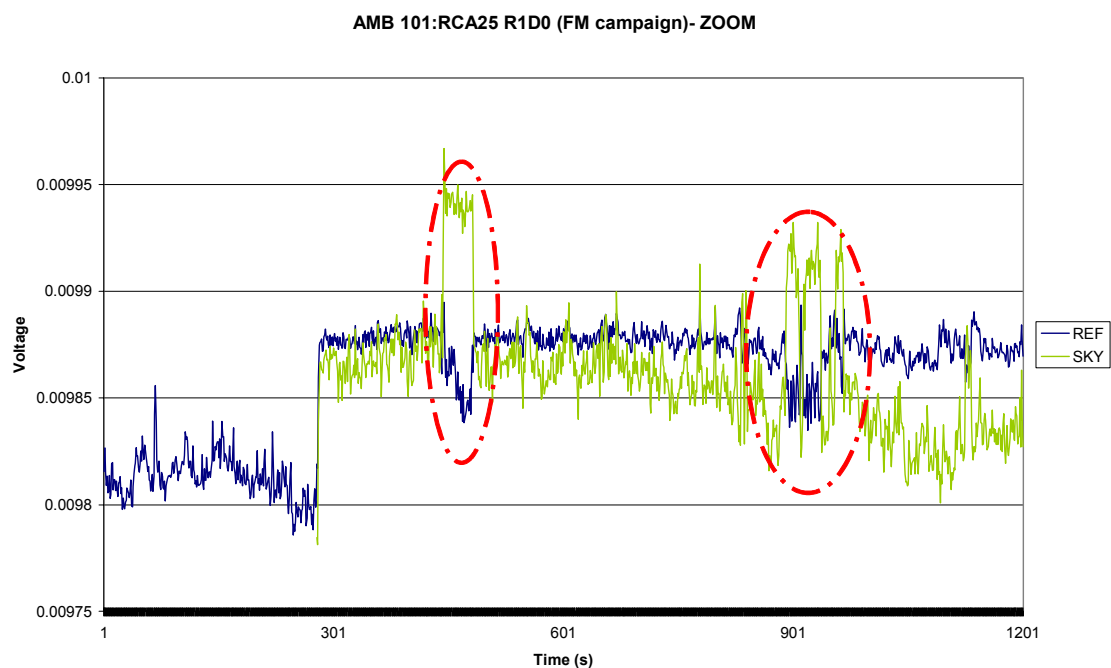
Figure 6 ZOOM on first part of above figure. The green line is sky
