**TITLE:** **PLANCK OPTICAL SHIELD 2:  
CRYO TESTS ON  
REPRESENTATIVE PANELS**

**DOC. TYPE:** Test Report

**PROJECT REF.:** PL-LFI-PST-RP-026      **PAGE:** I of III, 26

**ISSUE/REV.:** 1.0      **DATE:** January 2008

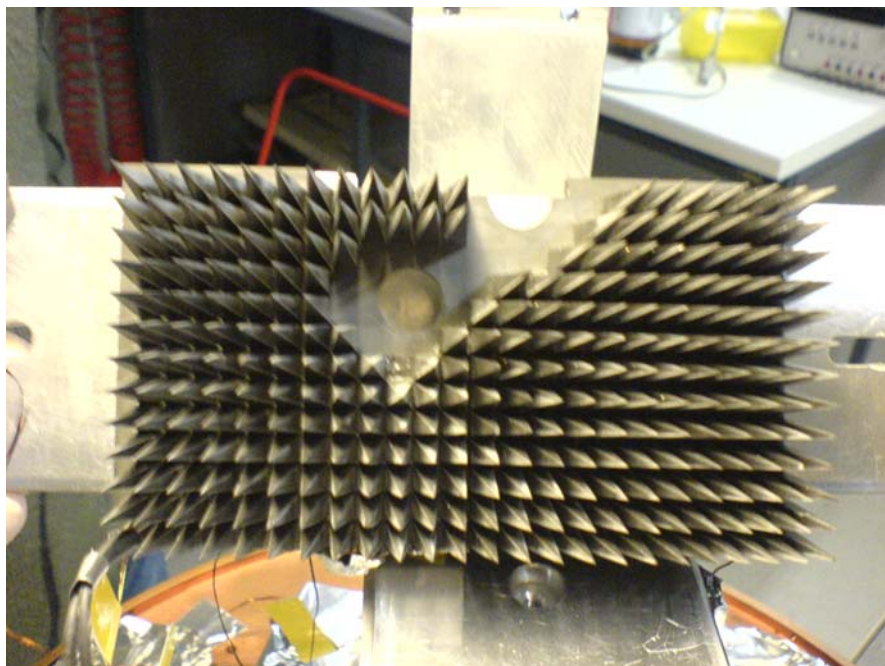
**Figure 4 special panel after removal for inspection**

Both inspections gave no evidence of possible problems or defects ascribable to the cycle.

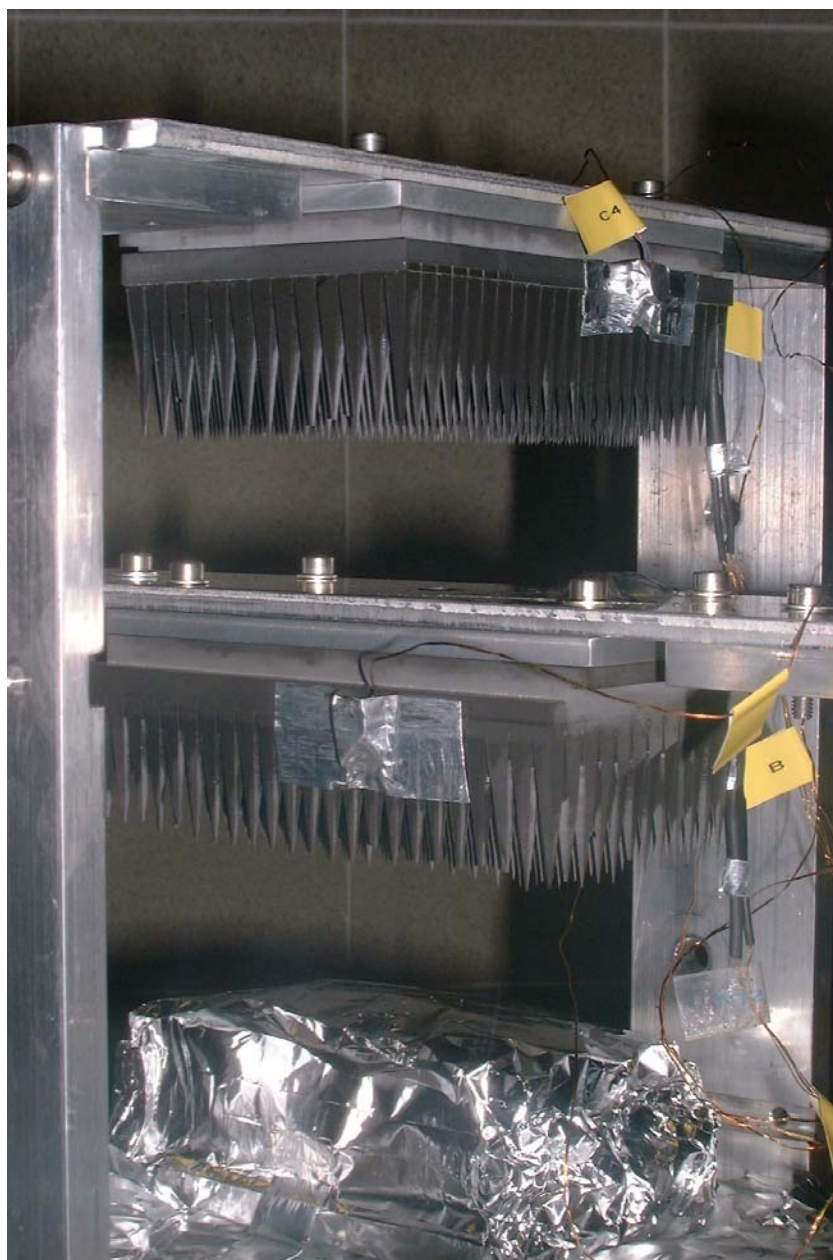
No evidence of change was observed in the panels: no broken parts (example Eccosorb tips) have been found on the aluminium foil put on the flange in order to collect eventual parts falling down from the panels.

**Figure 14** panels after the facility has been opened. Everything looks fine, no broken parts on the aluminium tape covering the cryo 4K flange.

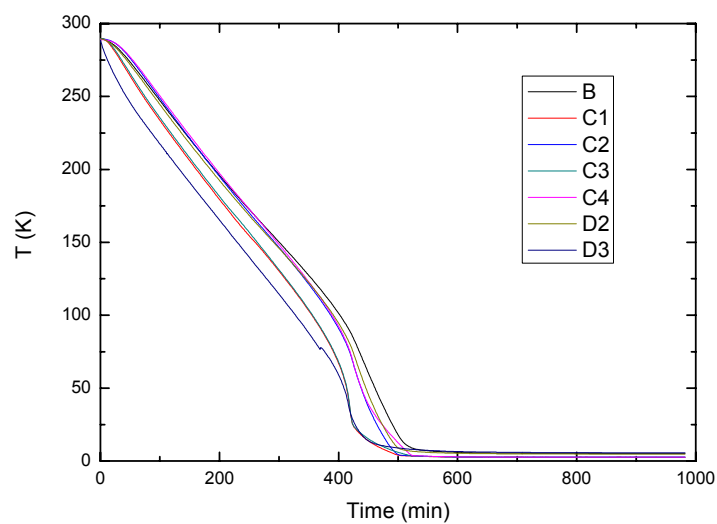
A non ideal behaviour of the sensor put on the 2.7K flange was recorded: it was probably due to a bad solder in the connector wiring it with the Lakeshore controller. However, since this sensor was put on the coldest part of the facility, and not used to monitor the panels but only the cryostat, this lack did not affect in anything results and full validity of measurements.

Figure 19 6<sup>th</sup> cooldown: a problem is evident in one sensor ( outermost trace on the left)

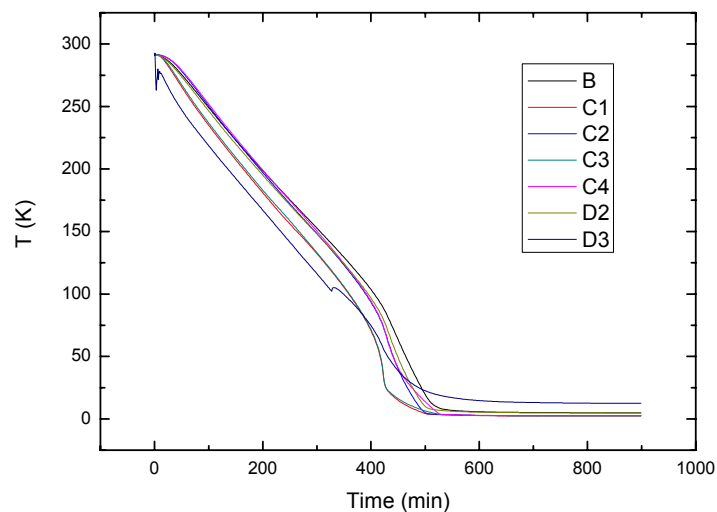
Figure 21 8<sup>th</sup> cooldown: the suffering sensor put on the flange does not thermalise anymore

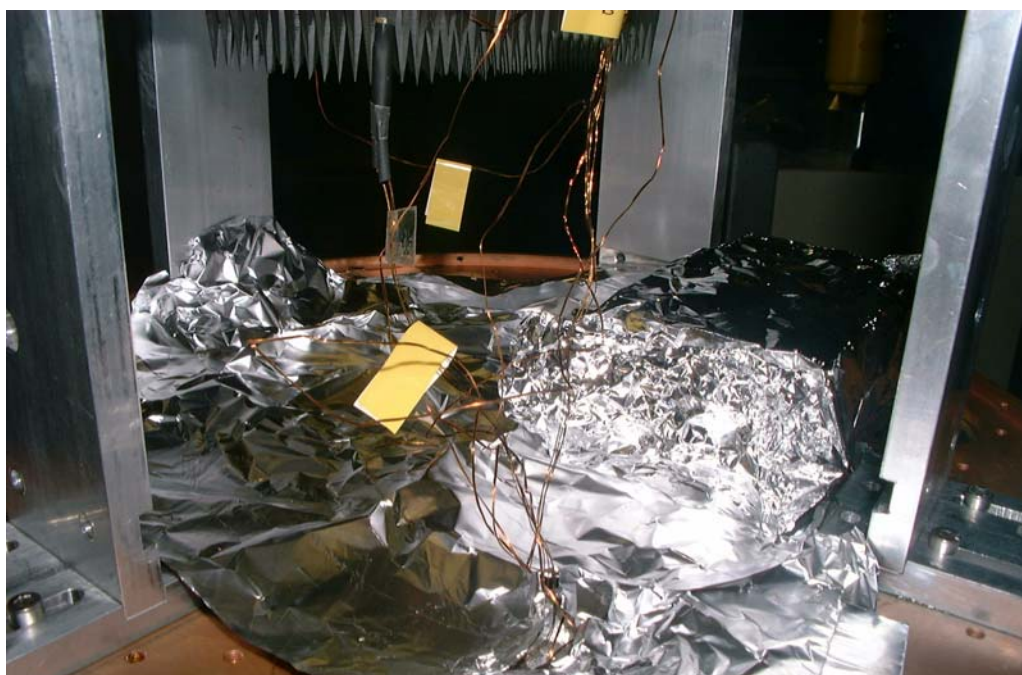
The aluminium foil was removed from the cold flange to search for eventual parts detached from panels: nothing was found on the foil.

**Figure 28 aluminium foil put on the cold flange to collect eventual parts detaching from panels: nothing found on it**

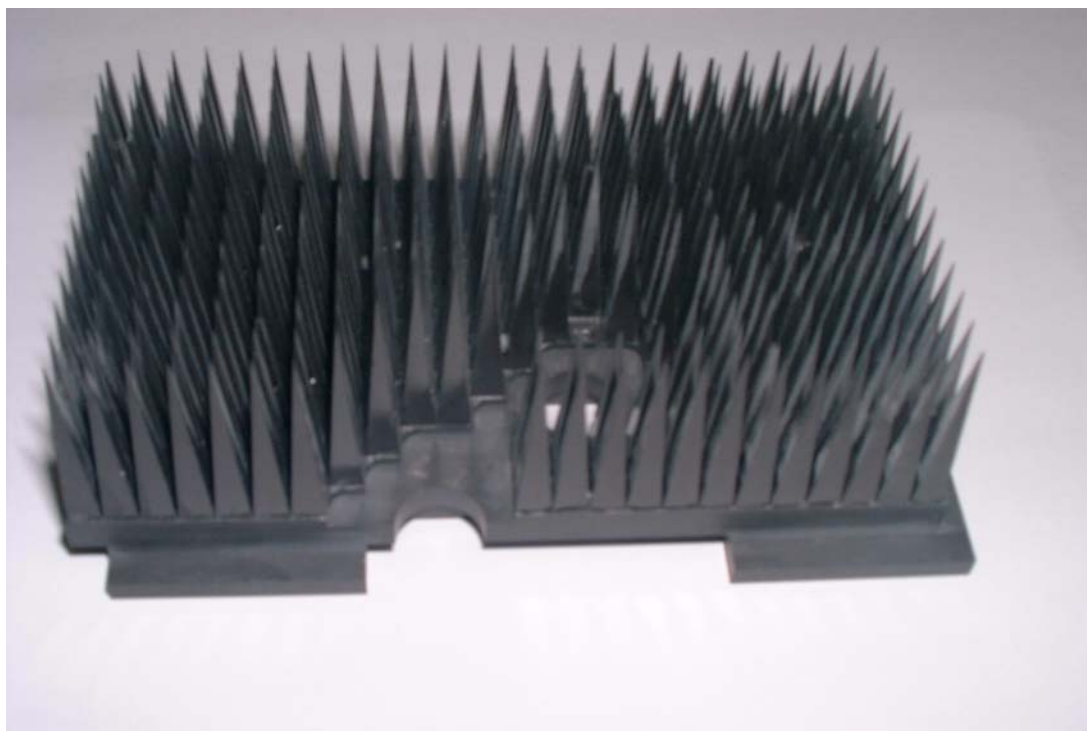
**Figure 29 special panel after inspection**

Panels have been then inspected by binocular: nothing new seems to be observed. Comparison with the initial map reporting broken tips and other defects seems to confirm this result.

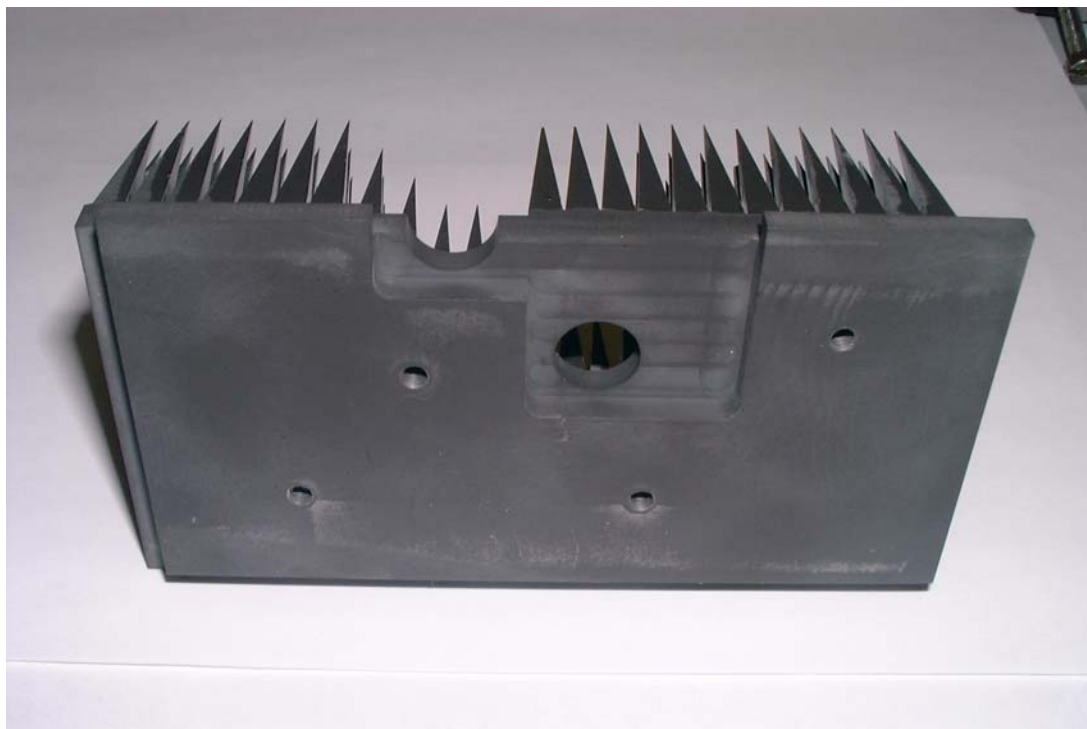
**Figure 30 special panel (back)**

Metal backs have been removed: It allowed to observe the back of ECCOSORB panels for the first time since tests started: everything looked nice, as before cryo tests.
