| <b>Title</b> | DPU-ASW Management of the DCU ERROR REG content with possible off-line recovery actions |

Ref : EUCL-IBO-TN-7-035  
Issue : 1.1  
Date: 20/10/2021  
Page: 1/45

| <b>TITLE:</b> | DPU-ASW Management of the DCU ERROR REG content with possible off-line recovery actions | | |

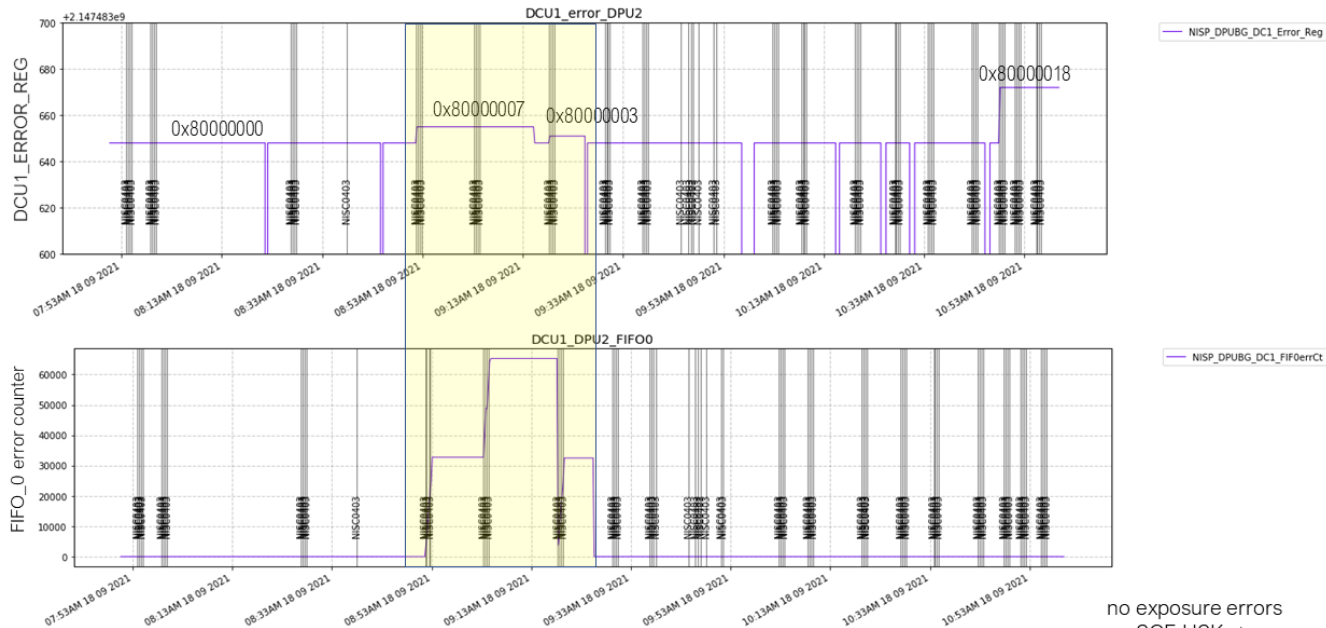
Test case (1)

no exposure errors  
no SCE HSK stop  
no TM(5,2)

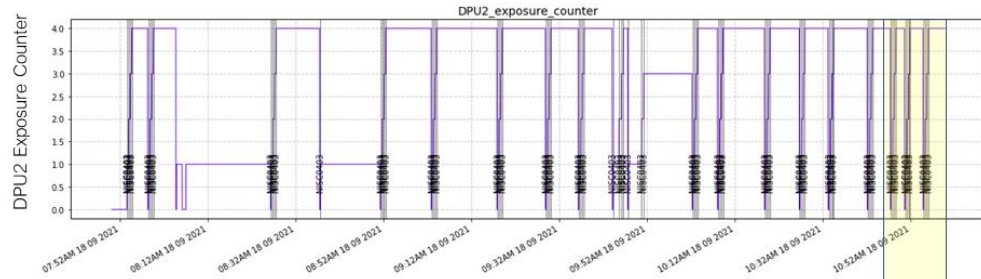
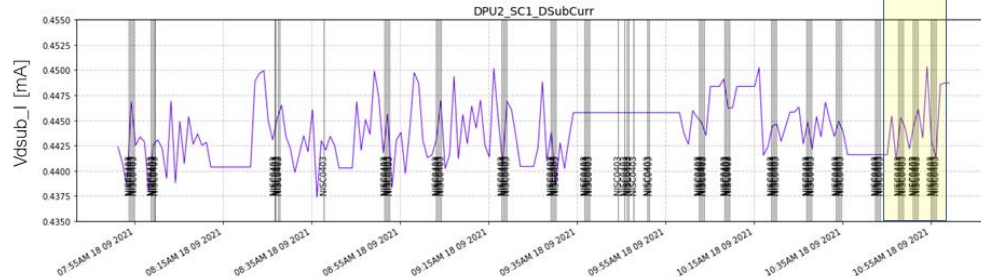
Test case (2)

no exposure errors  
no SCE HSK stop  
no TM(5,2)

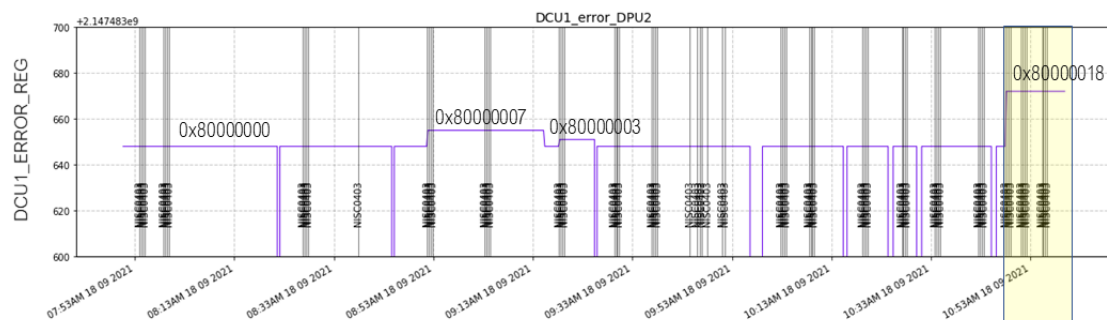
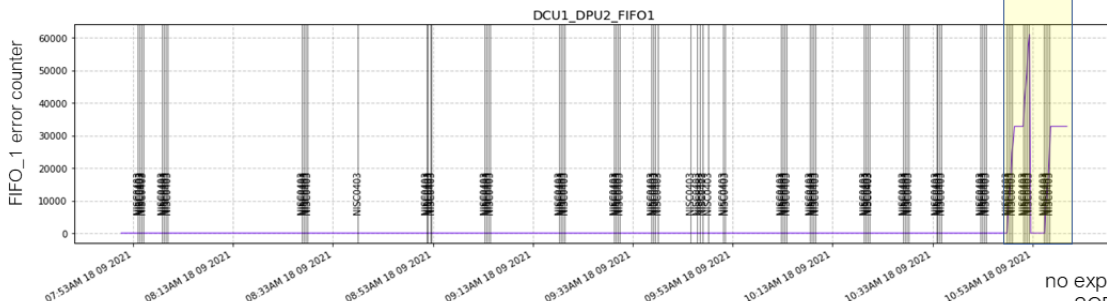
Test cases (1) and (2)

no exposure errors  
no SCE HSK stop  
no TM(5,2)

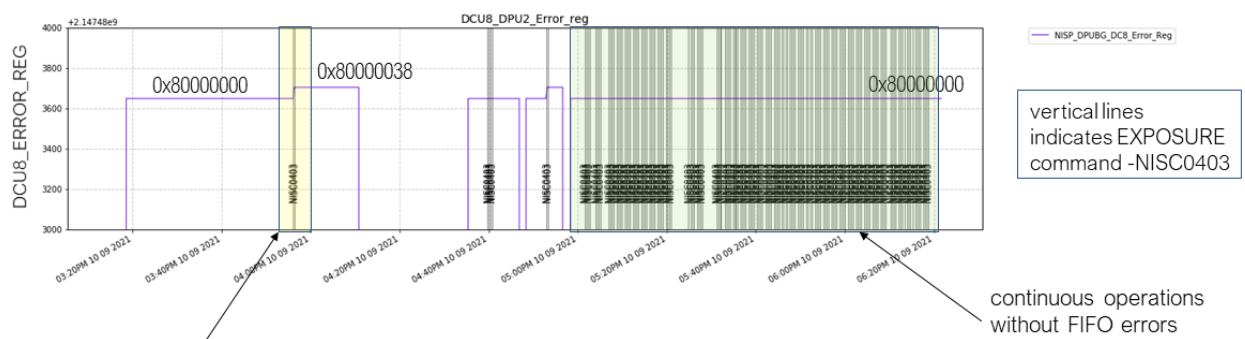
## Repetition of the error condition with DPU-ASWv1.3.7 (used at CSL) during LAM setup verification

## ERROR CONDITION

} same CSL error condition
