| <b>Title</b> | 4K Reference Load 30 GHz RCA Test Report |
| <b>Volume</b> | PL-LFI-TES-RP-004 |

**DATE:** November 8<sup>th</sup>, 2004

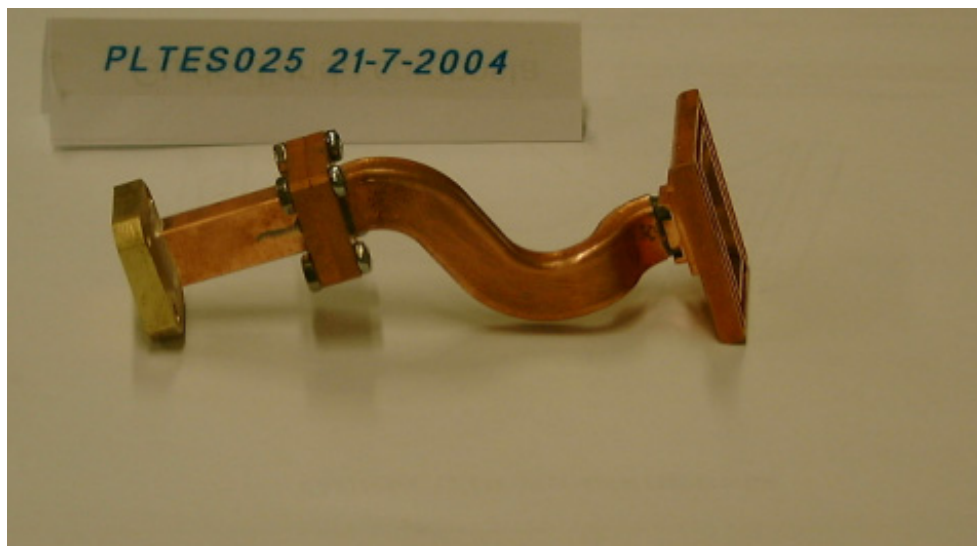
Fig. 2 Waveguide and Reference Horn 28L (id:PL-TES-025)

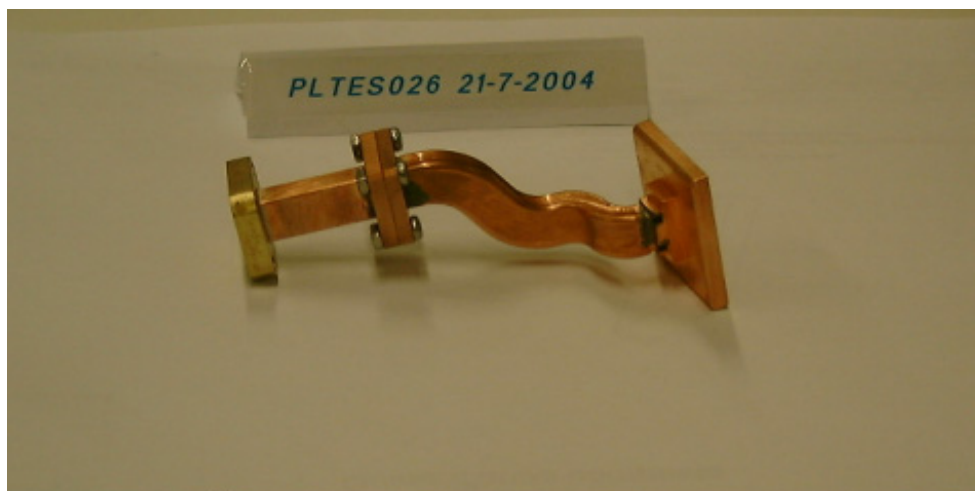
Fig. 4 Waveguide and Reference Horn 28R (id:PL-TES-026)

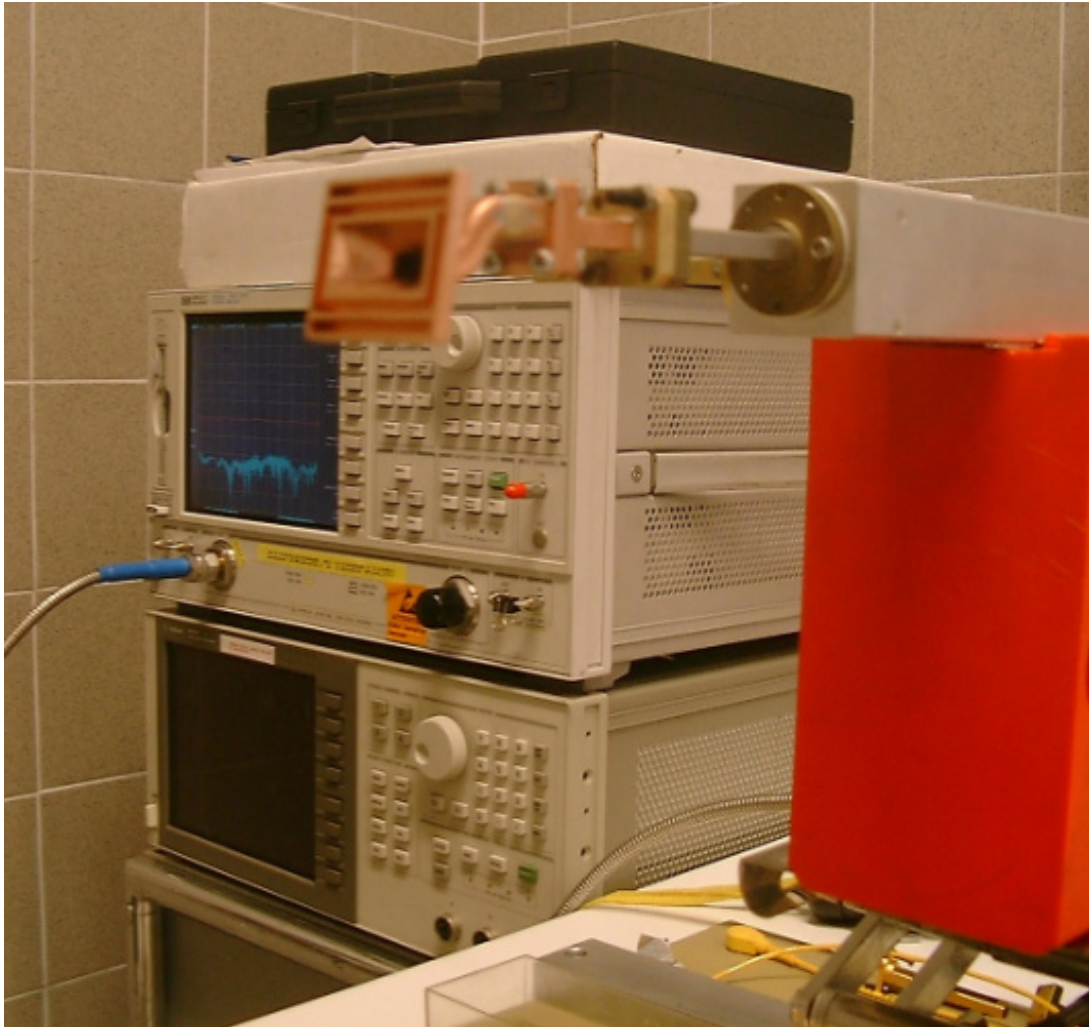
Figure 26 Free space Return Loss measurement for the horns under test; the VNA is visible in background.
