## Rapporti Tecnici INAF INAF Technical Reports

# **AAVS1 Hybrid Cable's assembly and testing procedure**

This document describes the procedure whereby the 440 AAVS1 (Aperture Array Verification System) FEM were reworked by Lightech s.r.l. to be compatible with the pyramid assembly created by UCAM. Then there is a description of the reworking verification and the final testing procedure of the HC (Hybrid Cables).

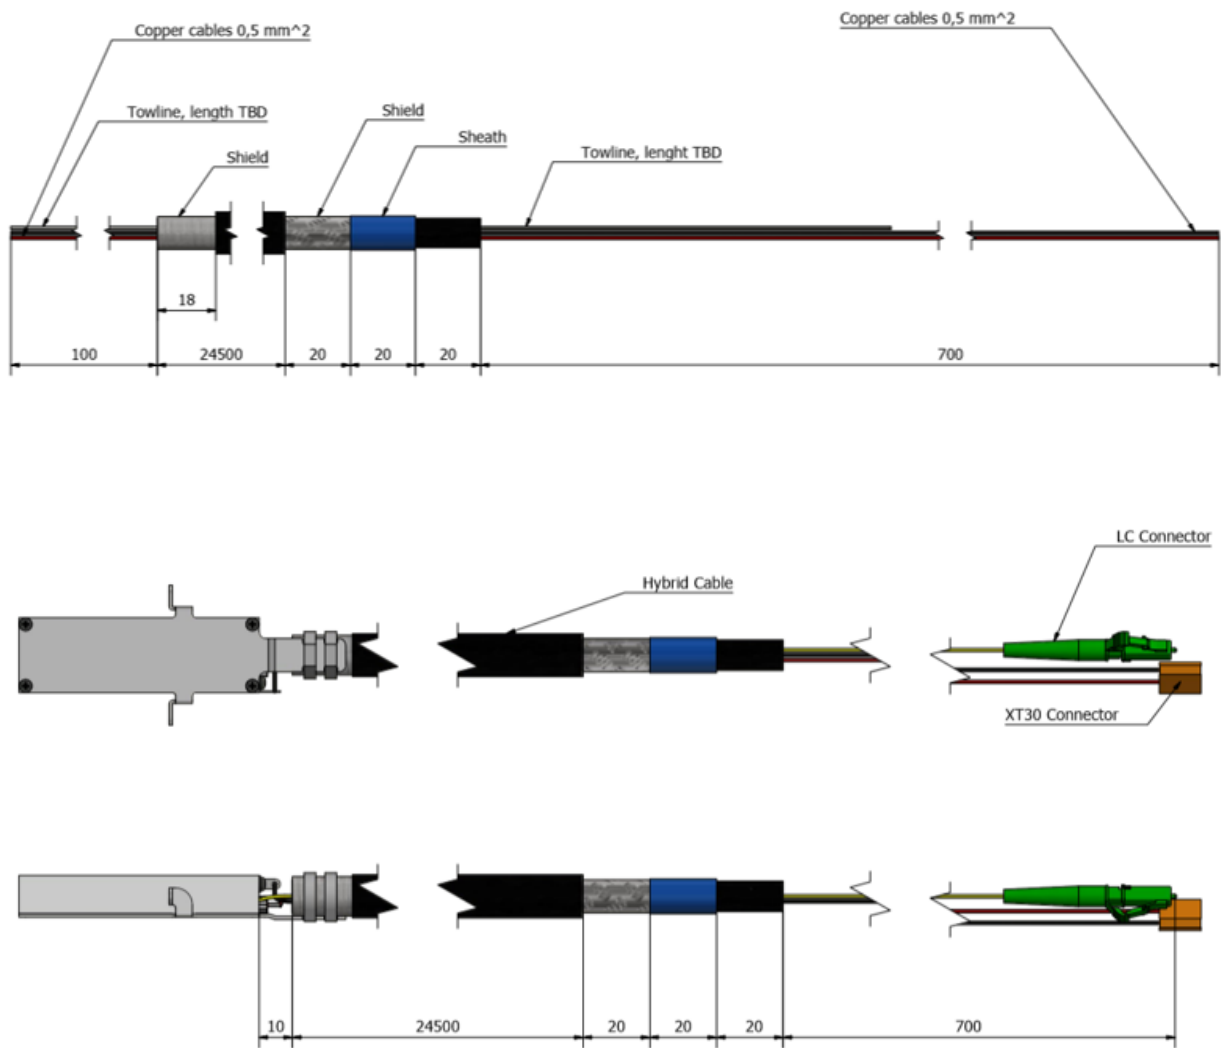
Figure 1: Hybrid cable preparation.

1. Preparation of the HC as depicted in Figure 1.

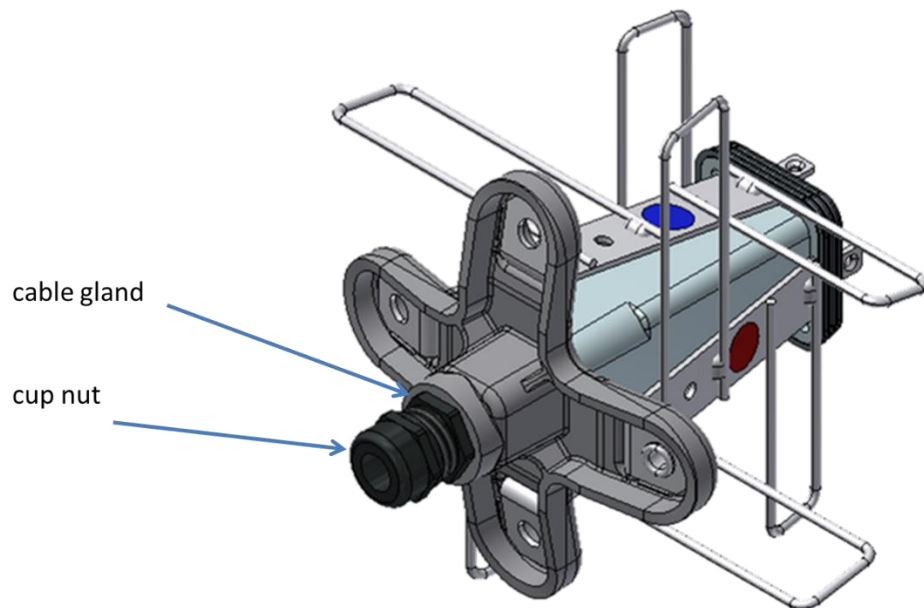
2. Make sure that the cable gland is fixed to the trumpet body and loosen the cup nut as in the figure below.

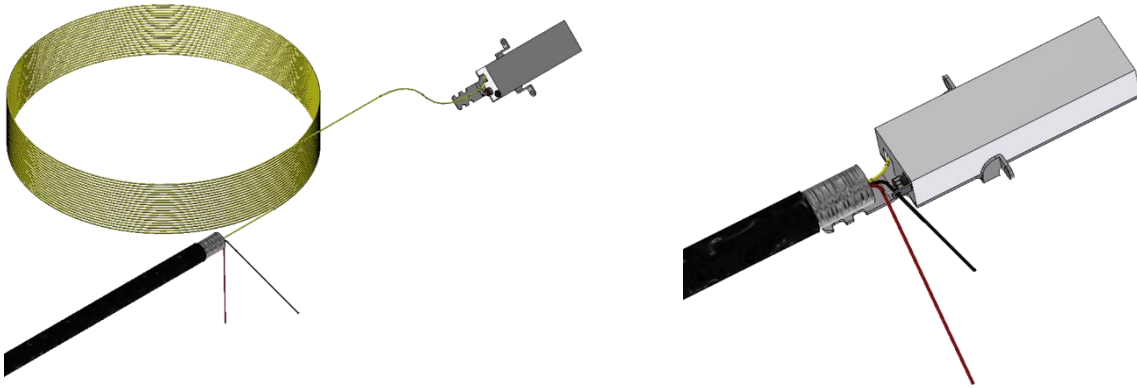
*Figure 3: Threading the fiber into the hybrid cable.*

5. Cut the LC/APC optical connector and pull the fiber inside the hybrid cable from the FEM's opposite side, since to have 10mm between the hybrid cable to the module.

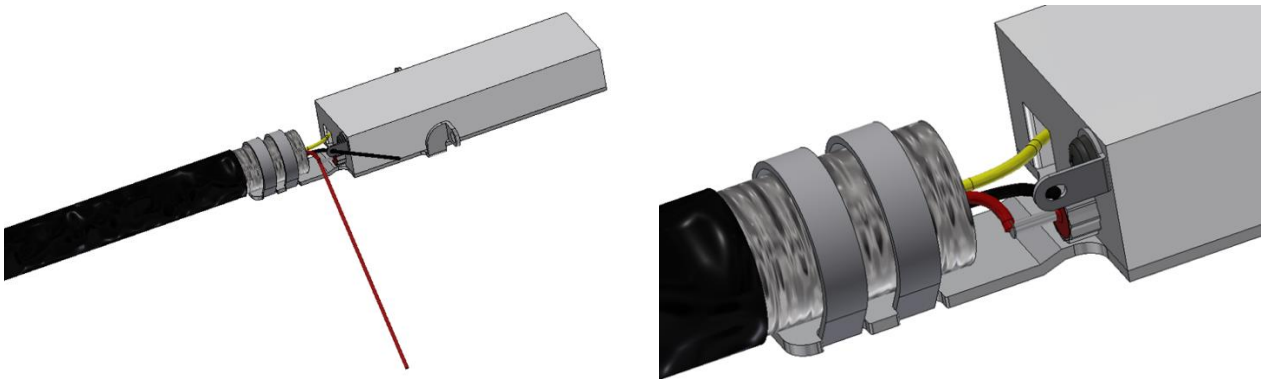
*Figure 4: FEM attachment and electrical wiring.*

6. Fix the module to the hybrid cable with two plastic cable ties. Make sure there is a good contact between the cable armor and the FEM cover. Then cut and connect the copper cables to the feed trough and the tab, as shown in Figure 4.

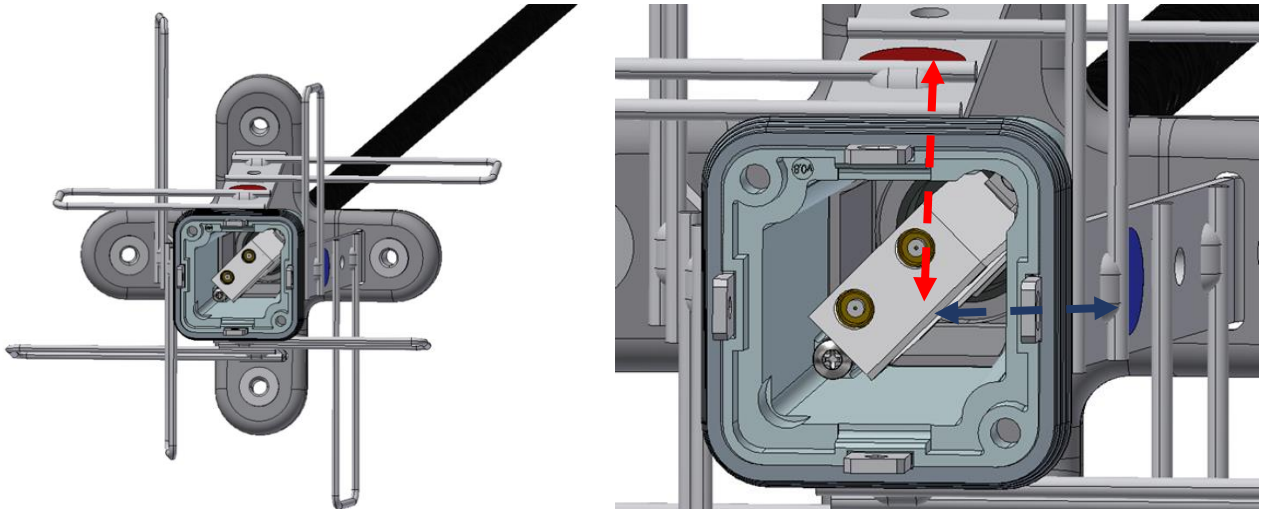
Figure 5: FEM correct position inside the trumpet assembly.

8. Insert the FEM inside the trumpet with the orientation explained in Figure 5 (the cover must be in front of the blue dot, and opposite to the red dot).

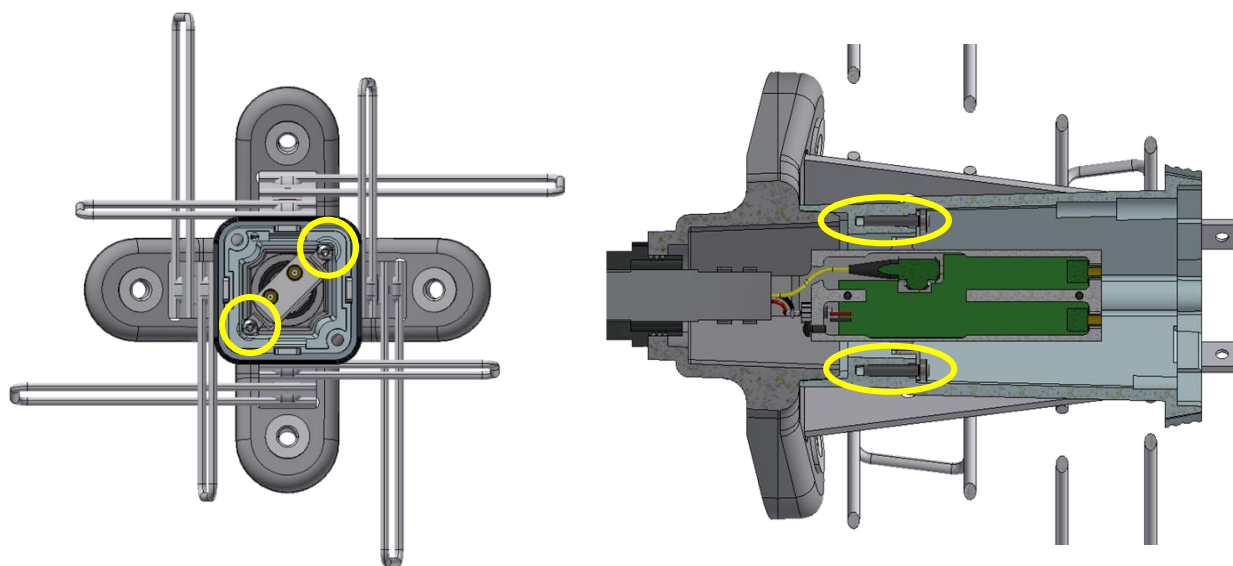
Figure 6: Screws position inside the trumpet.

9. Tighten the two screws with T10 screwdriver to fix the FEM as shown in Figure 6.

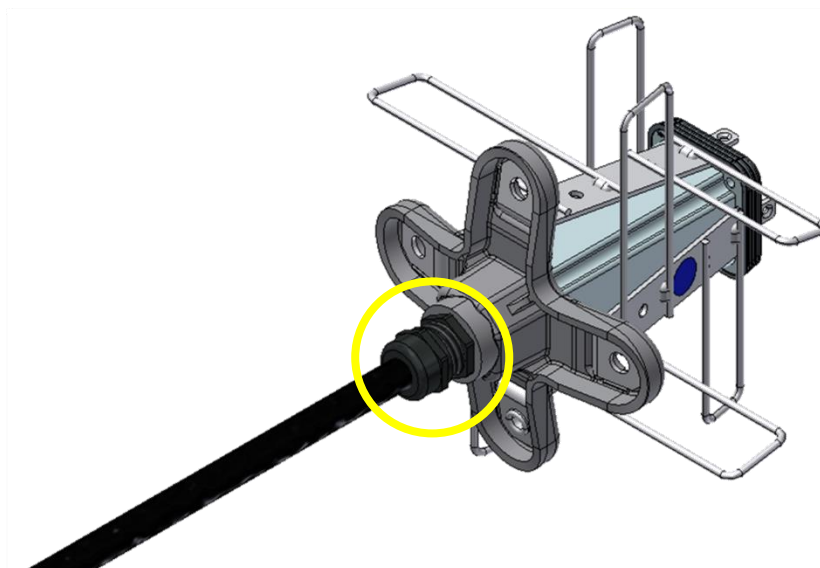
10. Tighten the cable gland to the hybrid cable.

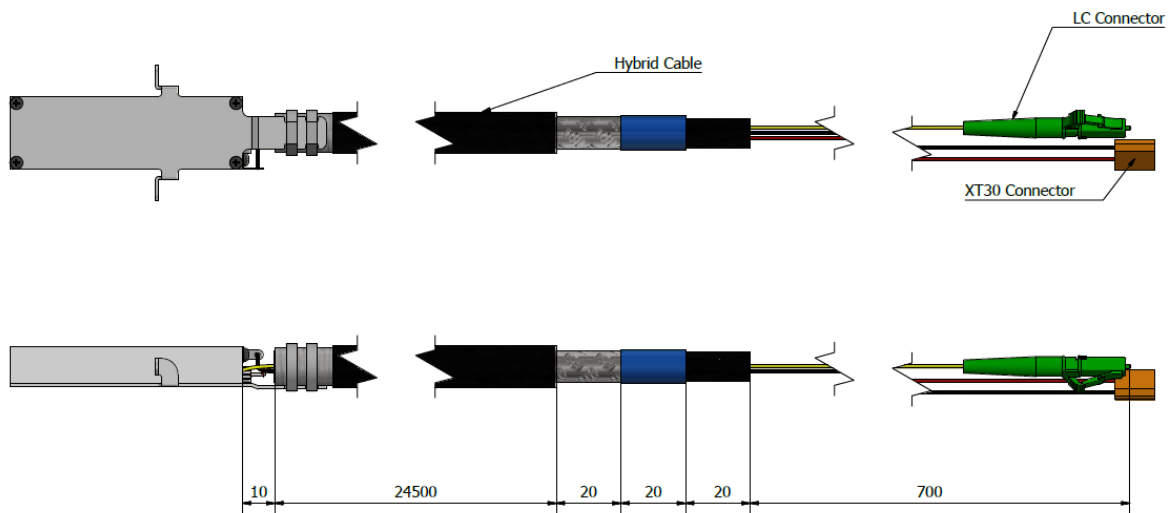
Figure 7: Hybrid cable part's dimensions.

11. Make sure that the different hybrid cable lengths are respected as shown in Figure 7.

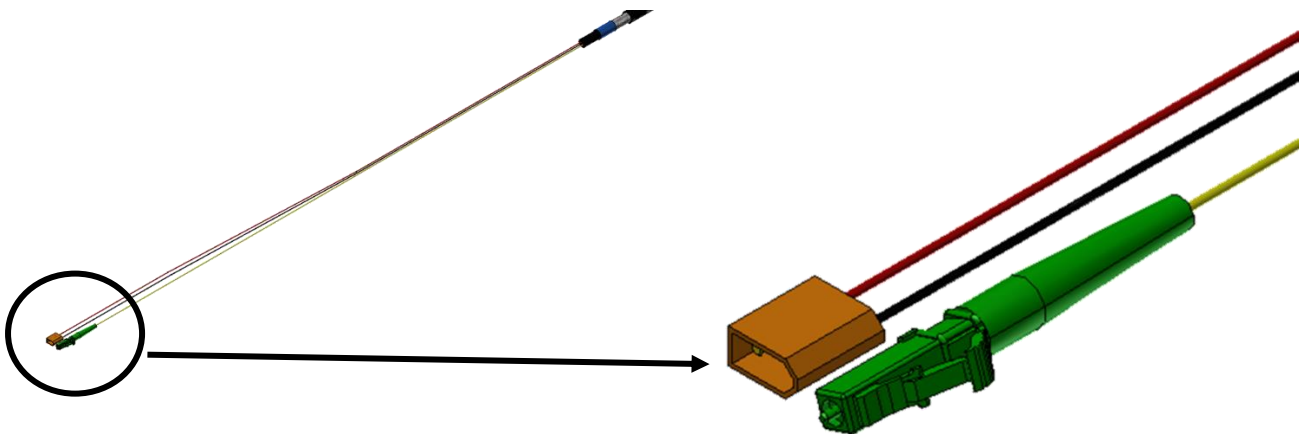
12. Weld the connectors and join an LC pigtail as shown in figure below.

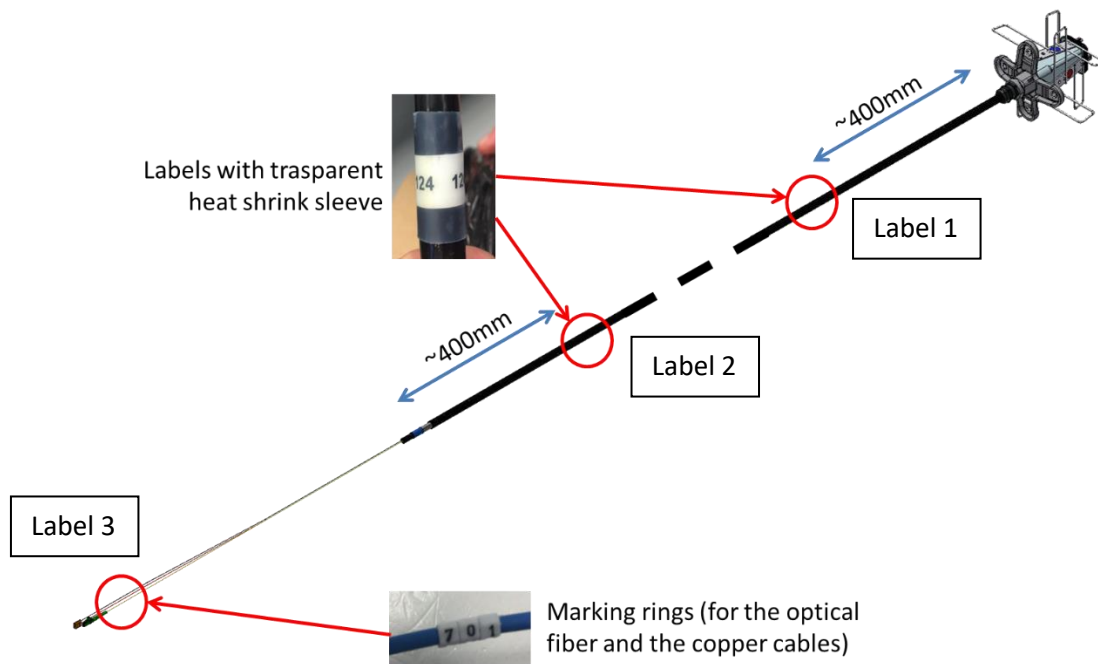
Figure 8: Hybrid cables label numbering.

13. Put the labels with the serial numbers, in the positions shown in Figure 8.

1. Labelling check: verification of the presence of the three labels on the HC showed in Figure 8 and matching the number with the FEM label (three digits in the red box in the Figure 9).

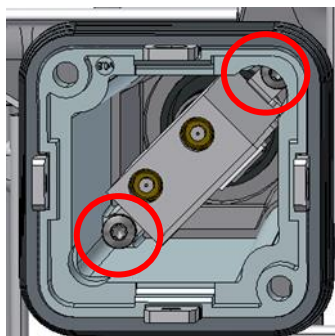
*Figure 12: FEM's anchoring screws position inside the trumpet.*

5. Tightening screws: verify the correct tightening of the screws indicated by the red circles in Figure 12.

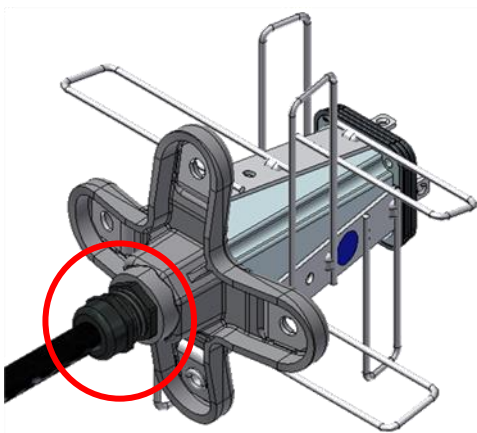
6. Cable gland tightening: check the tightening of the cable gland body on the trumpet and tightening the cable gland head on the HC (the HC must not rotate over the trumpet).

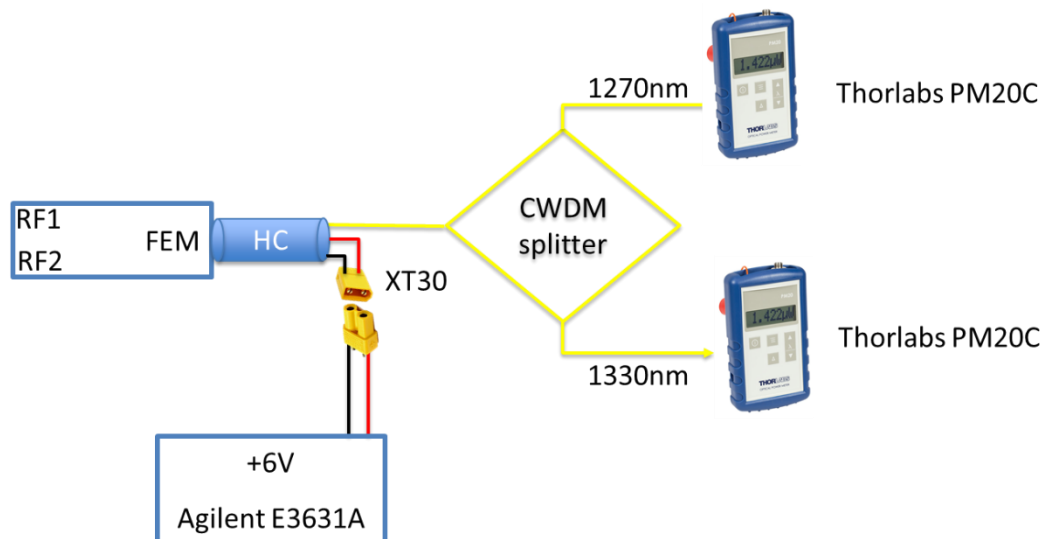
Figure 13: Bench test scheme.

Point 7 consist in evaluating the optical power emitted downstream the hybrid cable at two different wavelengths (1270 and 1330nm) using a CWDM splitter and two optical power meters Thorlabs PM20C. These values were compared to those measured during RX tests done before the hybrid cable reworking and some assumptions have been made to determine whether assembly problems have occurred (Fail) or not (Pass).

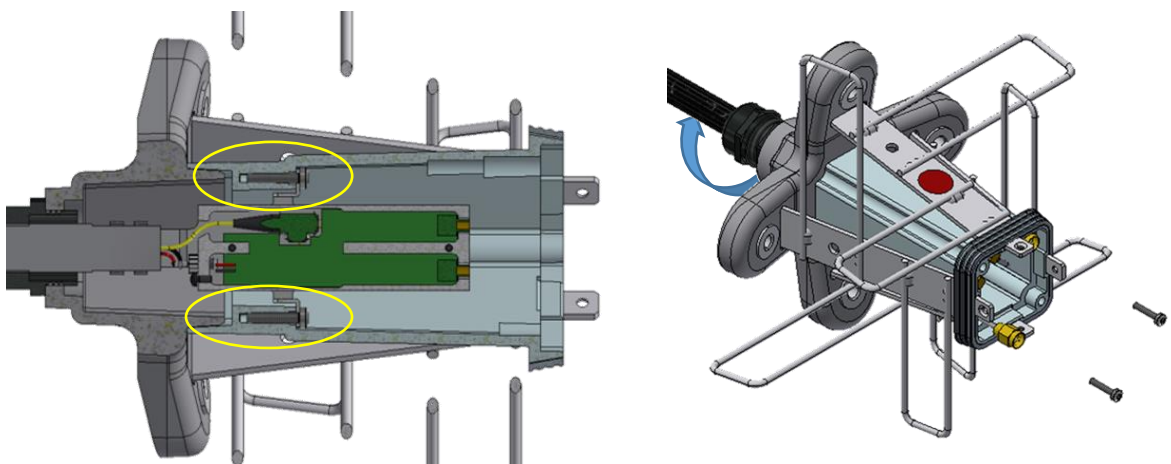
Figure 18: Torx screws positions (top) and cup nut loosening direction.

2. Unscrew the two torx socket pan head tapping screws that fix the optical transmitter to the trumpet body (a torx screwdriver is recommended) and then loose the cup nut of the cable gland.

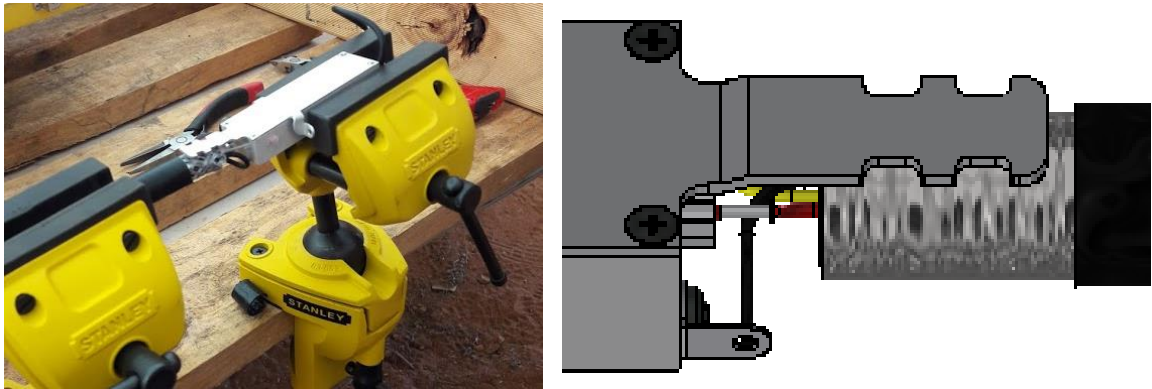
*Figure 22: Outer jacket removing.*

6. With a cutter remove the outer jacket of the hybrid cable close to the module cover, as indicated in the pictures. Be careful about the cover integrity.

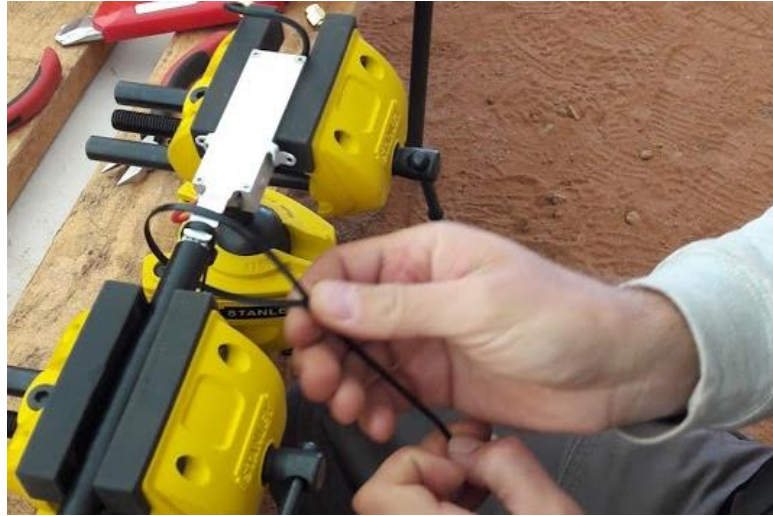
Figure 23: Cable ties tightening.

7. Tight two cable ties to connect the module to the hybrid cable. After that is possible to remove the assembly from the two clamps. Check if there are any short between the power lines.

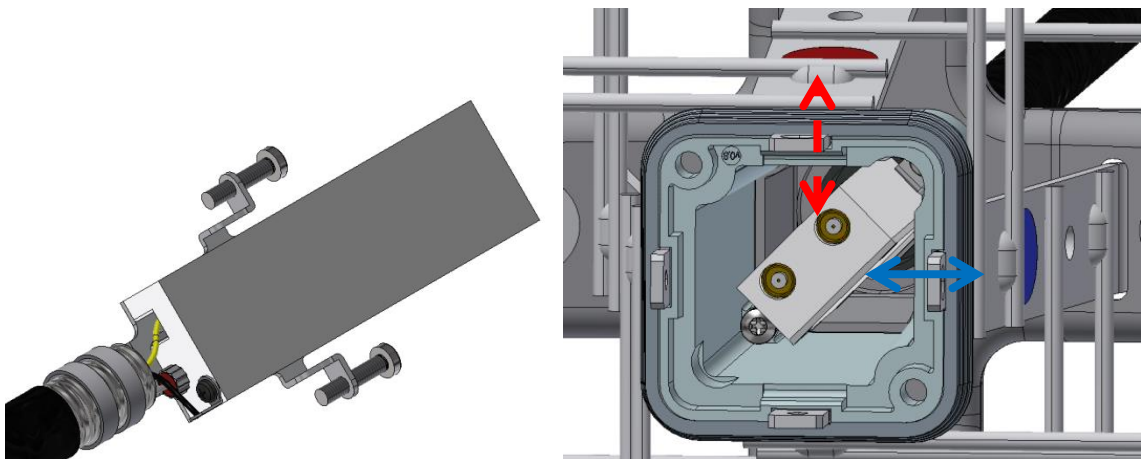
Figure 24: TX module fixing and orientation.

8. Place the two torx socket pan head tapping screws as shown in the figure, to simplify the connection of the module inside the trumpet. After that, by pulling the hybrid cable, insert the transmitter module into the trumpet and fix it screwing the two torx socket pan head tapping screws. There are two possible orientations of the module inside the trumpet. The right one is with the FE label faced towards the red dot and the FE cover to the blue dot. Then tight the cable gland nut.

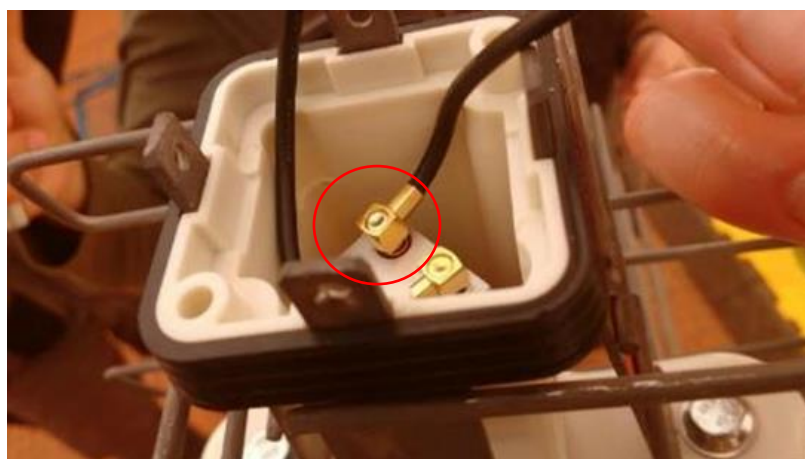
*Figure 25: Connections check.*

9. Check the connections of the coaxial cables with the MCX connectors of the FE module.

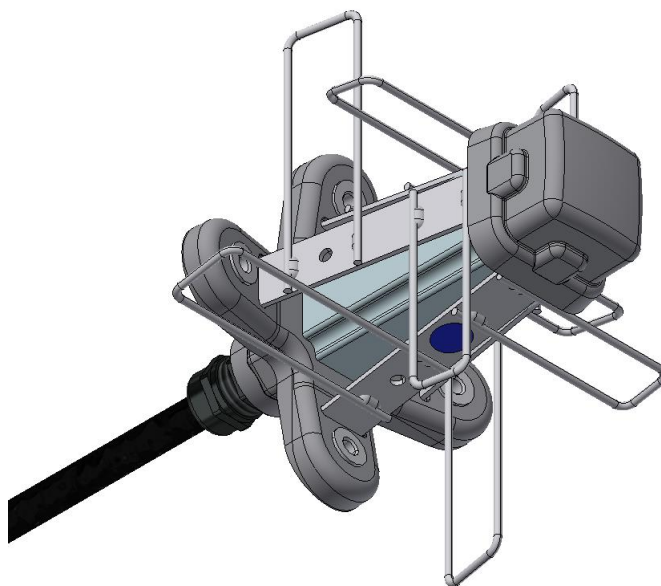
*Figure 26: Pyramid assembled.*

10. Re-install the two LNA boards and the trumpet hat.
