**TITLE:** **Current Drop Noise in RCA 23 FEM**

**DOC. TYPE:** **TECHNICAL NOTE**

**PROJECT REF.:** **PL-LFI-PST-TN-079** **PAGE:** I of IV, 7

**ISSUE/REV.:** **1.0** **DATE:** November 2007

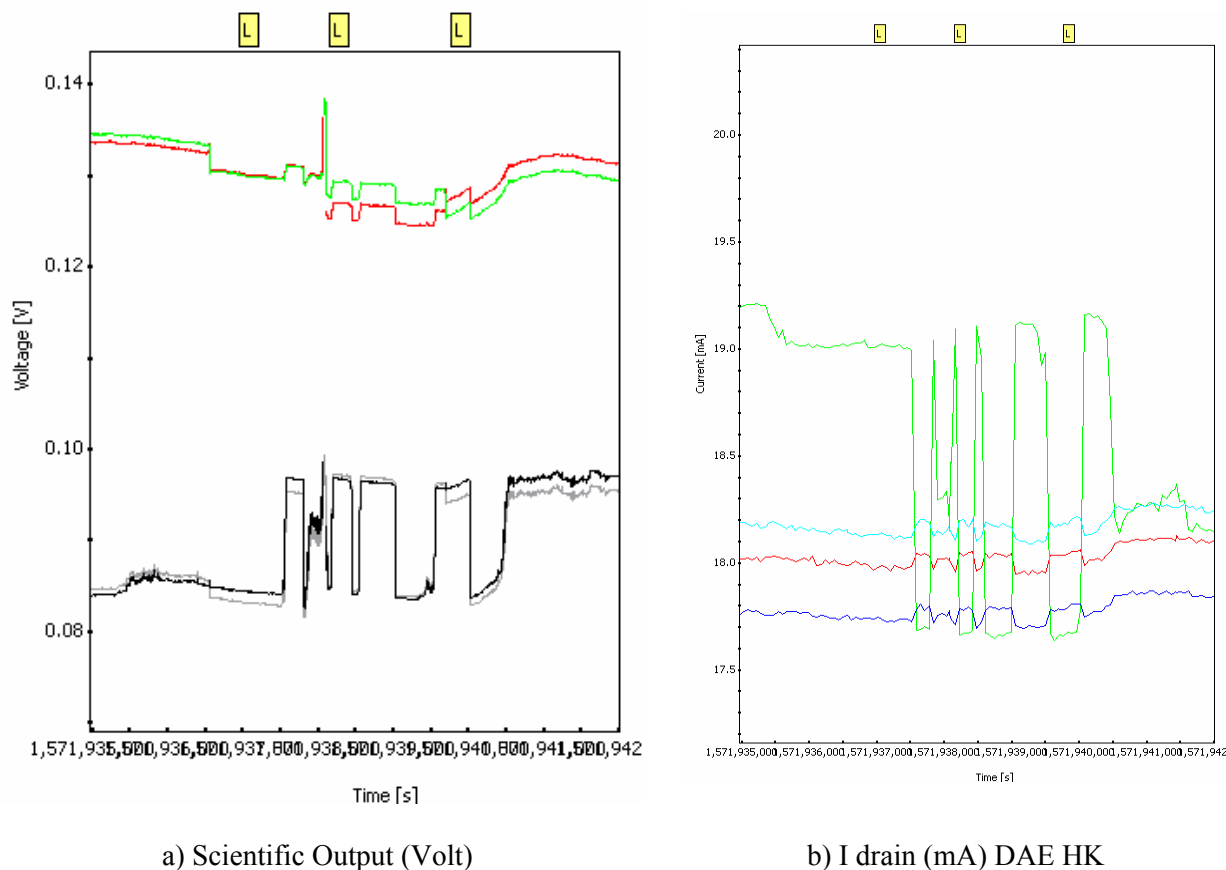
Fig. 1. RCA23 Burst Noise AMB\_0114

In the above figure the output from the detector R1D1 (in gray) and the output from the detector R0D0 (In red and green) are shown. A quite high “Burst Noise like” is visible in both outputs where no changes in LFI configuration were expected.

Looking at I drain current values (fig 1 b) from the House Keeping it is quite evident that the current of the LNA associated to S1 is changing within three different values (*high low* and *middle* values). The change in the S1 is somehow reflected in the currents of the others LNA and this is also visible in voltage output. The order of magnitude of the current changes is about 1.5mA (peak to peak).

The feature is visible for 1 hour and the I drain of S1 stabilize at a *middle* value. In this configuration the change in percentage of the current respect to WFT test that is our reference point is more than 5%, while at the beginning of the test when the current was in his *higher* state the difference respect to WFT was lower than 0.8%. The current remains in this *middle* values all along the test until the end.

The first time the feature appears in AMB\_0113 at the 14:09:06 just when the LUT of the SCS were uploaded via TC, anyway there is no direct connection between the two event because the LUT were uploaded also at 9:44:52 and no feature was visible at that time.

From literature, the nature of the *Burst Noise like* in output voltage is that it has a strong dependence with applied voltages to amplifier, this means that the higher the voltages the higher the noise could be. [RD02] From FM test campaign the Burst noise was no observed during the whole cryogenic test where lower biases to S1 ACA were applied respect to the one applied during the Warm Tests. If nothing is changed somewhere from the FM cryogenic tests we would expect that also in CSL and in Flight the feature will disappear, but indeed this Noise appeared only during the PLM SIT tests and it was not visible during WFT, SFT and EMC tests.

LFI would monitor the feature so a dedicated NCR should be opened.

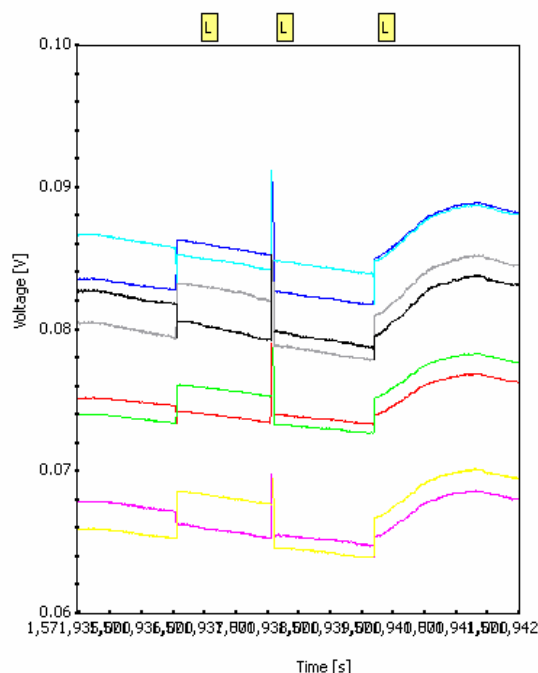
In the figure below is show the same output when the right current is applied and no noise is seen.

The changes in output in the figure above are due to changes of the PS status via TC sending.

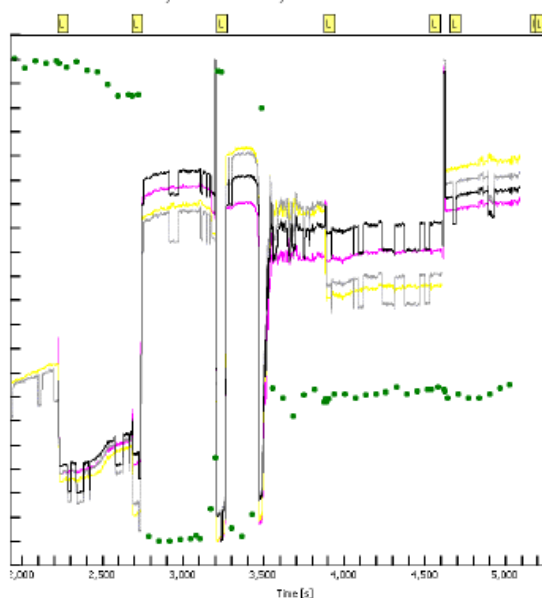
a) Scientific Output (Volt)

The above picture refers to data collected during FM test AMB\_0090 [RD01]. It is visible the current noise of the same order of magnitude of the one found in system level,  $\sim 1.5\text{mA}$ . The Burst noise was found before and after the FM calibration in cryogenic condition and a NCR was open at that time to keep trace of the unexpected behaviour.
