| <b>Title</b> | ECCOSORB Failure Analysis |

**TITLE:** ECCOSORB failure analysis

**DOC. TYPE:** TECHNICAL NOTE

**PROJECT REF.:** PL-LFI-TES-TN-015

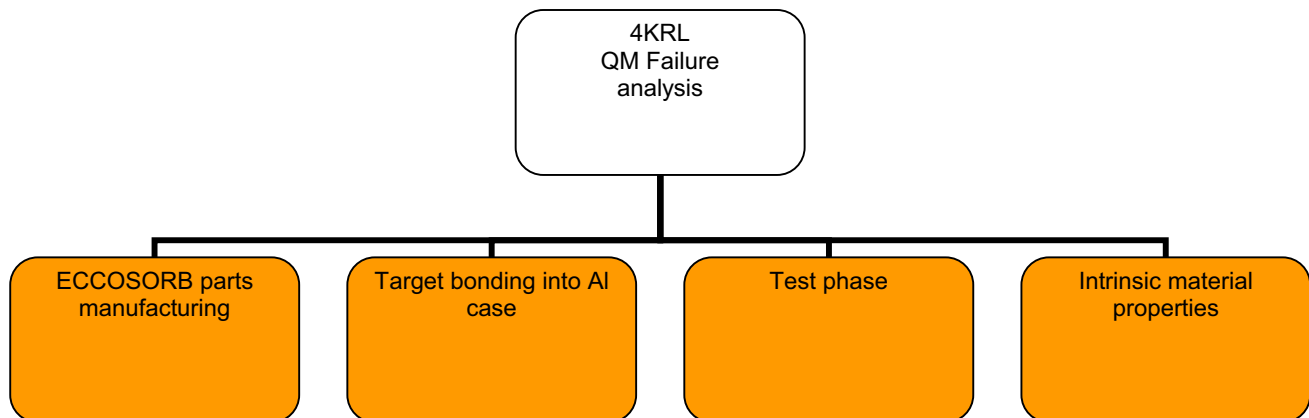
Figure 8: High level failure analysis tree

‘Failure tree’ is reported in XX. It is compiled considering all the possible factors which can have been causes of the failure. They have then been studied to identify the actual problem areas and divide them in different level risk. Color code is as follows:

- Green boxes refer to excluded causes.
- Light blue boxes refer to possible causes (needs to be further investigated).
- Orange boxes indicate high probable causes (need to be considered).
- Red boxes indicate identified problem areas (mandatory to solve).

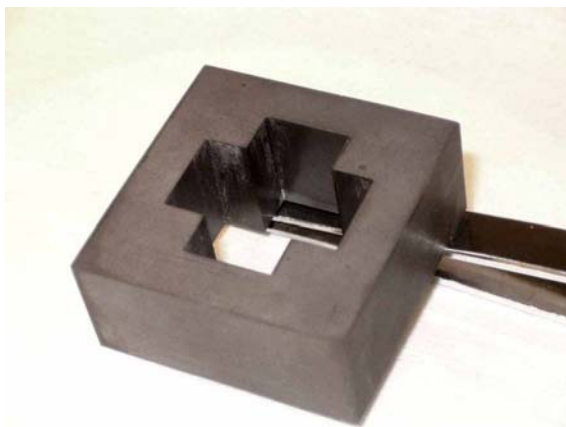
| DATE | TIME | TEST<br>CONDITION | NOTE |
|---|---|---|---|
| 11/03/05 | 15.55 | | <b>End of the VIII cycle of ultrasonic cleaning bath</b><br><b>Visual inspection:</b> there aren't additional visible defects. |

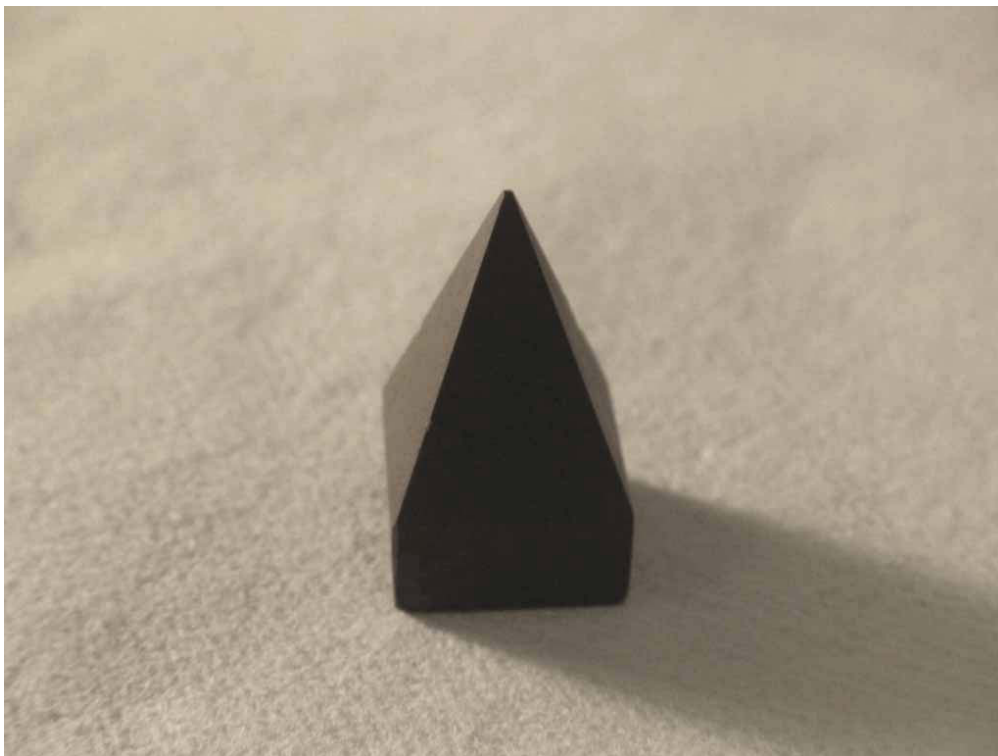
| DATE | TIME | TEST<br>CONDITION | NOTE |
|---|---|---|---|
| 15/03/05 | 10.00 | 21.5°C40.3%HR | <b>Visual Inspection:</b> there aren't visible defects.<br><b>Mass:</b> 1.95 [g] |

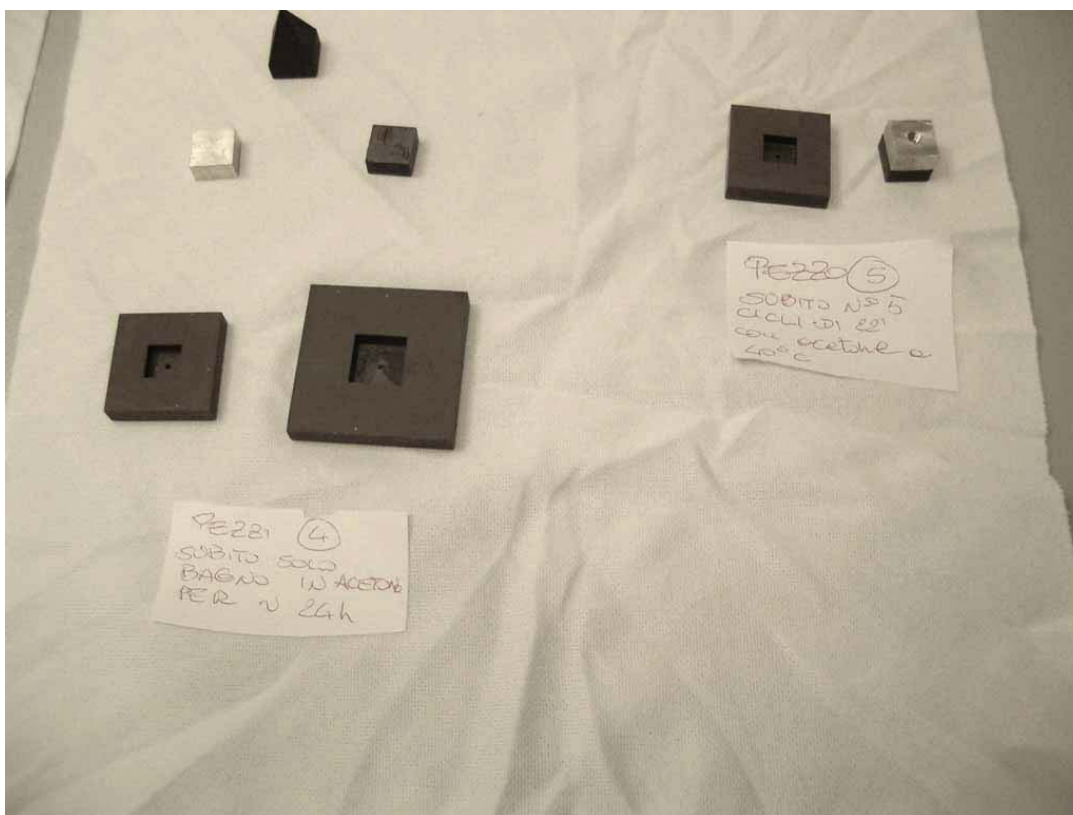
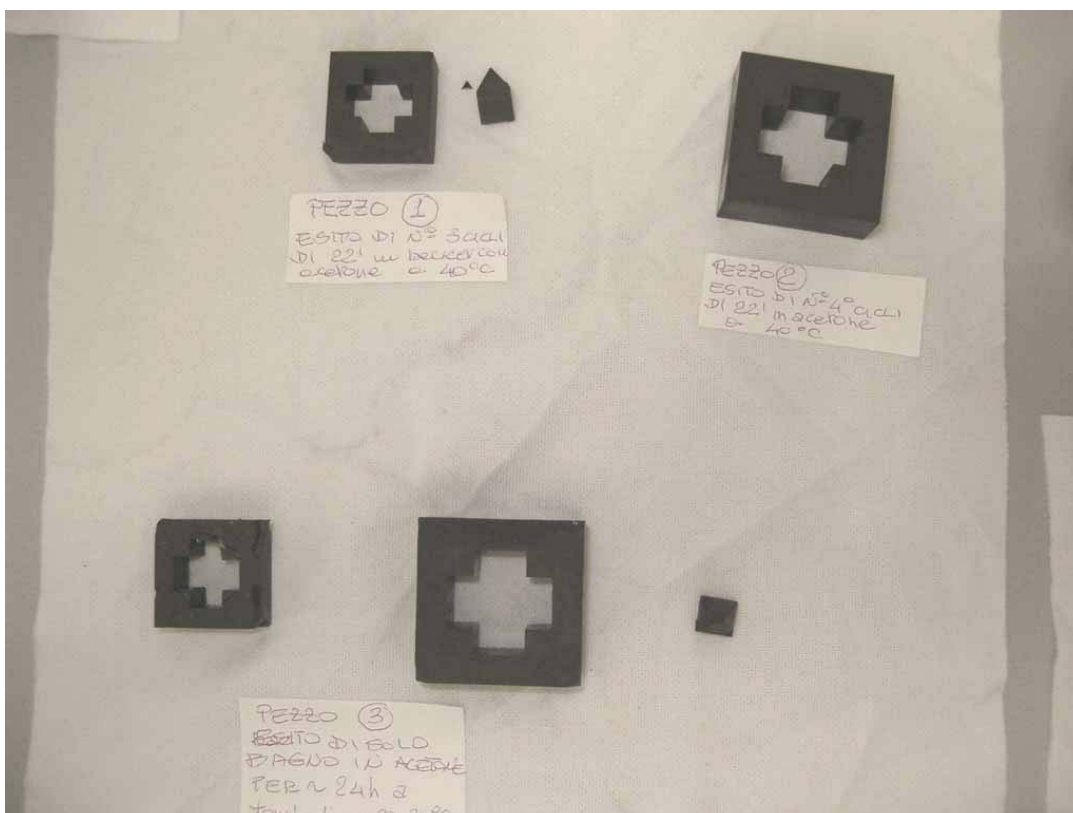
| DATE | TIME | TEST<br>CONDITION | NOTE |
|---|---|---|---|
| 21/03/05 | 15.00 | | <b>Visual Inspection:</b> there aren't visible defects. |
