**TITLE:** **PLANCK OPTICAL SHIELD 2:  
CRYO TESTS ON  
REPRESENTATIVE PANELS**

**DOC. TYPE:** Test Report

**PROJECT REF.:** PL-LFI-PST-RP-026      **PAGE:** I of III, 26

**ISSUE/REV.:** 1.0      **DATE:** January 2008

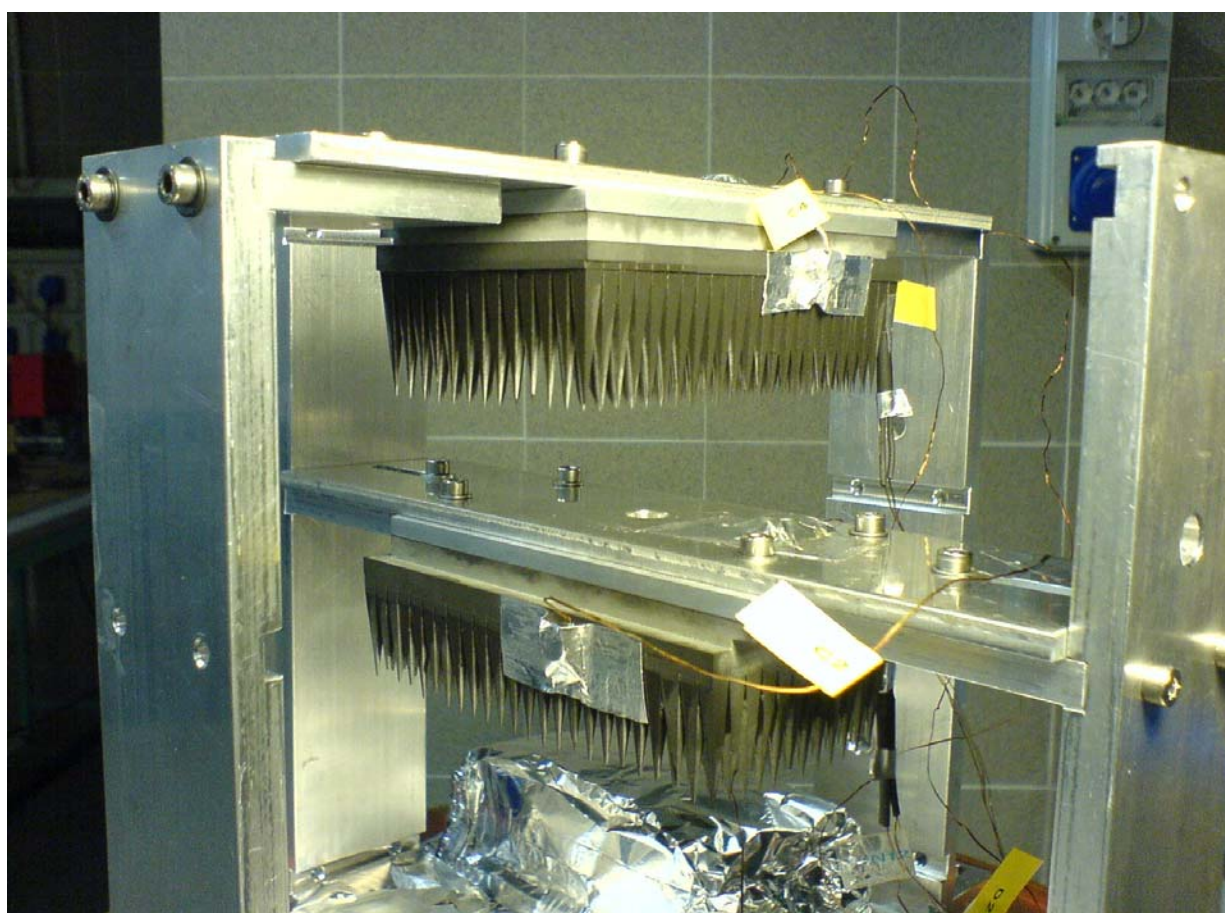
Both inspections gave no evidence of possible problems or defects ascribable to the cycle.

**Figure 3 detail of the mounting after warmup**

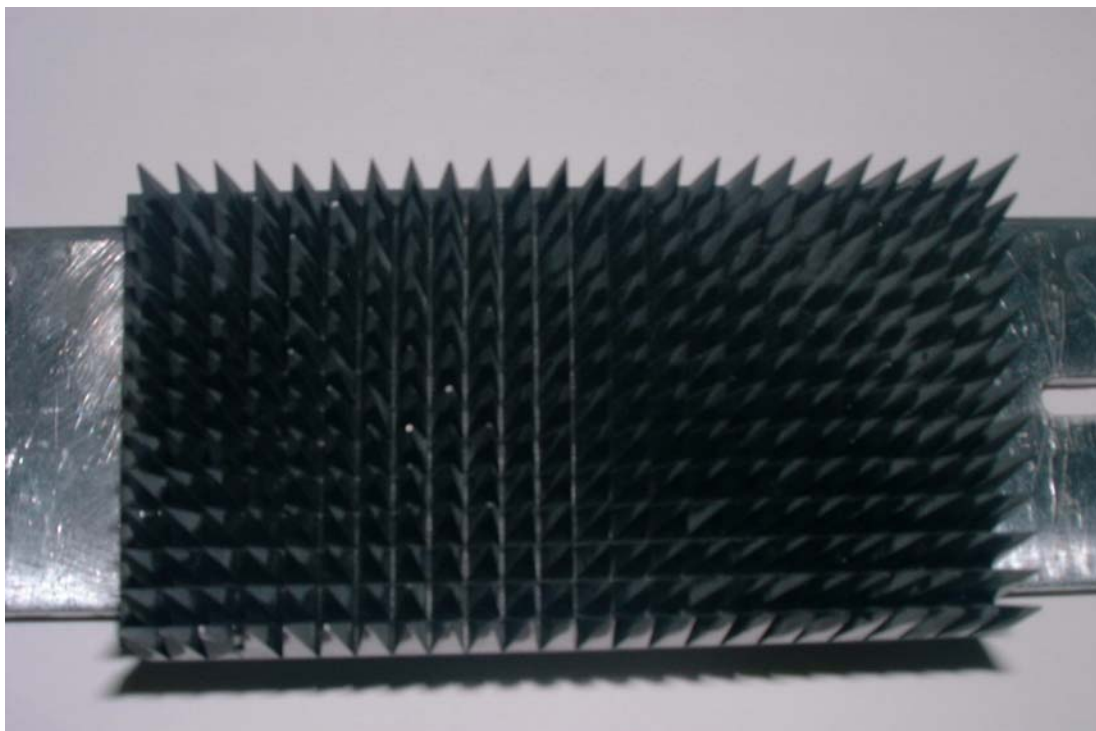
No evidence of change was observed in the panels: no broken parts (example Eccosorb tips) have been found on the aluminium foil put on the flange in order to collect eventual parts falling down from the panels.

**Figure 15 standard panel after dismounting from facility supports**

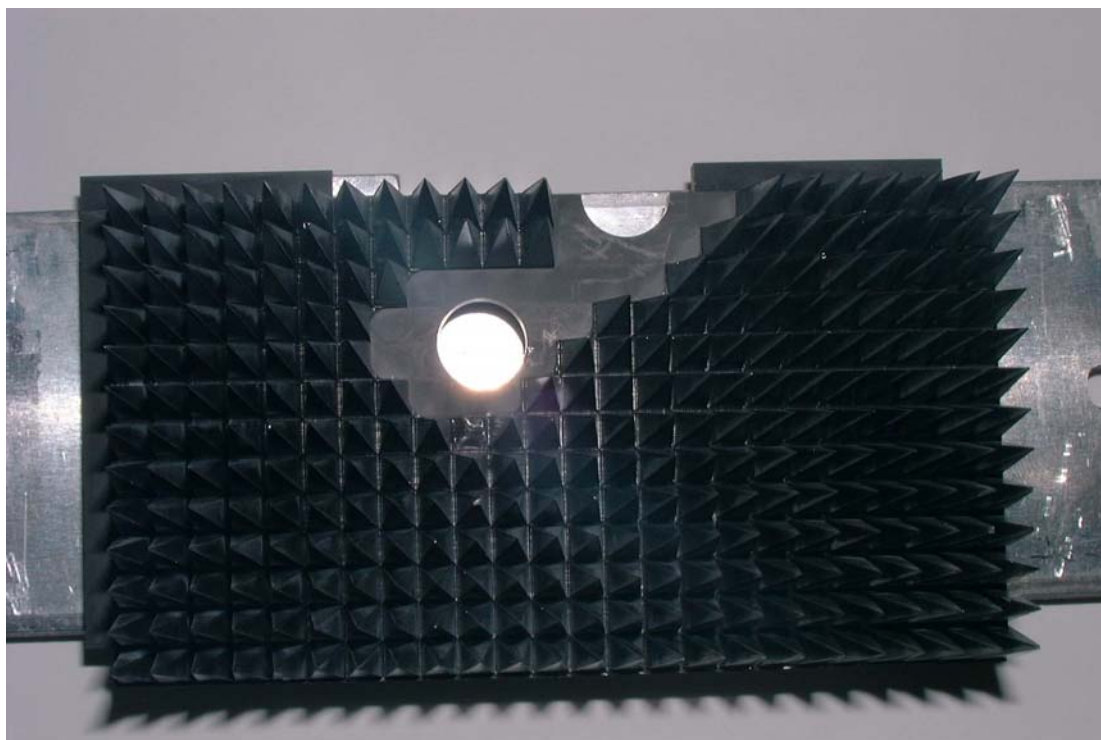
**Figure 16 special panel after dismounting from facility supports**

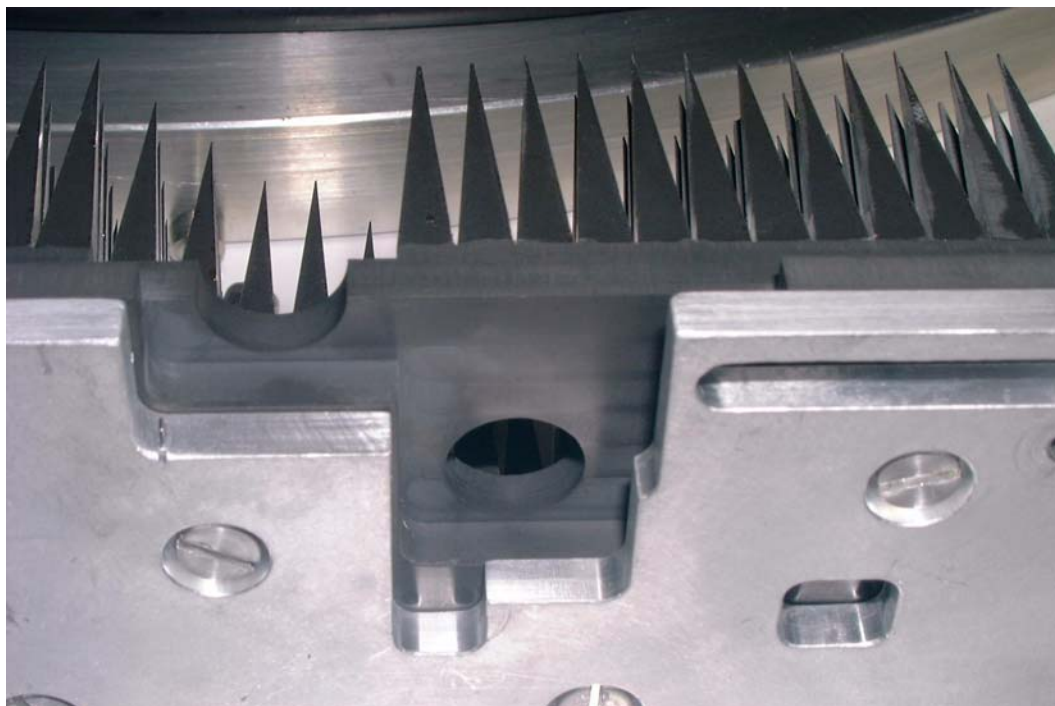
**Figure 17 special panel from the back after dismounting from aluminium interface with cryo facility supports.**

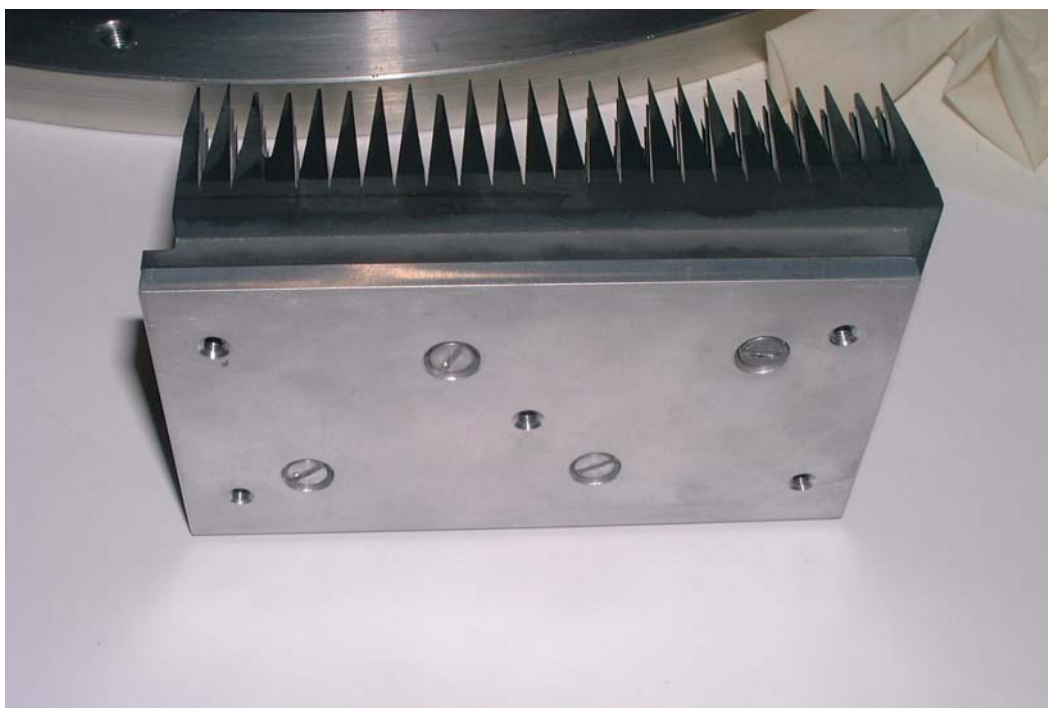
**Figure 18 standard panel from the back after dismounting from aluminium interface with cryo facility supports.**

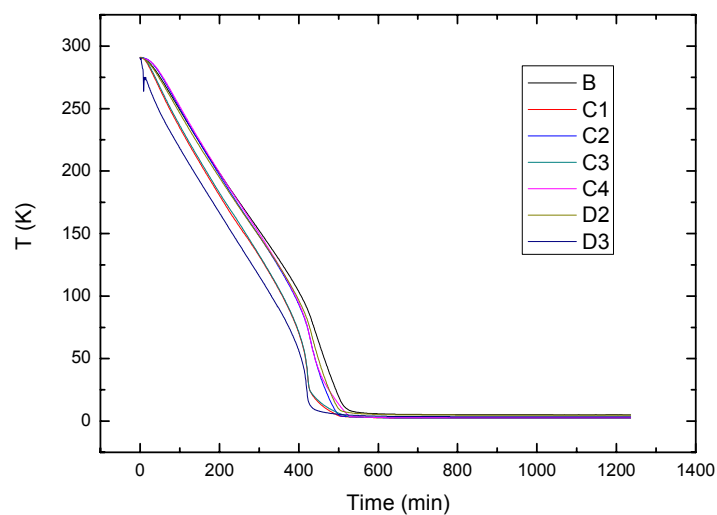
Figure 20 7<sup>th</sup> cooldown

During cycles, from 7<sup>th</sup> to 9<sup>th</sup>, one of the 7 thermal sensors showed instabilities and in the last two cycles did not reach the temperature foreseen. However, this sensor was used just to monitor the cold flange of the cryostat: hence, this failure did not affect the validity of the test.

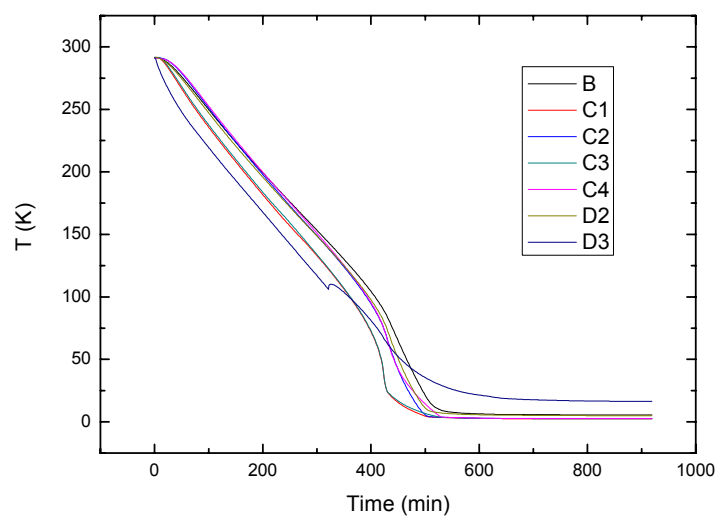
Figure 22 9<sup>th</sup> cooldown

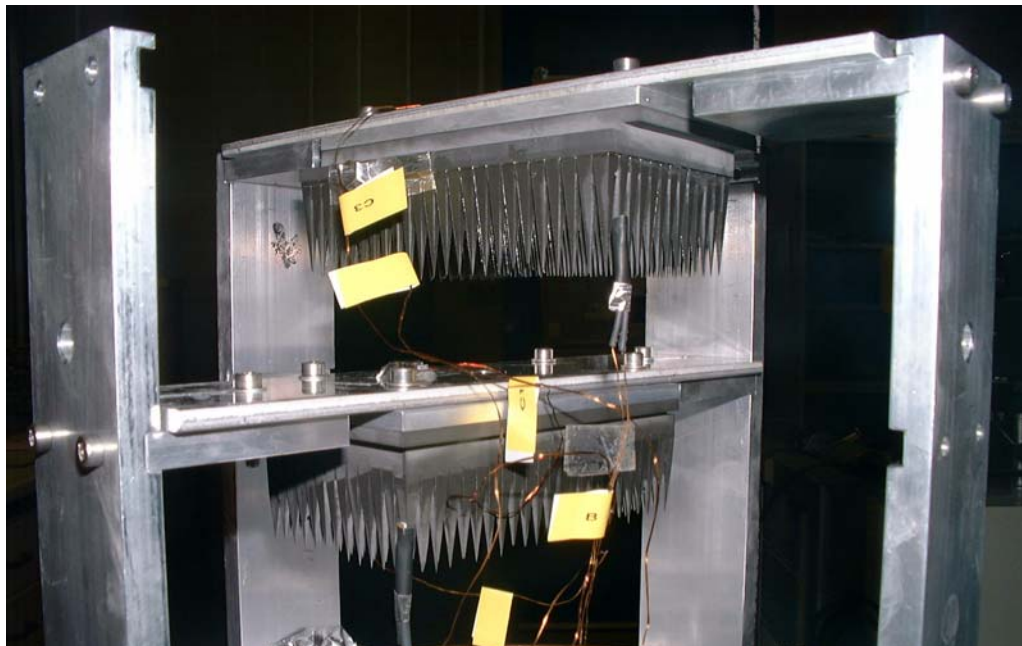
A first inspection was done just after opening the chamber, with panels still mounted on their supports. Nothing relevant was observed.

**Figure 27 panels mounted on supports before dismounting**

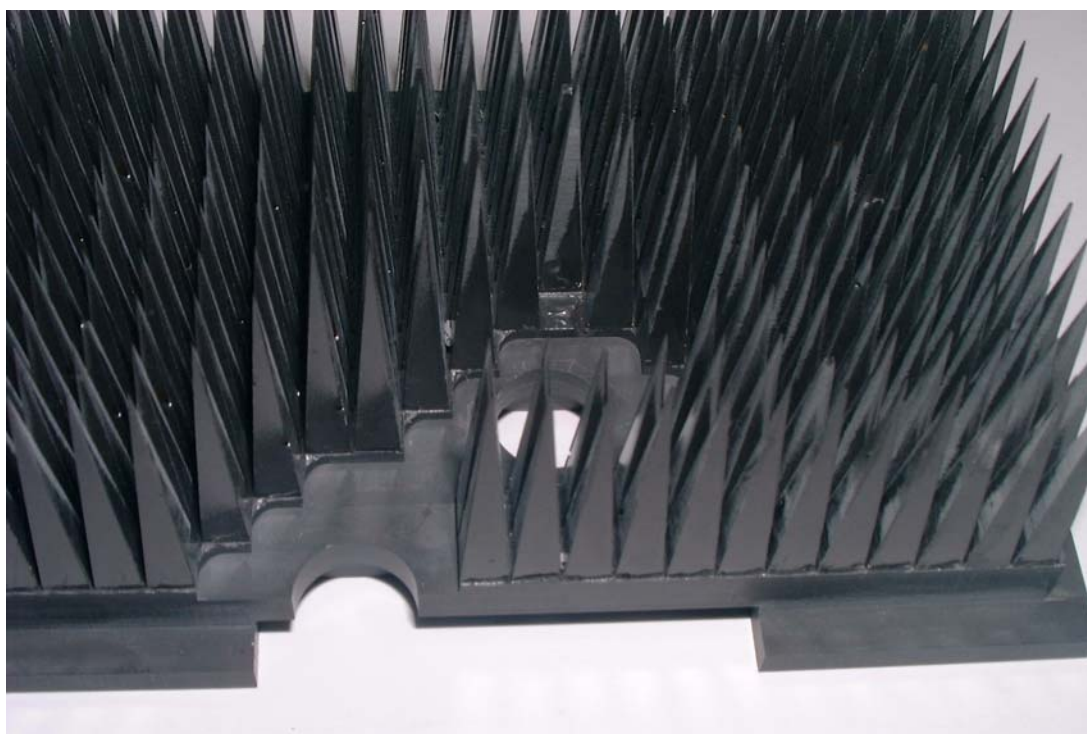
Panels have been then inspected by binocular: nothing new seems to be observed. Comparison with the initial map reporting broken tips and other defects seems to confirm this result.

**Figure 31 special panel: zoom on the region lodging sources**
