# **AMBIENT VIBRATIONS OF AGE-OLD MASONRY TOWERS: RESULTS OF LONG-TERM DYNAMIC MONITORING IN THE HISTORIC CENTRE OF LUCCA.**

The paper presents the results of an ambient vibration monitoring campaign conducted on so-called “Clock Tower” (Torre delle Ore), one the best known and most visited monuments in the historic centre of Lucca.

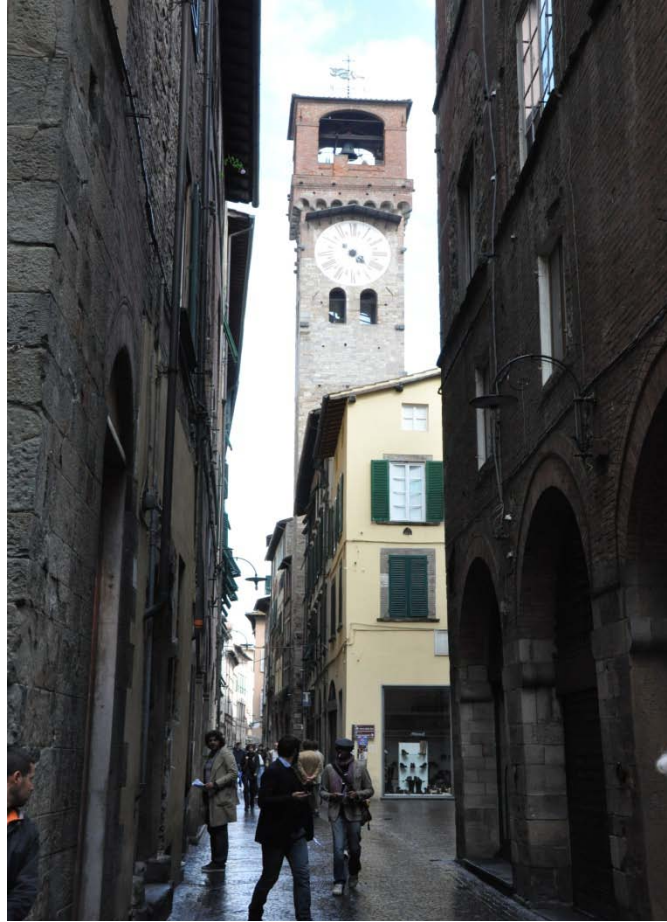
Figure 2. The Clock Tower: view from Via Fillungo.

clock visible on its southern facade (Figure 2). The Clock Tower rises at the corner between the roads named Via Arancio and Via Fillungo, one of the most popular in Lucca's historic centre; the adjacent buildings abut the tower on two sides for a height of about 13 m and constitute asymmetric boundary conditions for the tower's structure. The Clock Tower is 48.4 m high at the top of the bell chamber; it has a rectangular cross section of about 5.1 x 7.1 m and walls of thickness varying from about 1.77 m at the base to 0.85 m at the top. Two barrel vaults are set inside the tower at heights of about 12.5 and 42.3 m. The bell chamber, made up of four masonry pillars connected by elliptical arches, stands on the upper barrel vault and is covered by a pavilion roof constructed of wooden trusses and rafters. With regard to the materials constituting the masonry tower, visual inspection reveals that the masonry from the base up to a height of 15 m is made up of regular stone blocks and thin mortar joints. The upper walls are instead composed of regular stone blocks and bricks, also with thin joints. The pillars of the bell chamber are made of brick masonry. On 25 November 2016, during a preliminary experimental campaign, the ambient vibrations of the Clock Tower were monitored for a few hours via four SARA SS20 three-axial seismometric stations. The instruments were moved along the tower's height by adopting three different layouts and combining data in order to identify four natural vibration frequencies and mode shapes of the tower, as described in (Pellegrini et al, 2017). Data collected in this experiment also allowed evaluating the mechanical properties of the tower's constituent materials via model updating procedures, as described in (Girardi et al., 2019).

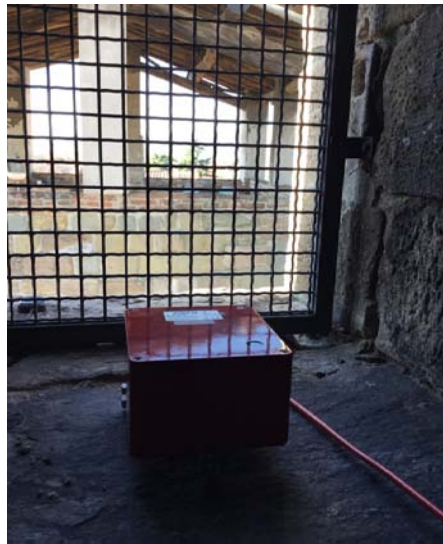
Figure 3. Sensor S.943 at level +24 m

In November 2017 a long-term ambient vibration monitoring experiment was begun with the fitting of six instruments along the tower's height: four Sara SS20 seismometric stations (tri-axial velocimeters, Fig. 3) from the INGV, named in the following S.942, S.943, S.944, S.945, and two tri-axial accelerometers (Fig. 4) provided by the firm Assist in Gravitation and Instrumentation (AGI S.r.l.), named in the following S.1 and S.2. The INGV sensors were coupled with a 24-bit digitizer and the signal was sampled at 100 sps. The AGI data were acquired by a laptop at a sampling frequency of 20 Hz using a 24-bit digitizer. With regard to the main characteristics of the instruments used in the monitoring campaign, the SS20 velocity transducers have a nominal sensitivity of 200 V/m/s, eigenfrequency of 2 Hz, and usable band from 0.1 to 250 Hz. The AGI accelerometers have an acceleration noise density of  $2 \cdot 10^{-8} \text{ g}/\sqrt{\text{Hz}}$  and usable band from  $10^{-5}$  to 50 Hz. It is worth noting that together the instruments can cover a very wide band of frequencies. The instrumentation was kept running on the tower up to March 2018. Figure 5 shows the layout of the sensors along the tower during the experiment: seismic station S.942 was placed at the base, collecting data from the ground, S.943 was at the height of 24 m above street level, the remaining two stations S.943 and S.944 were placed on the bell chamber, at about +42 m above street level. The AGI stations were both installed in the upper part of the structure, S.2 at +37 m and S.1 on the bell chamber level.

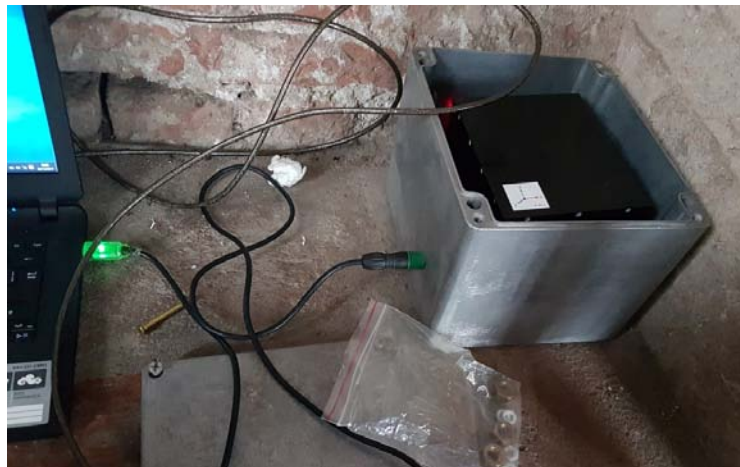
Figure 4. Sensor S.2 at level +37 m inside the tower.

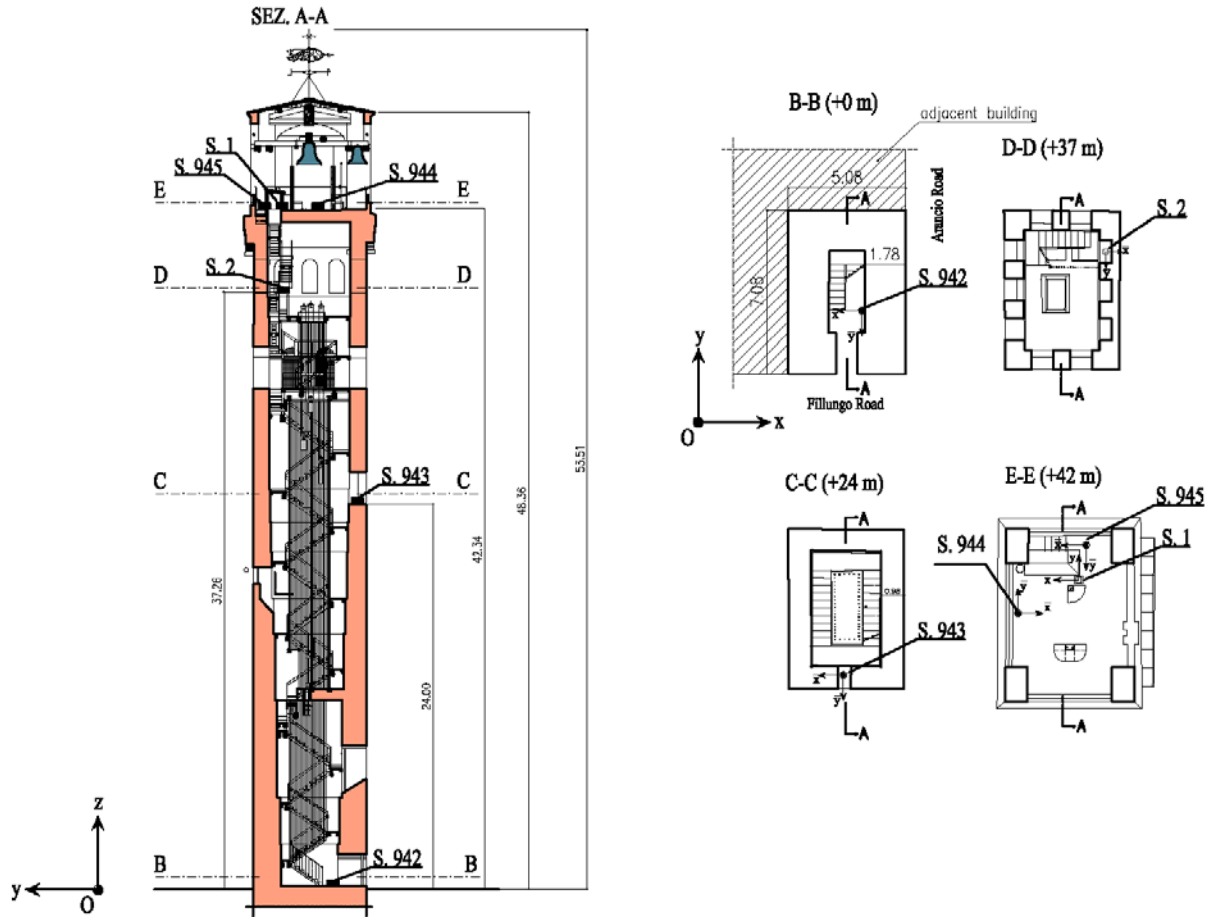
Figure 5. Sensor arrangement on the Clock tower: sensors S.942, S.943, S.944, S.945 (INGV), sensors S.1, S.2 (AGI).

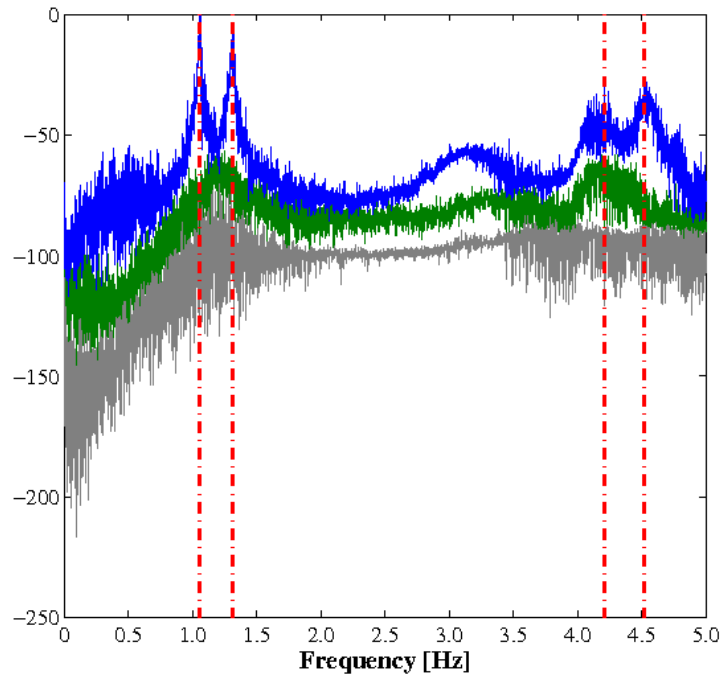
Figure 6. The three eigenvalues of the matrix  $H[j\omega]^H H[j\omega]$  vs. the frequency on a log-magnitude scale.

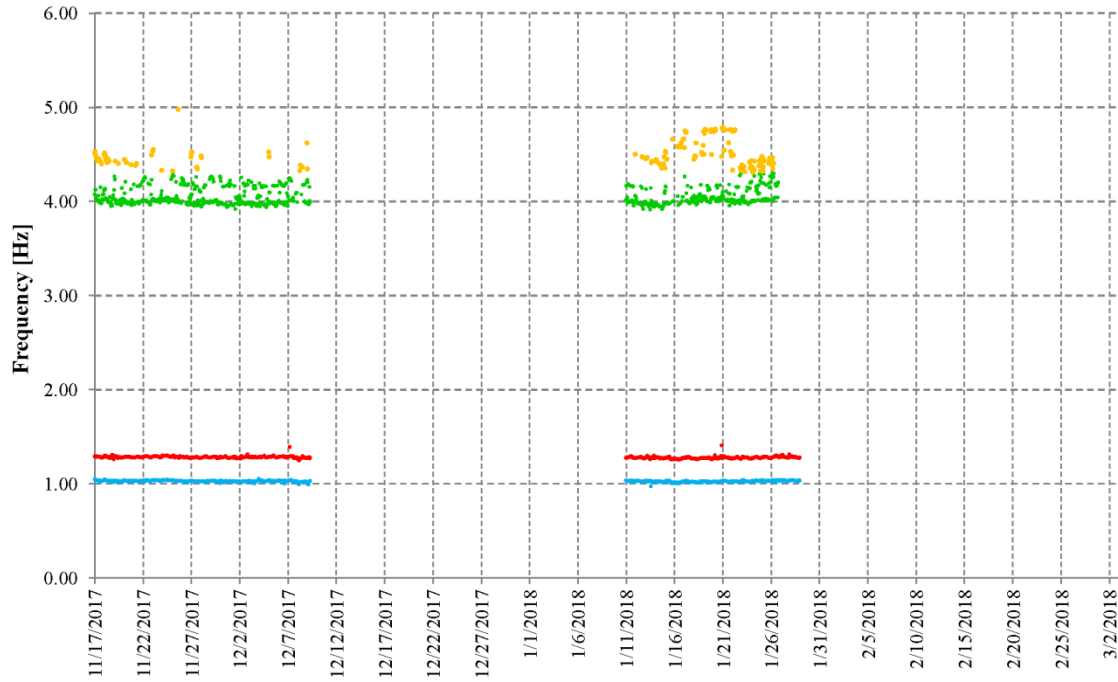
Figure 7. The tower's first four natural frequencies [Hz] detected by SS20 velocimeters during the monitoring period.

The tower's frequencies are reported in Table 1, where the mean values (evaluated over the entire monitoring period from November 2017 to March 2018) of the four frequencies are reported, together with their relative differences (evaluated on the 1<sup>st</sup> and 99<sup>th</sup> percentile) for the two different instruments. The frequencies values measured on the Clock Tower are in good agreement with those of other towers with similar geometries (Bartoli et al., 2017). The dataset from the SS20 seismic stations includes 970 hours of recordings, while the AGI instrumentation yielded 1110 hours of tower measurements. The frequency values vs. time are reported in Figures 7 and 8 for the SS20 and the AGI instruments, respectively. The mean values evaluated by the two instruments are in very good agreement. The first and the second frequencies were detected by the two instruments in all records, and the variation in the two frequencies is on the order of 3%. This variation is also in good agreement with the findings of another long-term dynamic monitoring conducted on the San Frediano bell tower in Lucca (Azzara et al., 2018a). The third frequency was also detected by the seismic stations in almost all records, while the fourth frequency only appears when the excitation level in the tower's structure was increased (it was detected in about the 30% of the records), and its values appear to be widely dispersed. A fifth frequency at about 5.7 Hz was also detected in about 30% of the records. With regard to the modal damping ratios, reported in Table 2, they are widely dispersed with variations on the order of hundreds of percentage points. Their values vary from 4% for the highest frequency, to 0.5% for the first. The values yielded by the seismic stations are generally higher than those from the accelerometers.

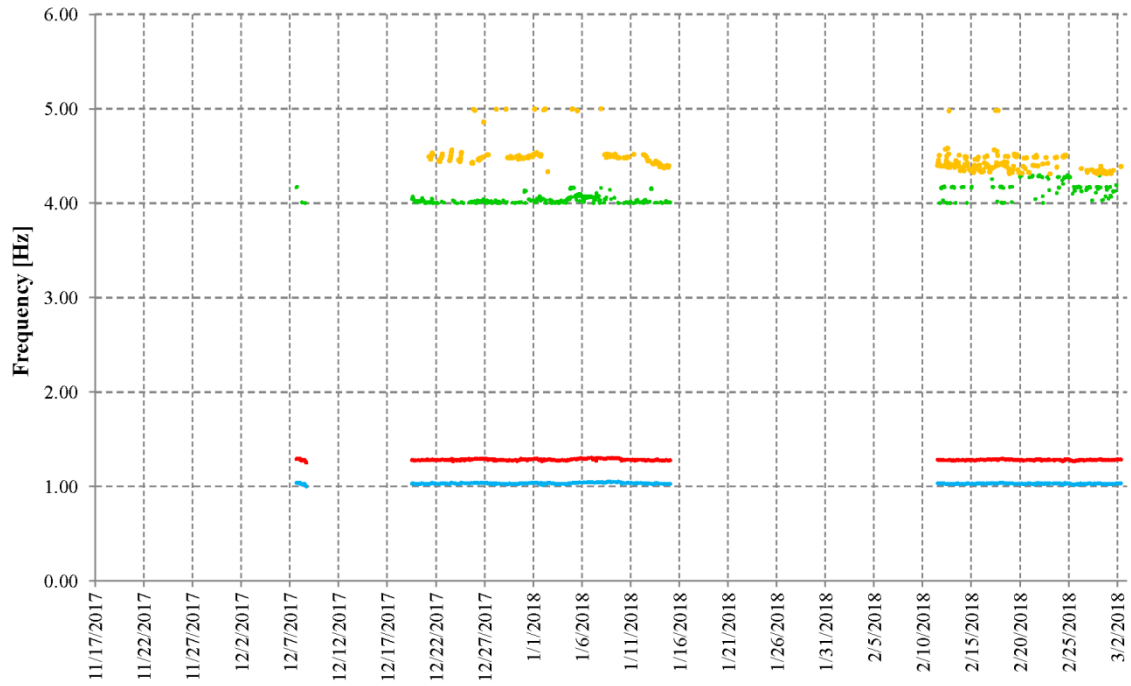
Figure 8. The tower's first four natural frequencies [Hz] detected by AGI accelerometers during the monitoring period.

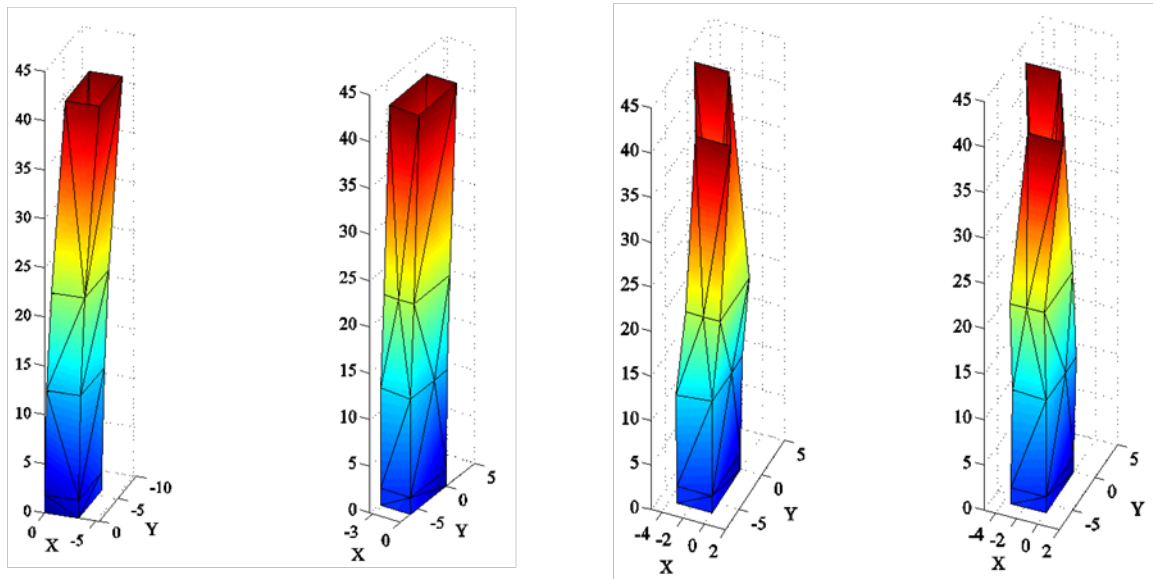
Figure 9. The tower's first four mode shapes [Hz] corresponding (from the left) to the frequencies  $f_1$ ,  $f_2$ ,  $f_3$ ,  $f_4$ .

The mode shapes of the tower corresponding to the four frequencies  $f_1, f_2, f_3, f_4$  are shown in Figure 9; these have been extracted from the data recorded in November 2016 by taking advantage of the different layouts used for mapping the tower's vibrations. The first two frequencies refer to bending modes along the x (first) and y (second) directions, while the third is a torsional mode and the fourth is a torsional-bending mode involving movements of the structure's upper parts.

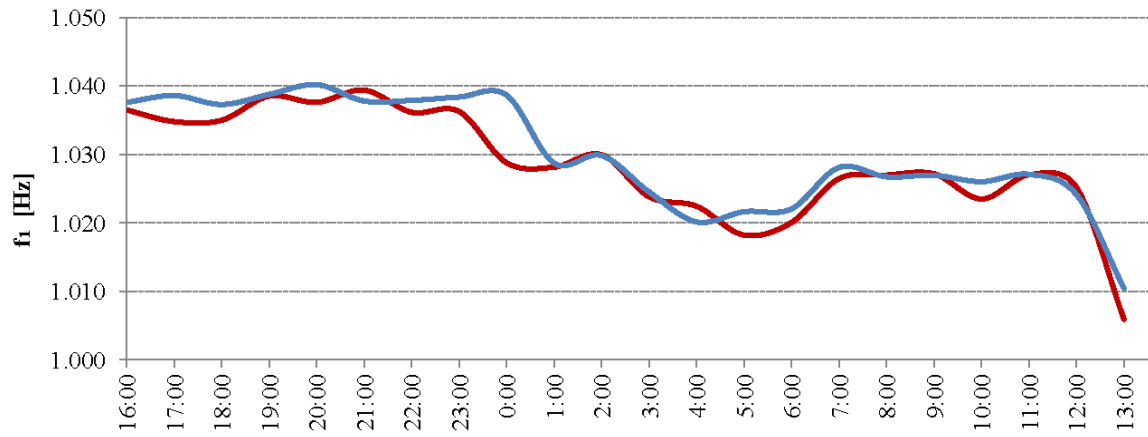
Figure 10. The tower's fundamental frequency obtained via AGI stations (blue) and SS20 stations (red) data from 7 to 8 December 2017 (respectively at 16:00 and 13:00).

Figures 10 and 11 show further comparisons of the results obtained via the two instruments. In particular, Figure 10 shows the trend of the tower's fundamental frequency from 7 to 8 December 2017, extracted from the AGI (blue) and the SS20 (red) devices. The very good agreement between the two measurements indicates that the fluctuations exhibited in the frequency values do not depend on the instruments' functioning, but are rather due to environmental factors. Figure 11 shows a comparison of the hourly maximum accelerations (absolute values) recorded by the instruments during that same period. The differences between the amplitudes are mainly due to the different positions of the instruments, which were placed at slightly different levels along the tower. It is worth noting that maxima in the acceleration values correspond to minima in the frequency values. In fact, a look at the weather those days revealed very bad conditions, with strong wind velocities (see also Figure 15), thereby suggesting a connection between the frequency reduction shown in Figure 10 and the action of the wind, which due to the masonry's inability to withstand large tensile stresses, tends to decrease the tower's stiffness.

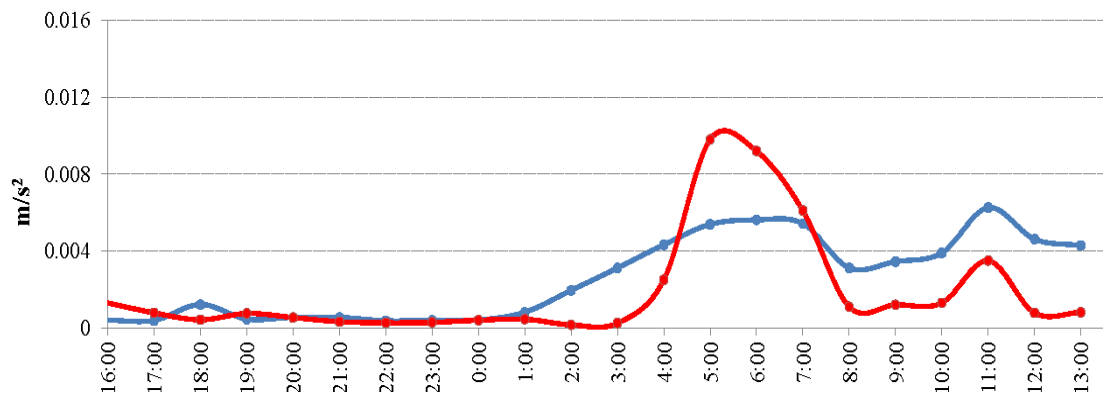
Figure 11. Maximum absolute accelerations recorded by the S.2 station (blue, +37 m) and the S. 945 station (red, +42 m) from 7 to 8 December 2017 (respectively at 16:00 and 13:00).

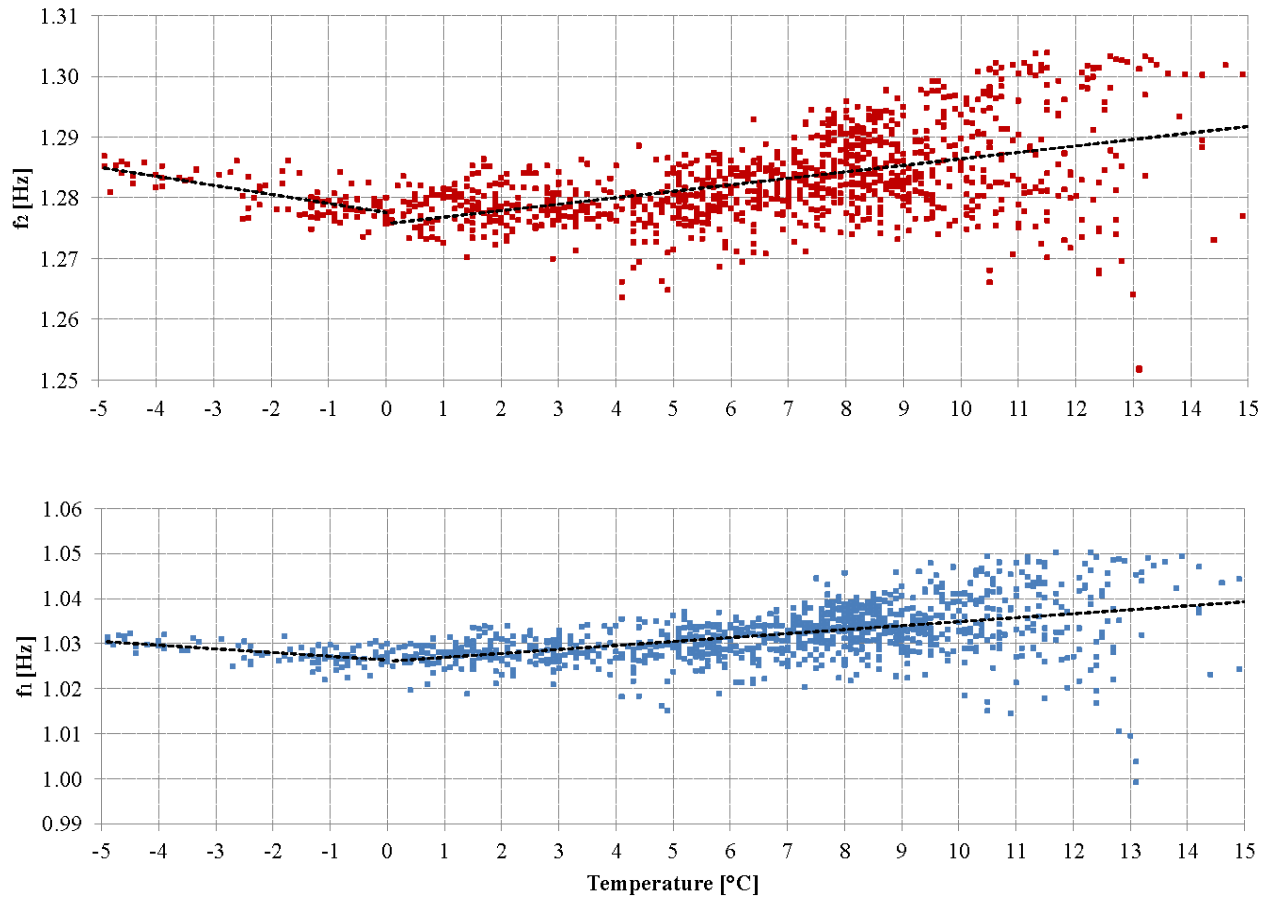
Figure 12. The first (blue) and second (red) natural frequencies of the tower [Hz] vs. temperature [°C].

With regard to the influence of temperature on the tower's dynamic behaviour, Figure 12 shows the correlation of the first two natural frequencies with air temperature, measured by a sensor located in the Lucca Botanical Gardens, in Lucca's historic centre. The figure confirms the findings of other

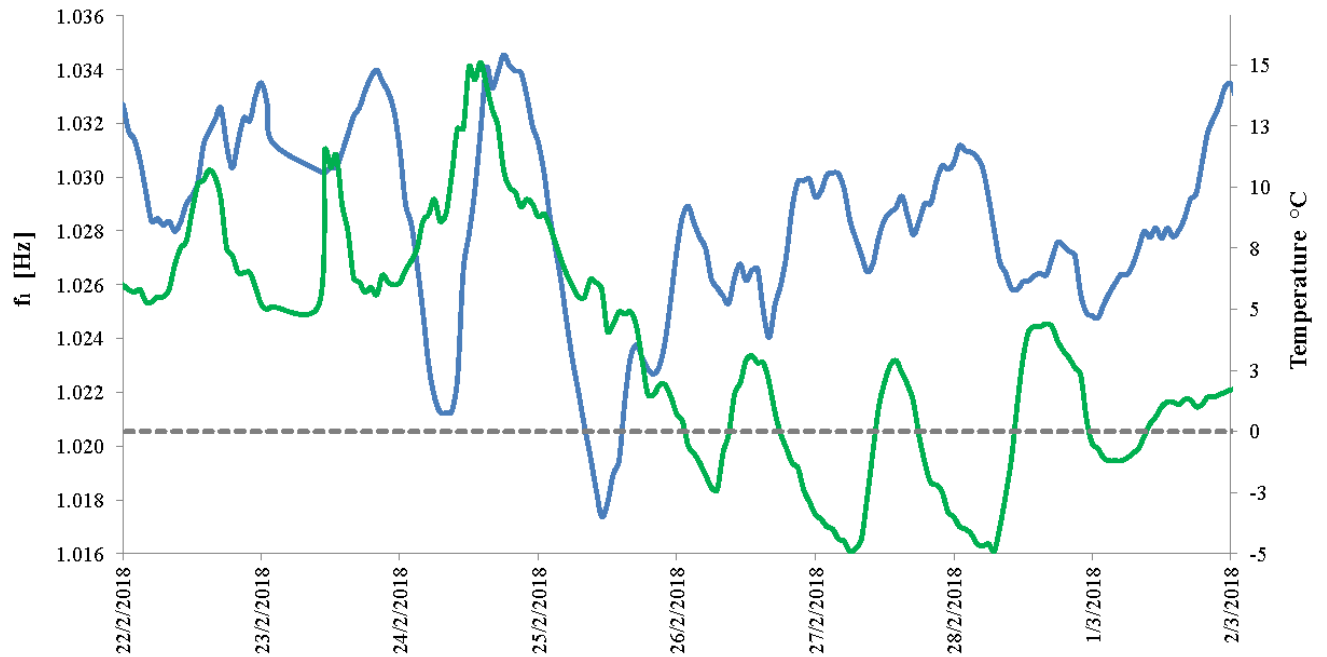
Figure 13. The tower's first (blue line) natural frequency [Hz] vs. temperature [°C] (green line), during February 2018.

long-term vibration monitoring campaigns on historical towers (Cabboi et al., 2017), (Ubertini et al., 2017), including that carried out on the San Frediano bell tower in Lucca (Azzara et al., 2018a): frequencies tend to increase with temperature. This behaviour is confirmed by the results described in (Girardi et al., 2017), which reports on a nonlinear FE analysis of the Clock Tower conducted by modelling the effects of the thermal variations on the structure's frequencies. The numerical simulation supports the hypothesis that an increase in temperature induces a reduction in the fracture strains inside masonry, thus increasing the global stiffness of the structure. With regard to negative temperature values, Figure 12 reveals opposite trend for frequencies, which turn out to increase when the temperature decreases. This phenomenon was mainly observed in the latter part of February 2018, when temperatures persistently decreased below zero, as highlighted by Figure 13. Correspondingly, the figure shows the change in the frequency trend. The behaviour below freezing has also been reported for similar weather conditions in (Ubertini et al., 2017) and (Cabboi et al., 2017). It is also worth noting that, as long as the temperature remains above zero, frequencies respond to temperature variations with a phase shift in time, while, below zero, the frequency and temperature appear to be in phase.

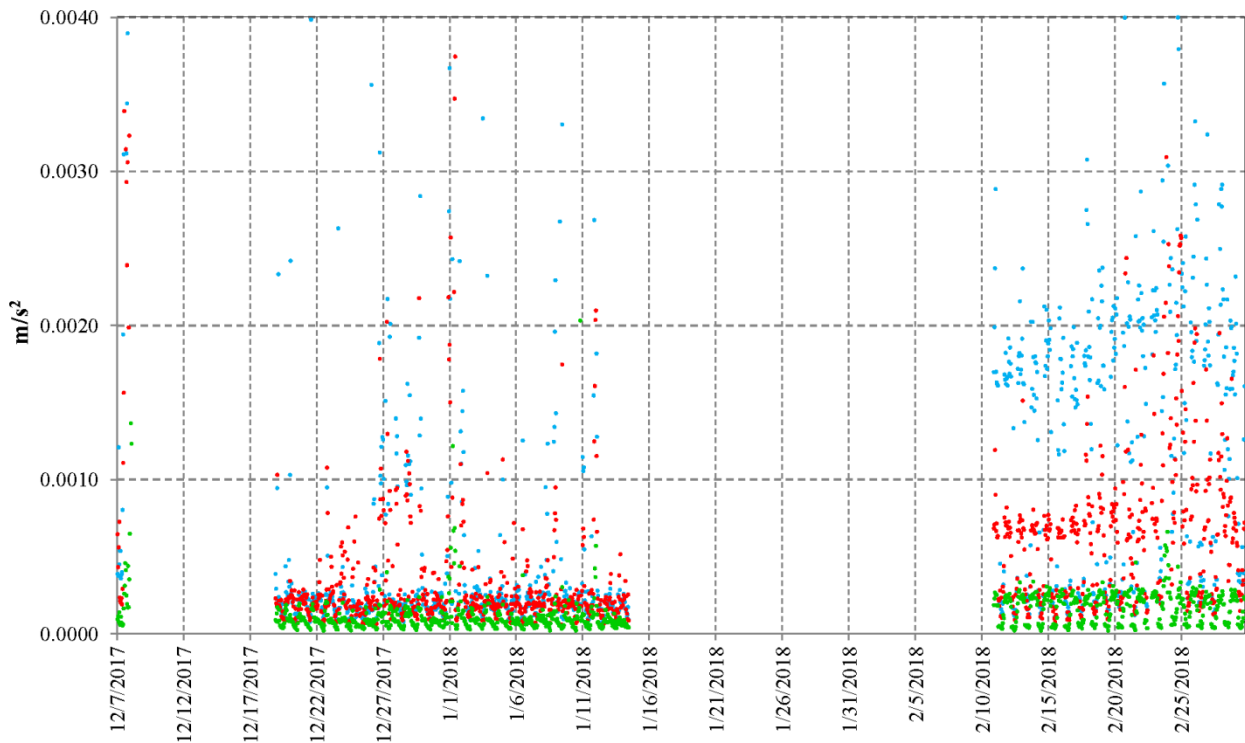
Figure 14. Maximum absolute values per hour of the accelerations recorded by AGI stations (S.2, +37 m) in the  $x$  (blue dots),  $y$  (red dots) and  $z$  (green dots) directions.

The trend over time of the maximum accelerations recorded by AGI sensors is shown in Figure 14. The vibration level in the tower is very low, generally under  $2 \cdot 10^{-3} \text{ m/s}^2$ , thanks to restrictions to vehicular traffic in force in the Lucca historic centre. The figure highlights an increase in the tower's vibration level during the Christmas holiday period (from 22 December to 1 January), connected to the increased pedestrian traffic in the historic centre, with a peak on New Year's Day. The figure also reveals a systematic increase in the accelerations, on average of one order of magnitude, from 9 February onward. This is due to the ringing of the tower bells, which had been suspended for restoration of the ancient clock and was restarted on 16 January 2018. The bell system is composed of three bronze bells, fixed at their supports and rung by hammers each quarter an hour in the  $x$  direction (along Via Fillungo). Indeed, Figure 14 shows significant amplification along  $x$  (blue dots).

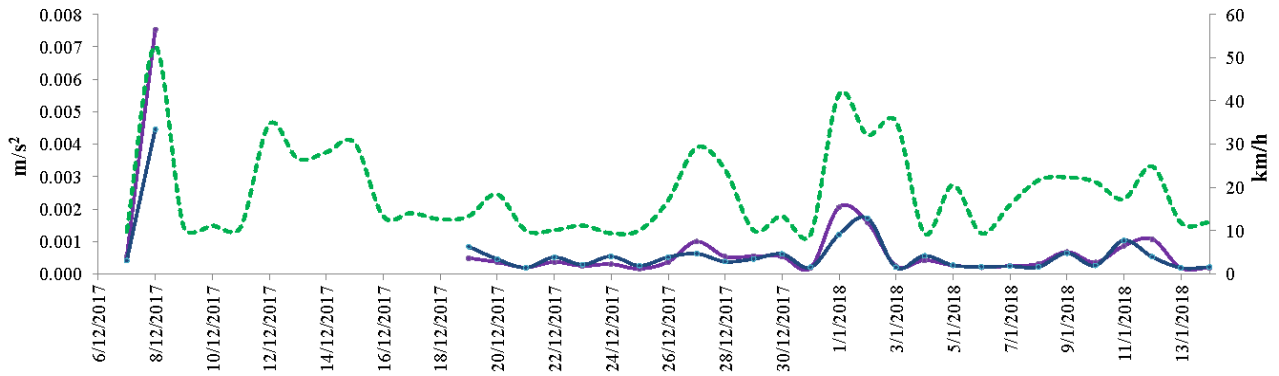
Figure 15. Daily average of the maximum hourly accelerations measured by S.2 vs. time along the x (blue) and y (red). directions. The dashed green line stands for the daily maximum wind speed.

With regard to the environmental parameters that could influence the acceleration levels on the tower, Figure 15 plots the daily average values of the maximum hourly accelerations in the  $x$  (blue) and  $y$  (red) directions, for about a month, together with the daily maximum wind speed recorded at Pieve di Compito, about 10 km from the Lucca historic centre (data available at [www.sir.toscana.it](http://www.sir.toscana.it)). The figure clearly shows a correspondence between the peaks in the acceleration levels and those in the wind speed.

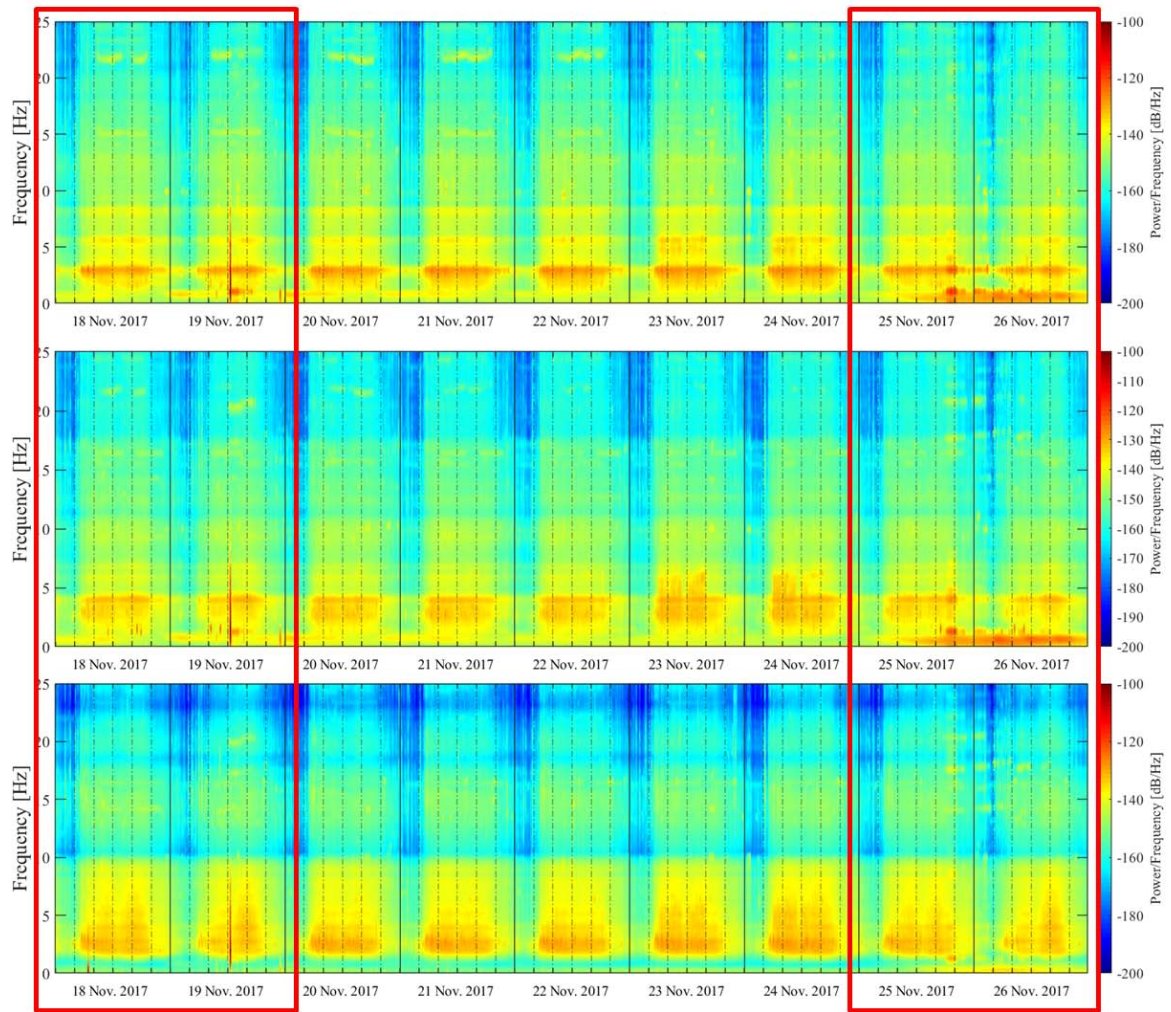
Figure 16. Spectrogram of the signal recorded by S.942 (+ 0,00 m) in the x (up), y and z (bottom) directions from 18 to 26 November 2017. Week-ends are highlighted by the red boxes.

Figures 16 and 17 provide information on the tower's vibrations over time in the band [0, 25] Hz. In particular, Figure 16 shows the spectrogram of the signal recorded by S. 942, at the base of the tower, in the period 18 November to 26 November 2017, for the three channels x (up), y and z (bottom). The tower's natural frequencies are clearly visible in the band [0, 10] Hz (horizontal lines), as well as the 3 Hz frequency of the building adjacent to the tower, along the x direction. As a result of anthropogenic activity, the power frequency increases in the entire band during the daytime, in particular during week-ends (18-19 November, 25-26 November). The three-dimensional spectrogram of channel x plotted in Figure 17 also highlights other anthropogenic activity between 20 and 25 Hz, which could be attributed to traffic in the historic centre. At about 12:30 (UTC) on 19 November, there is a clear frequency peak, which can be attributed to the M4.4 Parma earthquake reported in Table 3.

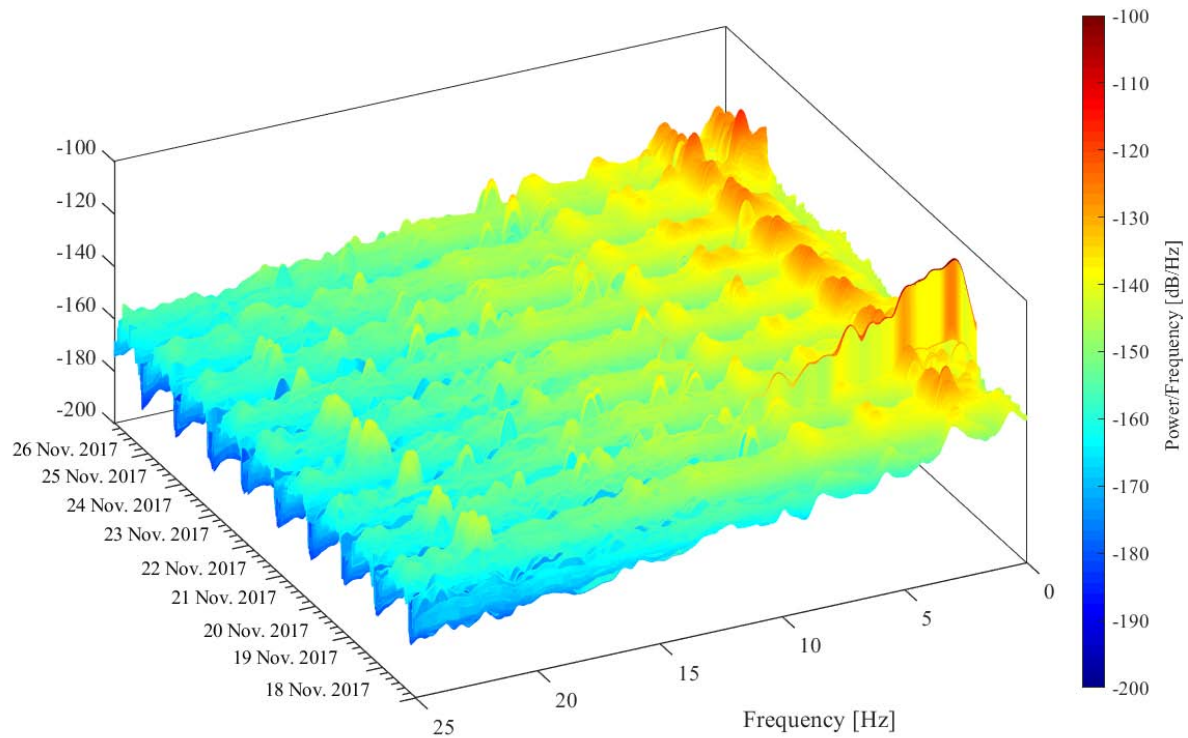
Figure 17. Three-dimensional spectrogram of the signal recorded by S.942 (+0,00 m) in the x direction from 18 to 26 November 2017.

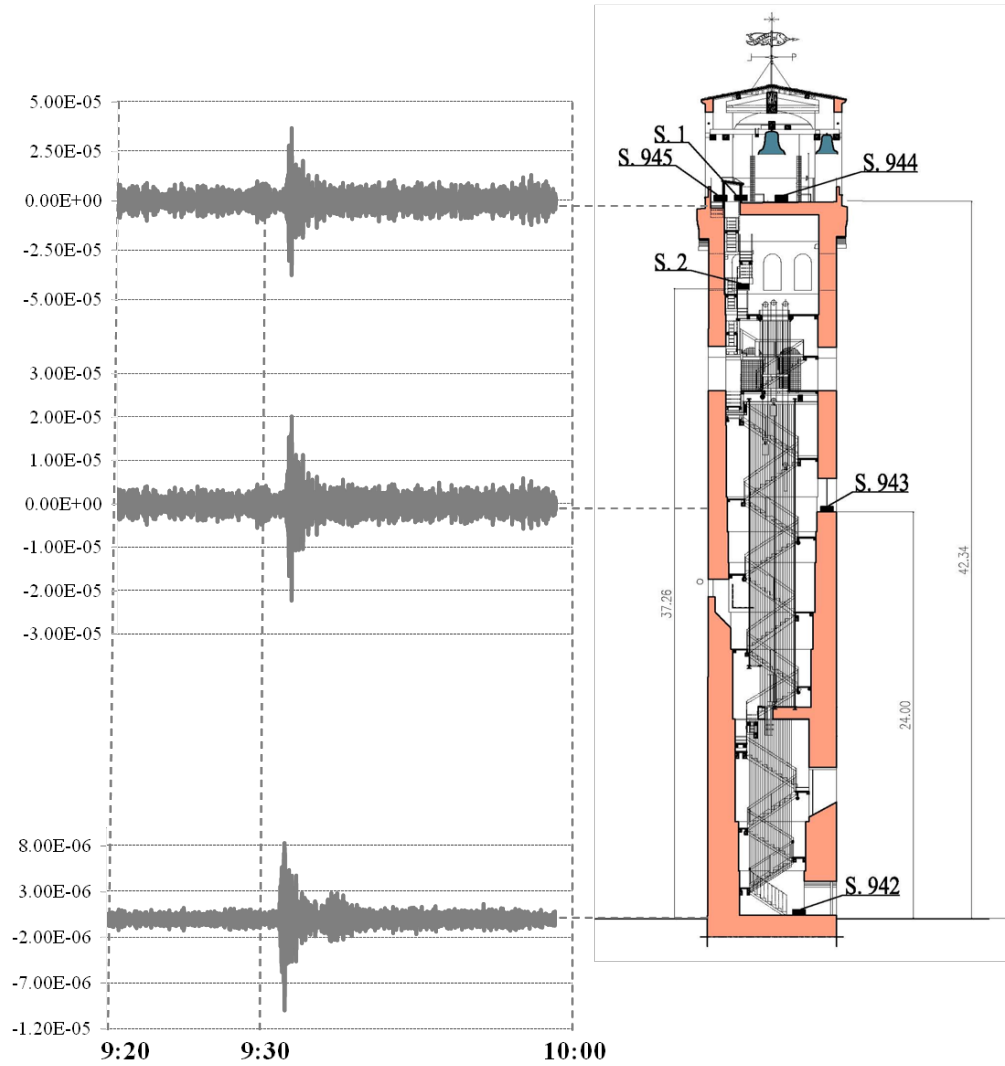
Figure 18. Signal of the Peru earthquake recorded on the tower in the  $x$  direction by S.942, S.943, S.944 on 14 January 2018 from 9:33 (UTC) onward. Signal amplitude is in  $\text{m/s}^2$ .

Many seismic events have been detected on the tower during the monitoring period. Table 3 shows the main earthquakes recorded, while Table 4 reports the teleseismic events identified in the signals. Figure 18 shows the teleseismic record of the Peru earthquake, which occurred at 09:18.44 (UTC) with a magnitude of 7.1, and was recorded at about 09:33 (UTC) by the instruments on the tower. In particular, the figure shows the signals recorded by the SS20 seismic stations at different levels along the tower's height in the x direction. The same event was also recorded by the S.2 accelerometer. At such a considerable distance from the epicentre, the seismic signal loses its high frequency content and becomes recognizable only at low frequencies. The records in the Figure were obtained by filtering the signals via a Butterworth band-pass filter with lower cut-off frequency of 0.04 Hz and a higher cut-off cut at 1 Hz. It is worth noting that after the first arrival of the waves the event remains clearly recognizable in the signals for long time.

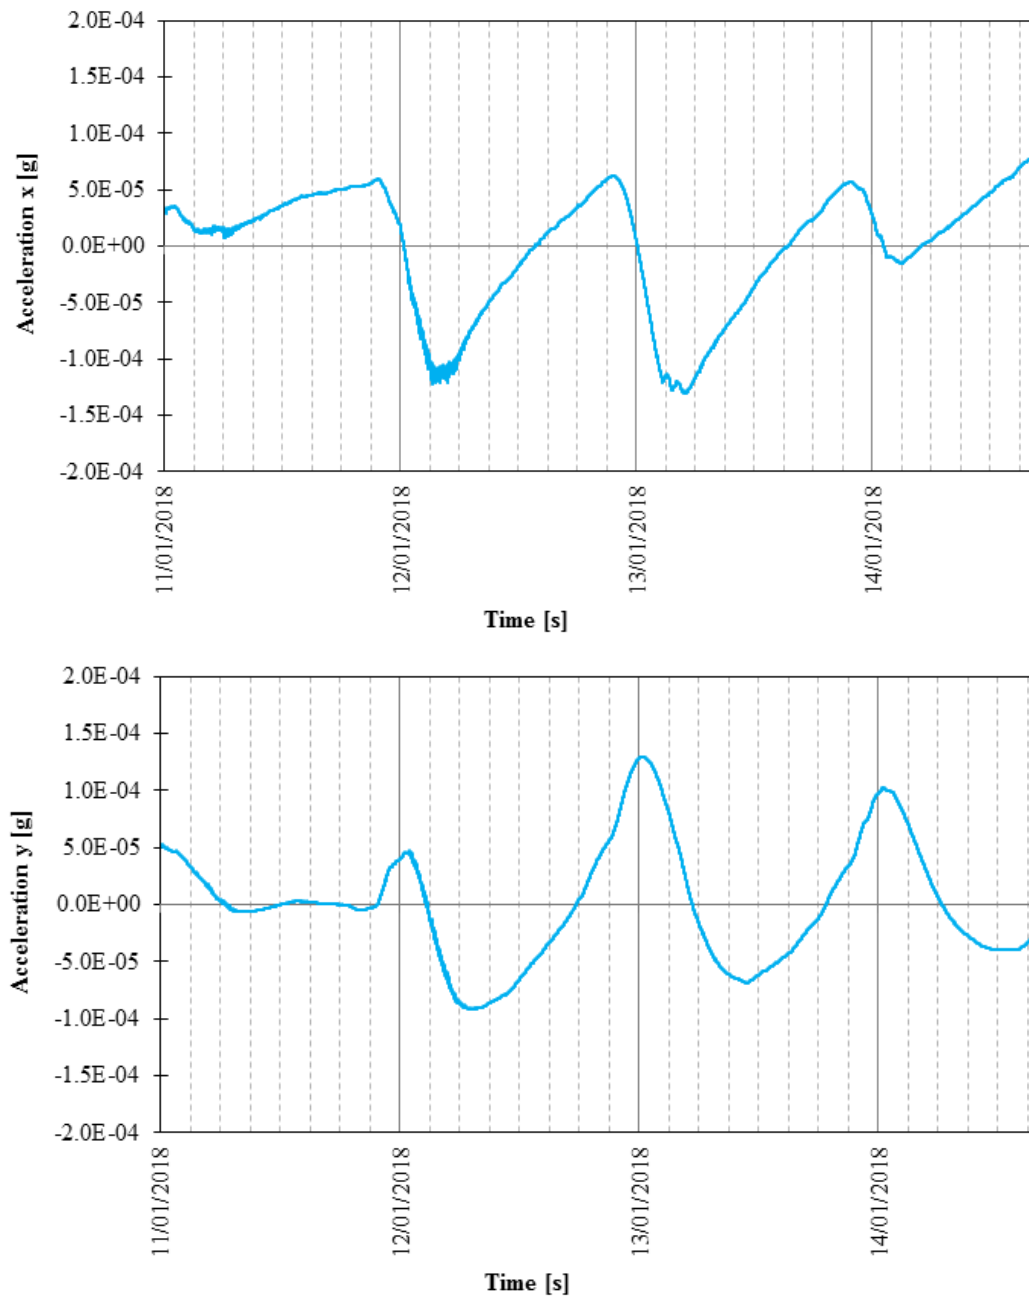
Figure 19. Low-pass filtered accelerations recorded by S.2 along the x and y (bottom) directions from 11 to 14 January 2018.

Analyzing the low frequency content of the recorded signals can provide further information on movements of the tower. Figure 19 shows the signals recorded by the S.2 accelerometer from 11 to 14 January 2018 along the  $x$  (up) and  $y$  (bottom) directions. The signals in the figure were low-pass filtered with a cut-off frequency of 0.5 Hz, and clearly reveal a slow oscillation with period of about 24 hours. The same oscillations can be detected in the temperature signal (Figure 20) measured by the sensor inside the instrument. The temperature signal is however not in phase with the accelerations, thus demonstrating that the oscillations of the accelerometric signal are not a direct effect of temperature on the instrument. It is also worth noting that the signals along the  $x$  (North-South direction) and  $y$  (East-West direction) directions present a phase shift of 3 to 6 hours, and the  $y$  signal is delayed with respect to that along  $x$ . A possible interpretation of these oscillations lies in the daily temperature variations caused by exposure of the tower to the sun. As the exposure of the façades changes during the day, the tower appears to twist as shown in the figures. A measure of the displacements induced by this effect at the top of the tower can be easily obtained from the figures. In fact, for small oscillations, the modulus of the tangential acceleration expressed in  $g$  coincides with the inclination angle of the tower in radians. Thus, taking into account the actual position of the instrument (at +37 m), horizontal displacements turn out to be on the order of 3-4 mm for both

directions. These daily movements appear to be the largest that the tower undergoes under normal conditions, as an effect of environmental factors.

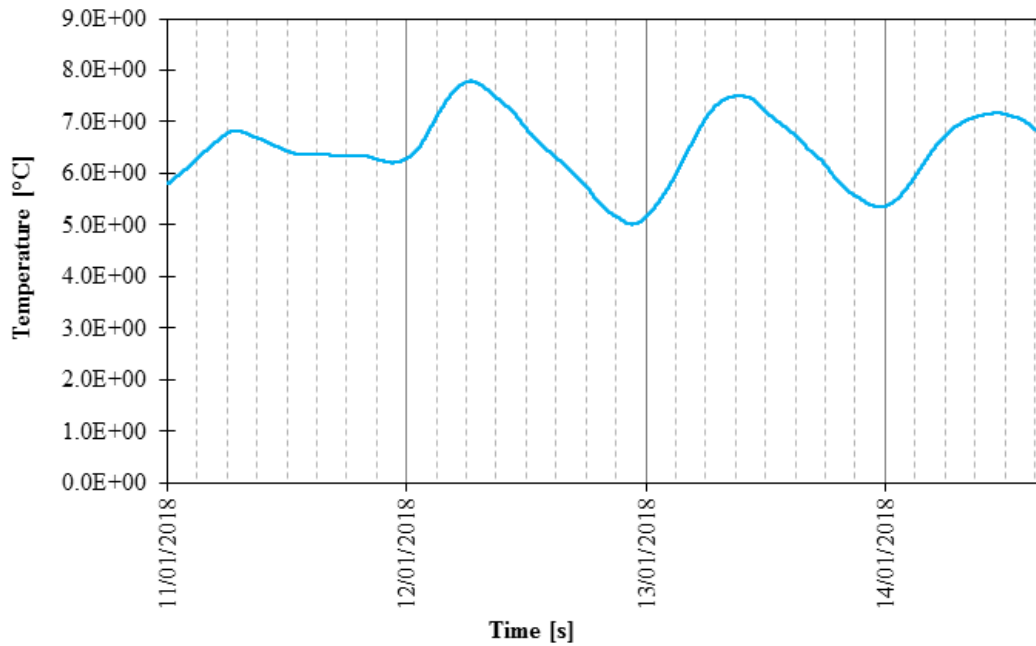
Figure 20. Temperatures recorded by the sensor installed inside S.2 from 11 to 14 January 2018.
