## **Analysis of Voltage Jumps In LFI18 R0D0-R0D1 and LFI26 R1D0-R1D1 and debug procedure on LFI 26 during OD204**

**DOC. TYPE:** Test Report

**PROJECT REF.:** PL-LFI-PST-RP-089

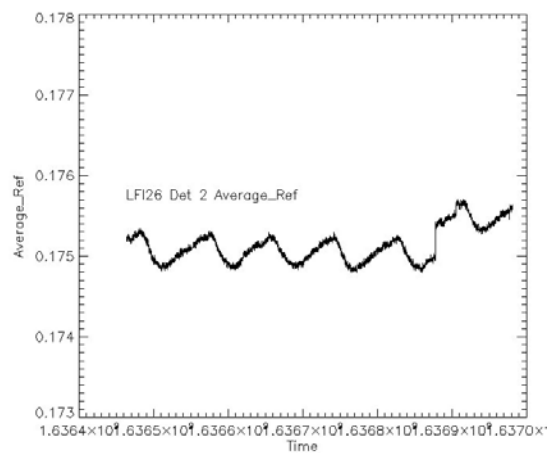
*Figure 1 Vout change on LFI 26*

In the case of channel LFI 26 the signal increased suddenly on both sky and ref without decreasing again. In the case of LFI 18 the signal decreased again.

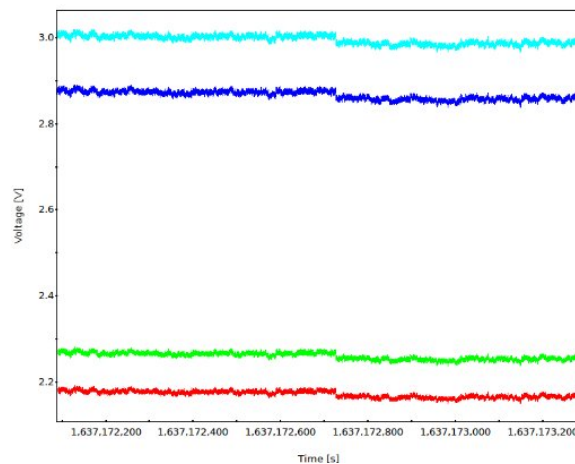
*Figure 2 Vout changes on LFI 18*

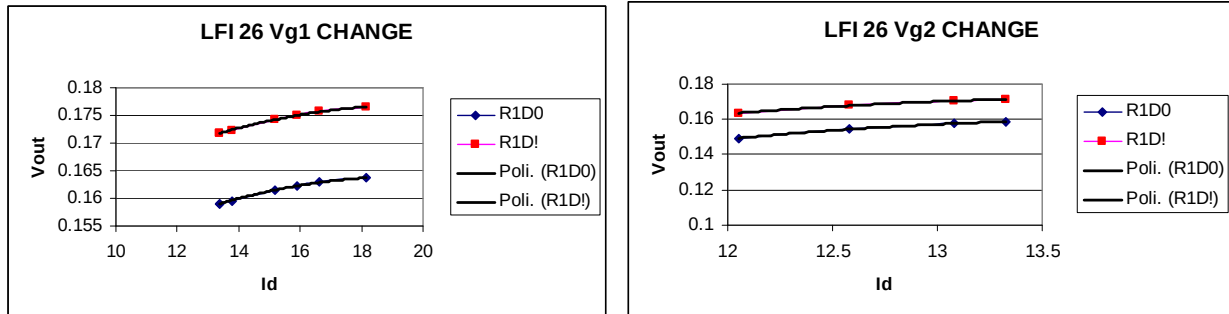
Actually, from I-V curves (below) fits using, as usual, a power law, it comes out that in the case the Id variation was due to a Vg changes on S2, the expected Vout change should be hundred times smaller :

Vg1 (Id) change → DELTA R1D0\_sky (Id) =  $2.36 E-6$   
Instead of the measured  
DELTA\_meas  $>3 E-4$

Vg2 (Id) change → DELTA R1D0\_sky (Id) =  $1.16 E-6$   
Instead of the measured  
DELTA\_meas  $>3 E-4$

Hence, the difference between expected and measured data is by a factor 50 about.  
This possibility does not fully explain the numbers we are measuring.

Figure 3 I-V curves for LFI 26 in the  $I_d$  range considered: left panel ,  $V_{g1}$  is changed keeping  $v_{g2}$  still; right panel,  $V_{g2}$  is changed keeping  $V_{g1}$  still.

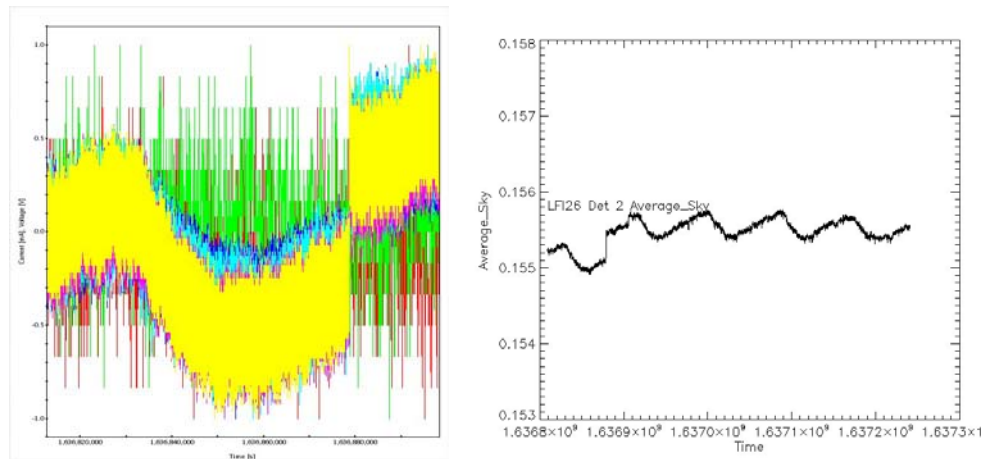
However, A bias change should be related to a drain current change in the LNAs. In LFI 26 no relevant Id changes are observed. Despite the Id changes are different on the two coupled ACAs (relative variation on S2 is ten times the variation on S1) , however the numbers involved seem to be too low to justify the V change.

Figure 4 LFI 26 :  $V_{out}$  change (yellow, cyan, traces) vs.  $I_d$  . the two behaviours seem uncorrelated. The Voltage value keeps constant since the variation occurred on OD 184 (Right panel)

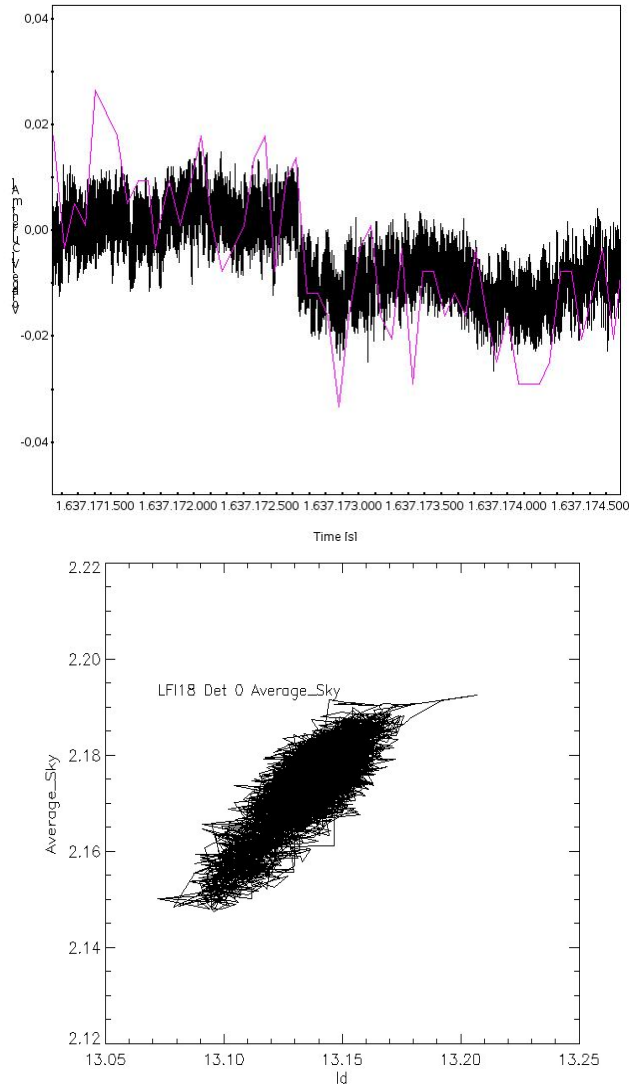
- a) b) c) The same as said before for LFI 26
- d) It seems to be a good explanation: actually, as reported in Figure 8, the signal changes are proportional on sky and ref. Moreover, if we consider the  $I_d$  change and correlate it with the signal change, a good agreement comes out:

*Figure 5 LFI 18:  $I_d$  (M1, magenta) vs  $V$  (R0D0, black) correlation ; right panel:  $I_d$ (M1) on x axis Vs  $V_{out\_R0D0}$  along three days*

If we follow the same approach as for LFI 26, the amplitude of the expected  $V$  change due to  $I_d$  change is :

Vg1\_M1 ( $I_d$ ) change →  $\Delta R0D0\_sky(I_d) = 6 \text{ E-3}$   
Vg2\_M1 ( $I_d$ ) change →  $\Delta R0D0\_sky(I_d) = 5 \text{ E-3}$

Vg1\_M2 ( $I_d$ ) change →  $\Delta R0D0\_sky(I_d) = 8 \text{ E-4}$   
Vg2\_M2 ( $I_d$ ) change →  $\Delta R0D0\_sky(I_d) = 6 \text{ E-4}$

Instead of the measured  
DELTA\_meas 1.2 E-2

Hence, the difference between expected and measured data is by a factor 2 about.

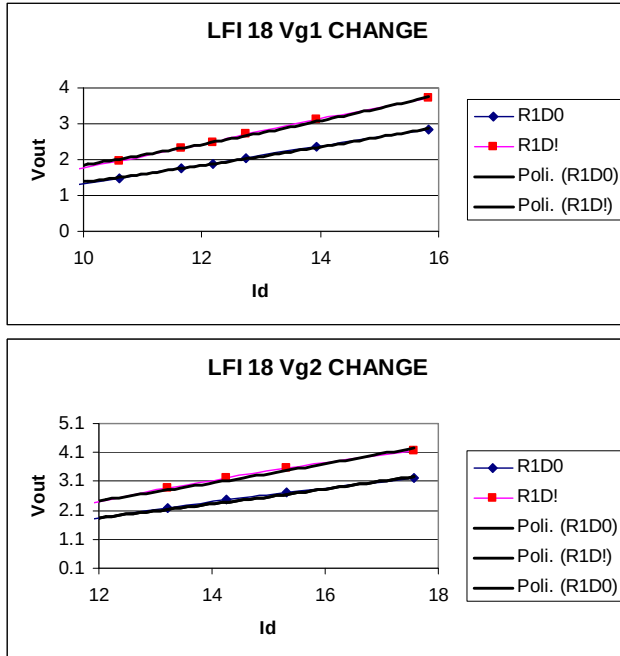
Figure 6 I-V curves for LFI 18 in the  $I_d$  range considered: left panel,  $V_{g1}$  is changed keeping  $v_{g2}$  still; right panel,  $V_{g2}$  is changed keeping  $V_{g1}$  still.

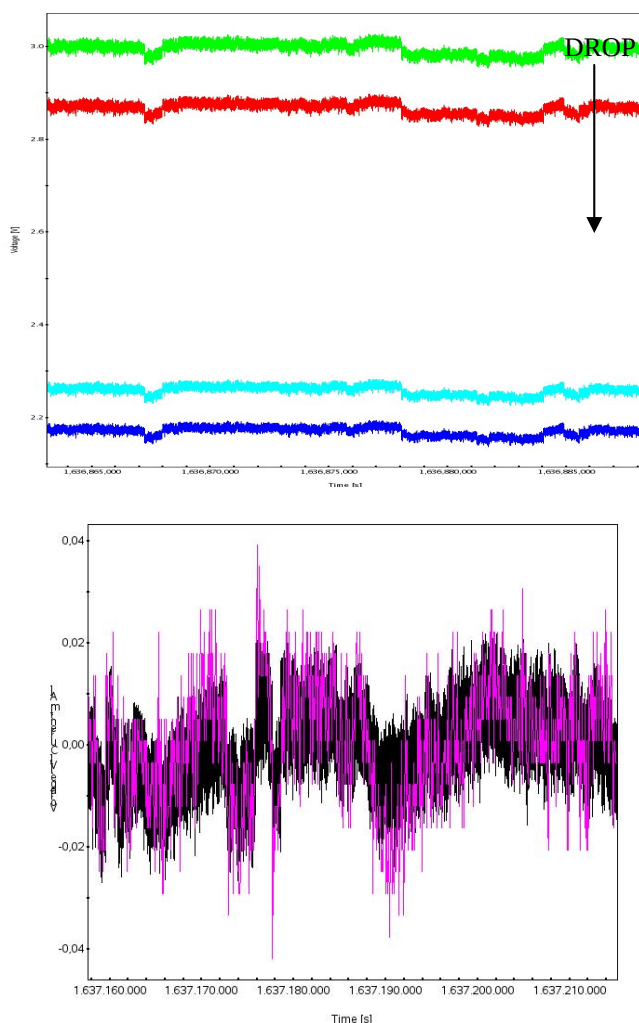
In add, we see that this behaviour is typical of this channel and that the previous signal level is restored after a certain time:

*Figure 7 Left panel: Typical behaviour of LFI 18 M ( OD 178 ) ; Right panel: OD 188 : correlation between Vout and Id along 18 hours .*

The above explanation seems to be satisfactory, not requiring to investigate also frames e) and f).

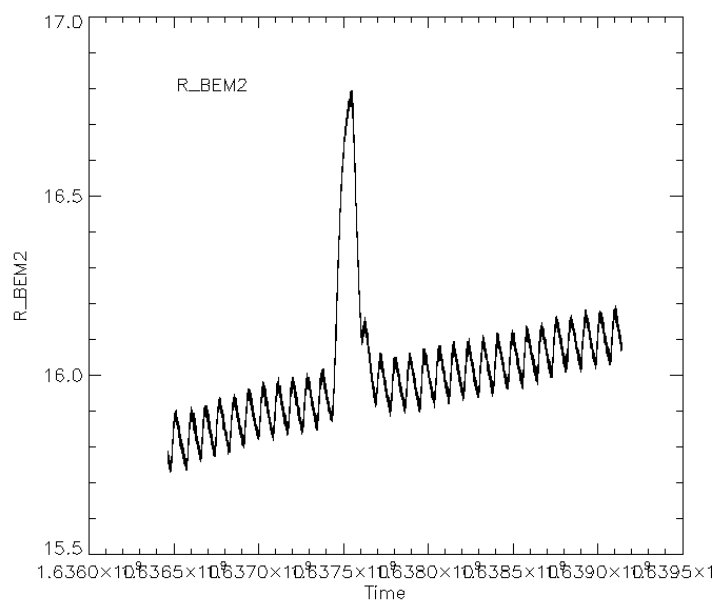
It is worth mentioning the problem occurred with the transponder during OD 192, exhibiting as an abrupt change in the scientific output of the most radiometers caused by the heating up and down of the Back End Unit containing the LFI warm amplifiers, for a period longer than the usual daily three hours.

*Figure 9 BEU temperature from OD 180 to OD 210: the abrupt increase is due to the transponder heating effect.*

Actually, as shown by Figure 9, for the time being the BEU temperature is higher than during OD 184. Hence, due to the typical thermal response of the LFI 26 (voltage output anti-correlated with the BEU temperature) we would expect today a Vout lower than that measured after the event of OD 184.

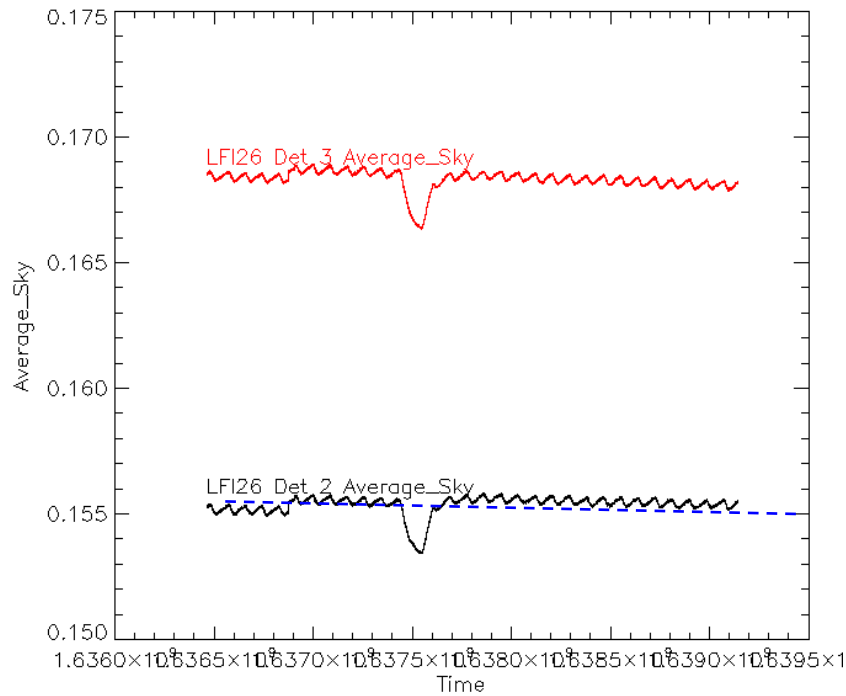
An overall view of the R1D0 sky signal and R1D1 ref signal during a range of about 30 days, from OD 180 to 209 (Figure 10), does not show changes comparable to the OD 184 jump during the recovery procedure.

Instead, what we observe today is a larger V out on one diode (R1D0) and a comparable voltage on the coupled diode (R1D1). The following plots support this thought, showing that the permanent change on LFI 26R1D0 is not correlated with a temperature change in the BEU.

In the two following figures, it is however evident the different behaviours of the two detectors before and after the OD192 long transponder heatup : RCA26 – 10 detector shows a discontinuity in the trend that was not recovered in the following days.

Figure 10 RCA26 R1D0 sky signal (black, bottom) and R1D1 ref signal (red, top) from OD 180 to 210. Jump in the signal during OD184 is evident in the plots together with the 32 hours Transponder on period on OD 191-192. No evidence of a relevant change during the debug procedure applied during OD204 is clearly visible. A further remark is the behaviour of the RCA26 – 10 before and after the transponder long heating; it is evident that while detector 11 has gone back to its previous status, detector 10 has an increased baseline.

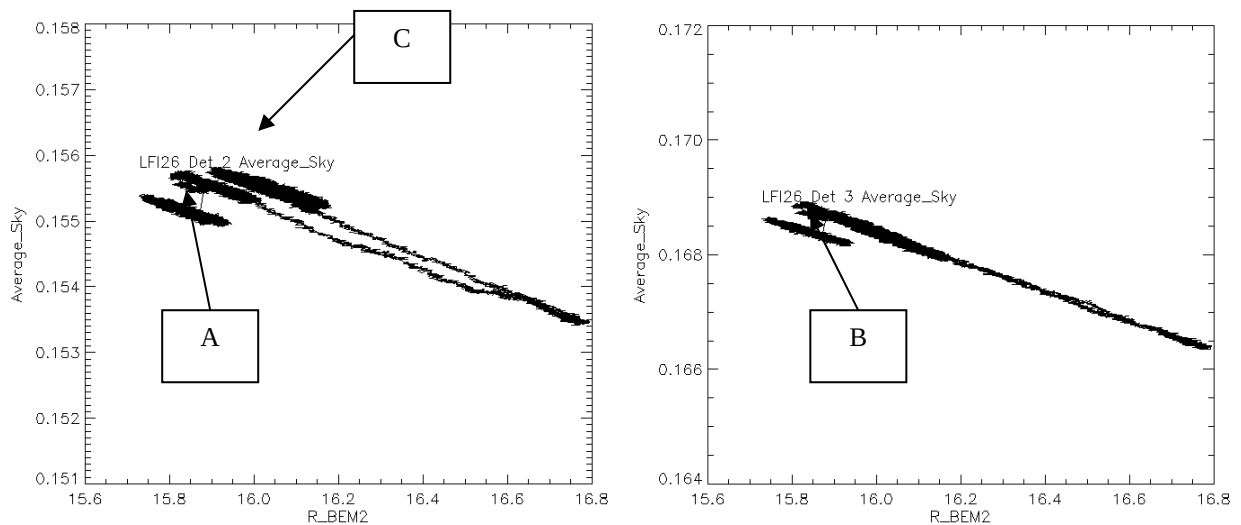
Figure 11 Correlation between RBEM temperature and sky signal on R1D0 (left) and R1D1 (right). In both panels it is evident the discontinuity due to the Voltage (A, B) jump: however, in

*R1D0 we observe also a second discontinuity ( C ) due to the non recovered voltage change following the transponder effect.*

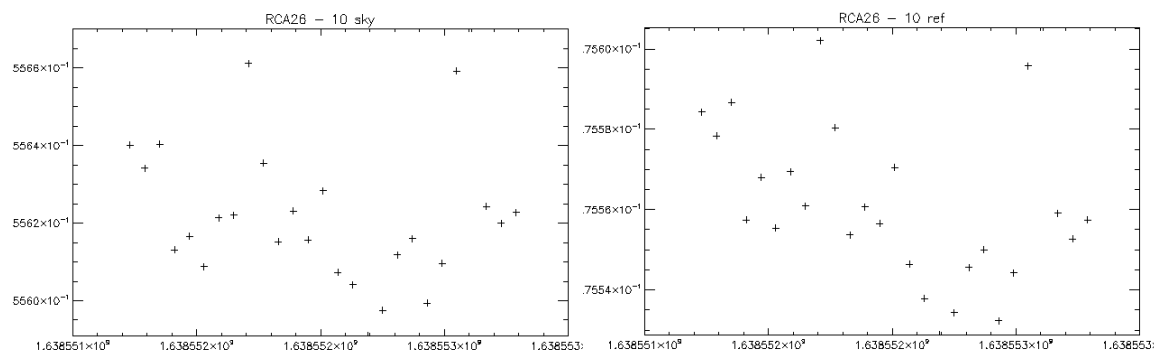
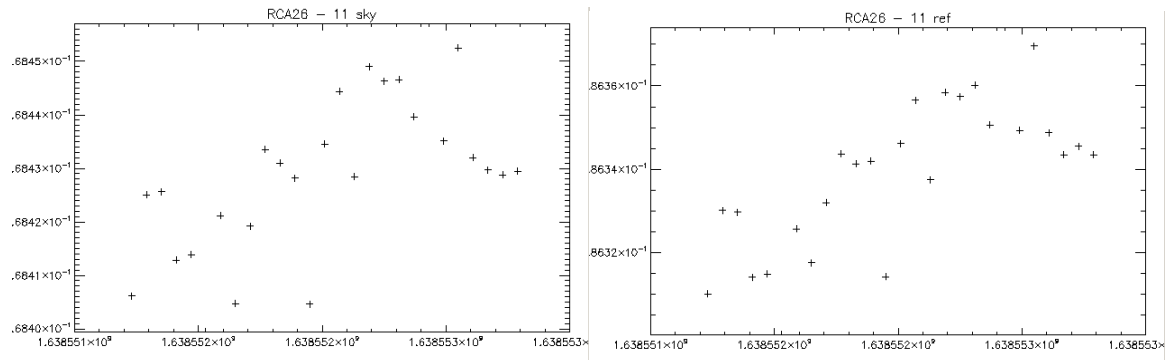
As a first analysis, the average signal was evaluated for each minute (starting from 17:07), on the 40 central seconds, i.e. cutting first and last 10 seconds. Results are reported in the Figure 12.

Time range is from 17:07 to 17:35, when the dedicated scientific real time visibility ended. First three points are taken as a reference before the first setting (Gain) is applied. Last two steps, separated by only 30 seconds, are mixed in a single point.

*Figure 12 Each point in the plots is the average of 40 seconds of data starting from second 10 to 50 of each minute, from 17:07 to 17:35. So the first 3 points are taken before the procedure is applied, than 16 points report the values for each of the procedure steps and last points give the behaviour until the end of Real Time science acquisition. There is no evidence of a sudden change towards a systematic different level.*

In the detector R1D0 a change in both the sky and ref level is visible after the third point, i.e. as the first setting was applied, but the dispersion of the subsequent points show it is not really a definite jump.

In the detector R1D0 the mean value of the first points is at a lower level than in the final part, but no clear and systematic discontinuity or jump is visible.

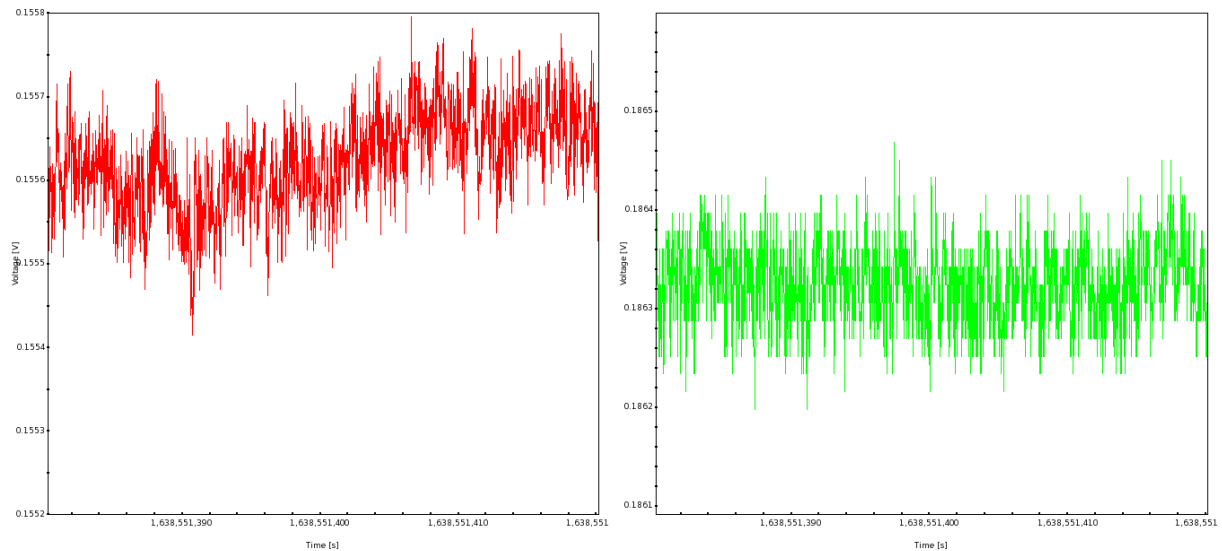
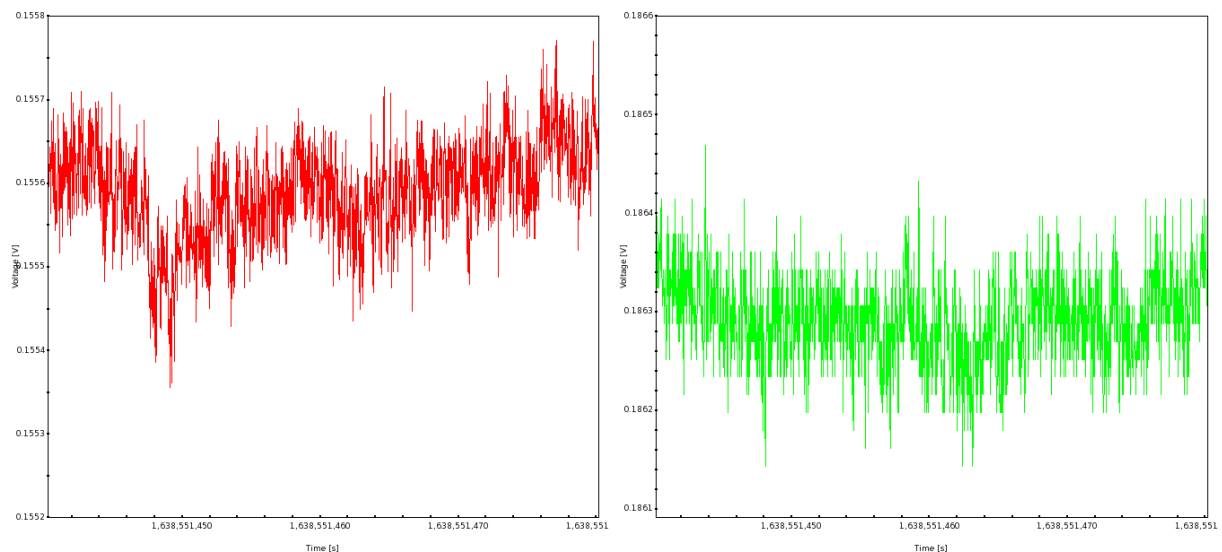
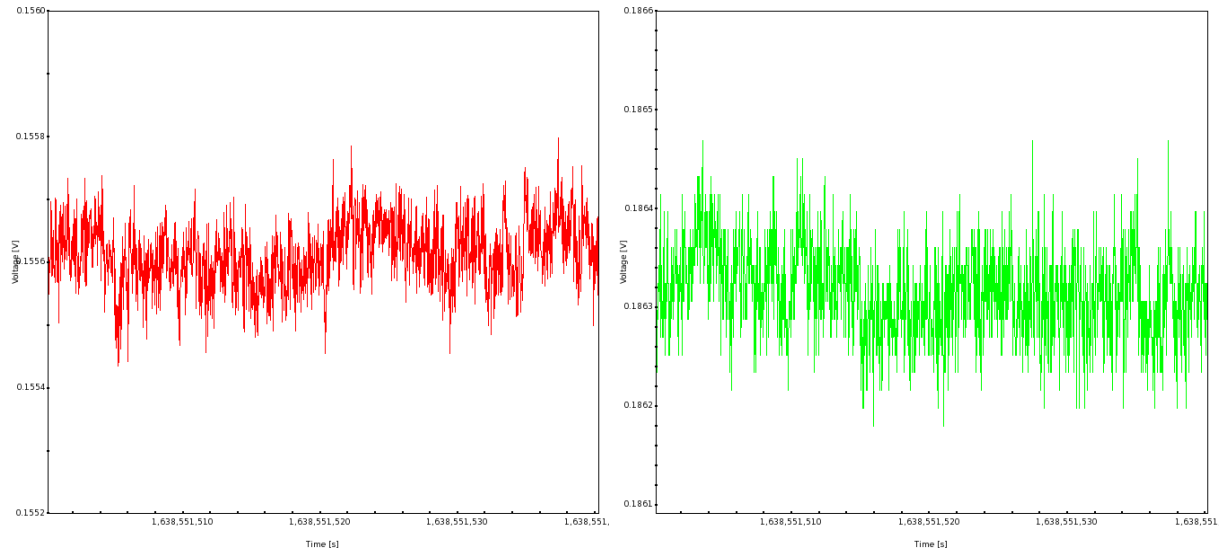
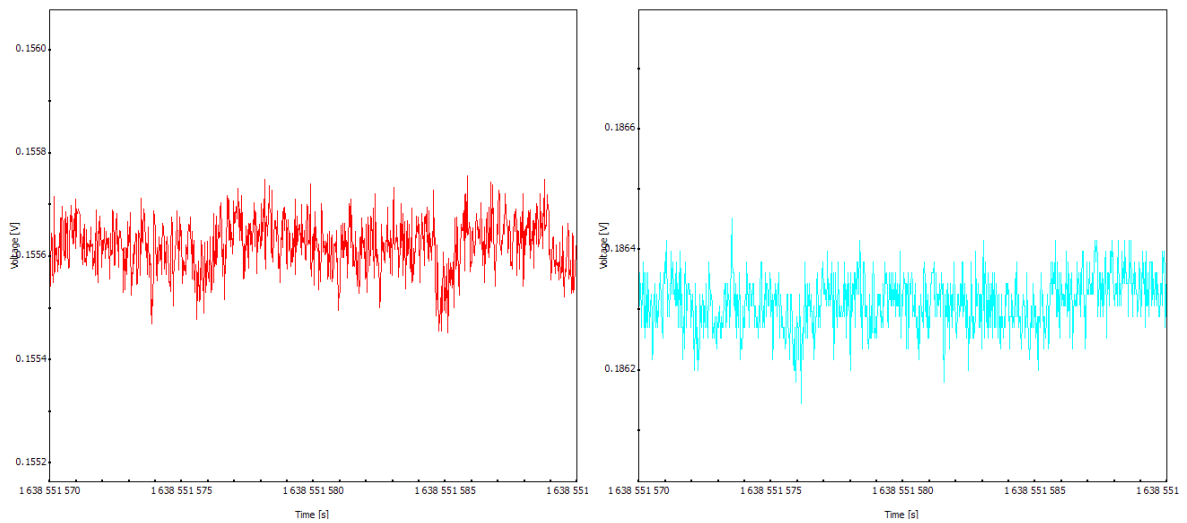
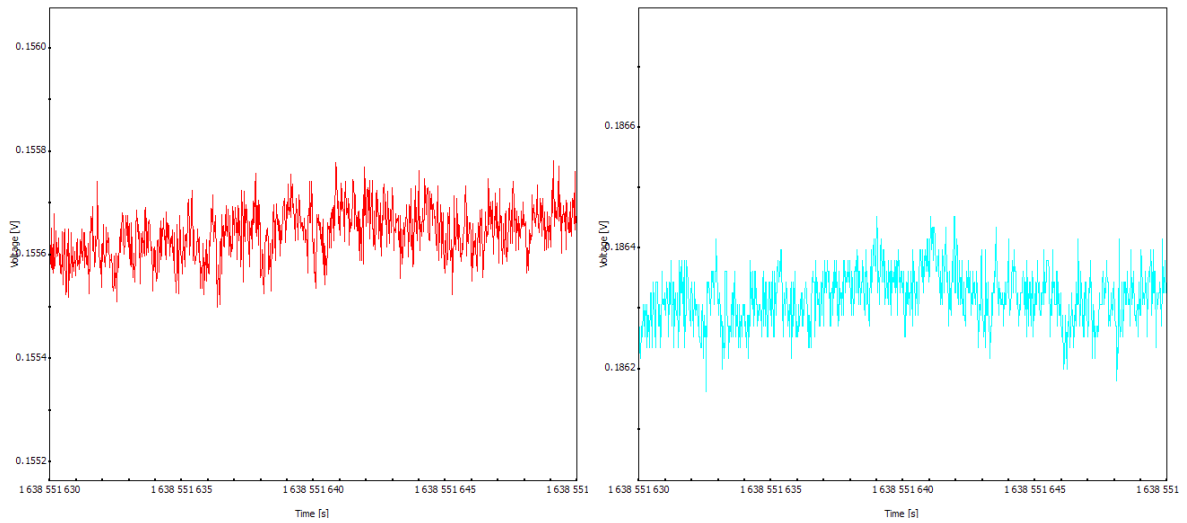
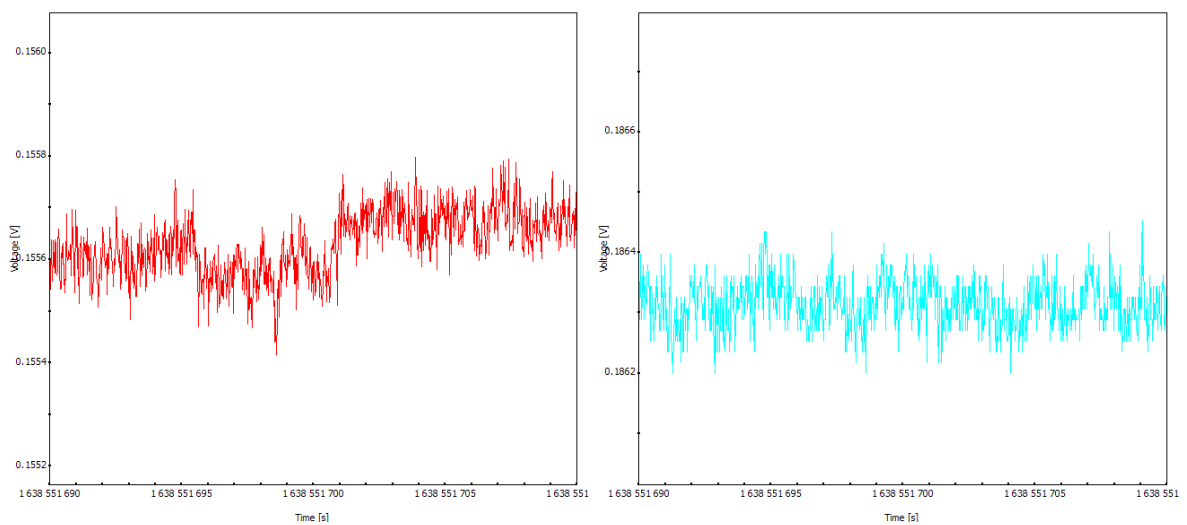
A zoom of 20 seconds, centered on the TC application time, of the R1D1 ref signal and R1D0 sky, as representatives of the whole radiometer is reported for each minute. The TC is applied in the central point of the graph which is the point referring to the time reported above each of the plots.

- the last two plots, where 60 seconds of data since 17:24:50 to 17:25:40 are reported in order to display both the last two steps separated by just 30 seconds. Left panel is Sky output of the R1D0, right panel is Ref output of the R1D1.
- the first three plots which spans 40 seconds; in this way, it was possible to display the only suspect gap soon before 17:11 in the R1D0 that was anyway not outstrading being definitely at the same level of the normal fluctuations.
