| <b>Title</b> | SWEPT SOURCE TEST: COUPLING MEASUREMENTS REPORT |

## SWEPT SOURCE TEST: COUPLING MEASUREMENTS REPORT

TECHNICAL NOTE

PL-LFI-PST-TN-058

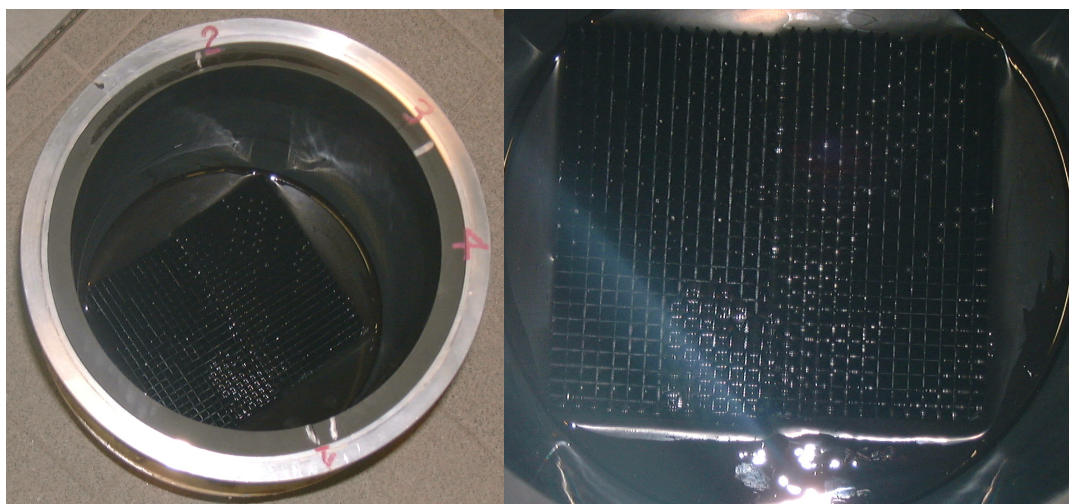
The sky load used here is not the sky load will be integrated in the LFI RCA cryo chamber but is similar. Internal dimensions are the same and on the bottom part a two rectangular sheets of pyramids have been inserted to simulate the actual sky load.

Figure 2: Sky load used during this tests.

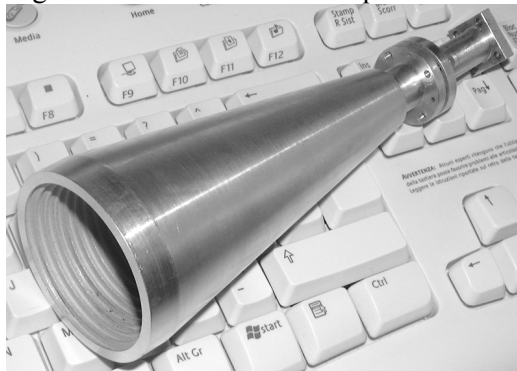
The sky horn is the LFI 30 GHz EBB. Its performances are reported in **Errore. L'origine riferimento non è stata trovata.** and [RD 3]. This horn design is similar to the Flight Model. The corrugation profile is the same. The circular waveguide straight section and the external profile are not.

*Figure 4 Sky horn. This horn is the LFI EBB horn connected to the circular / rectangular waveguide transition.*
