| <b>Title</b> | Zero Bias Configuration - validation test using the NI-PLM setup |

# Zero Bias Configuration validation test using the NI-PLM setup

Ref : EUCL-IBO-TN-7-031  
Issue : 1.0  
Date : 04/01/2021  
Page : 1/27

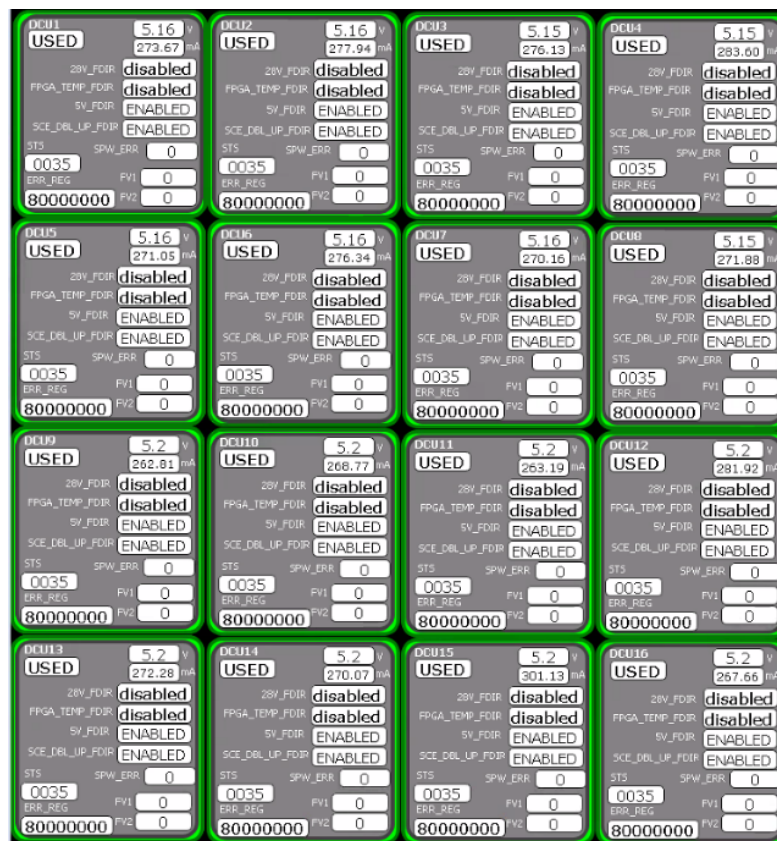
Figure 2, entire NI-Focal Plane under ZBC, all telemetries correspond to nominal values. The image is the Focal Plane's display of the TASI synoptic.

- Tested with 16 DCUs/SCEs all OK see Figure 2; each ZBC register was tested correctly using a memory DUMP; 2 x repetitions of the ZBC configuration (1) were done, for each one a single broadcast nominal dither cycle was acquired.
